Michael K. Aselton Memorial Park

Town of Barnstable
ADA Transition Plan
October 2021

**Town of Barnstable
Michael K. Aselton Memorial Park**

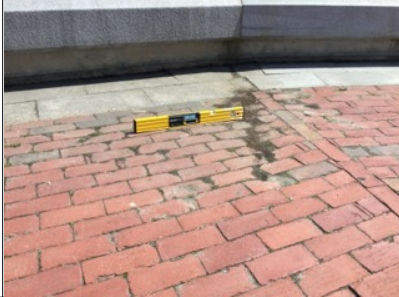
ID	Location	Floor	Room	Element	Type	Photo	Issues	Current Measure	Recommendations	Quantity	Price	Cost Estimation
Approach and Entrance												
Exterior Access Route												
1	Near Asselton Memorial	Ext		Exterior Access Route	Walkway

Cross slope > 1:50 (2.00%)	3.5%	Reduce cross slope to be no steeper than 1:50 (2.00%).	1	-	\$0
2	Brick Route on South Side	Ext		Exterior Access Route	Walkway

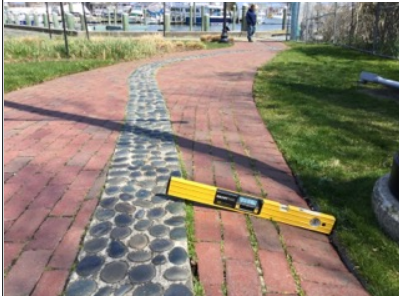
Cross slope > 1:50 (2.00%)	23.1%	Reduce cross slope to be no steeper than 1:50 (2.00%).	1	-	\$0
3	Route to East Side Staircase	Ext		Exterior Access Route	Walkway

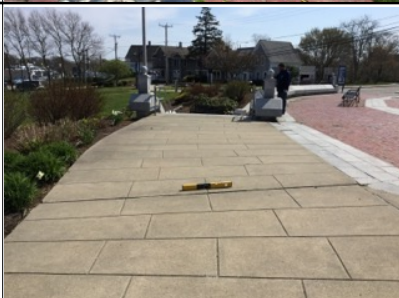
Cross slope > 1:50 (2.00%)	4.2%	Reduce cross slope to be no steeper than 1:50 (2.00%).	1	-	\$0
4	Northeast Route	Ext		Exterior Access Route	Walkway

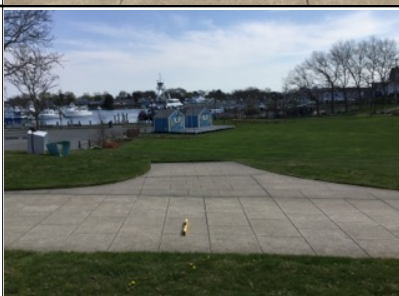
Cross slope > 1:50 (2.00%) Running slope > 1:20 (5%)	4% 7.3%	Reduce cross slope to be no steeper than 1:50 (2.00%). Reduce running slope to be no steeper than 1:20 (5%).	1	-	\$0
5	Brick Route on South Side	Ext		Exterior Access Route	Walkway

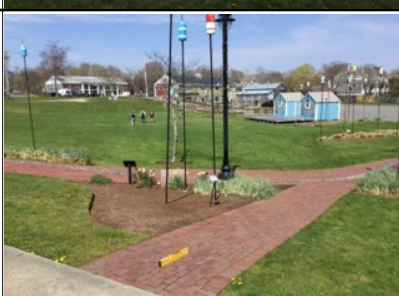
Running slope > 1:20 (5%)	15%	Reduce running slope to be no steeper than 1:20 (5%).	1	-	\$0

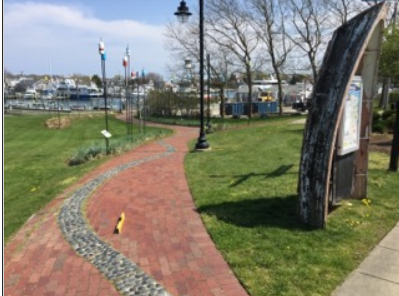
ID	Location	Floor	Room	Element	Type	Photo	Issues	Current Measure	Recommendations	Quantity	Price	Cost Estimation
6	Brick Route on South Side	Ext		Exterior Access Route	Walkway

Running slope > 1:20 (5%)	8.9%	Reduce running slope to be no steeper than 1:20 (5%).	1	-	\$0
7	Brick Route on South Side	Ext		Exterior Access Route	Walkway

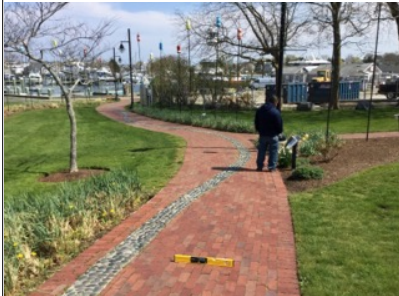
Running slope > 1:20 (5%)	8.6%	Reduce running slope to be no steeper than 1:20 (5%).	1	-	\$0
8	Cement Route West Side	Ext		Exterior Access Route	Walkway

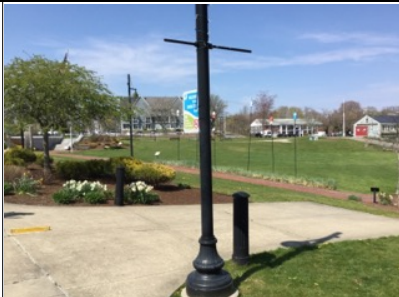
Running slope > 1:20 (5%) Vertical clearance < 80" above ground	9.1% 69"	Reduce running slope to be no steeper than 1:20 (5%). Install sign with the bottom of the sign 80" min. above the ground.	1	-	\$0
9	Cement Route West Side	Ext		Exterior Access Route	Walkway

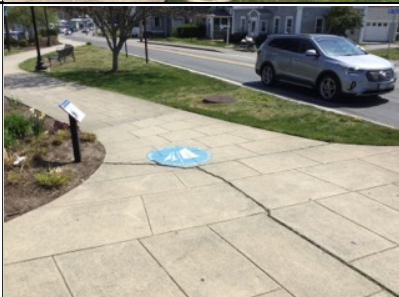
Level changes > 1/4"	0.5"	Alter change in level to be 1/4" high max.	1	-	\$0
10	Route West Side	Ext		Exterior Access Route	Walkway

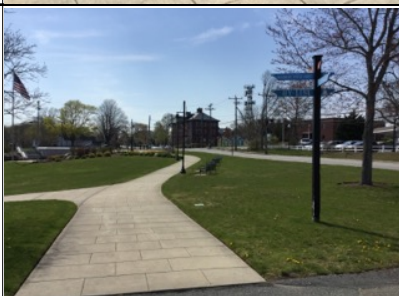
Level changes > 1/4"	1.5"	Alter change in level to be 1/4" high max.	1	-	\$0

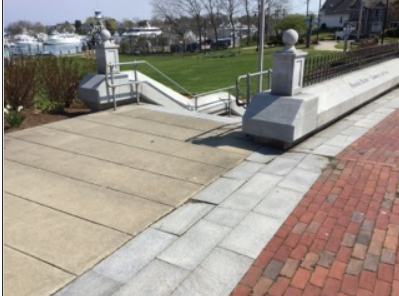
ID	Location	Floor	Room	Element	Type	Photo	Issues	Current Measure	Recommendations	Quantity	Price	Cost Estimation
11	East Side Stairwell	Ext		Exterior Access Route	Walkway

Level changes > 1/4"	0.5"	Alter change in level to be 1/4" high max.	1	-	\$0
12	Memorial Near East Staircase	Ext		Exterior Access Route	Walkway

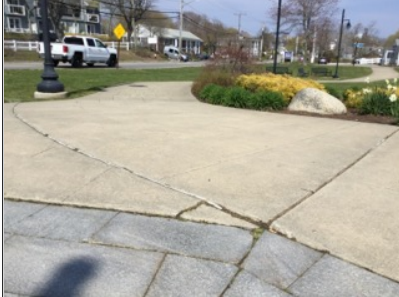
Level changes > 1/4"	0.5"	Alter change in level to be 1/4" high max.	1	-	\$0
13	East Side Stairwell	Ext		Exterior Access Route	Walkway

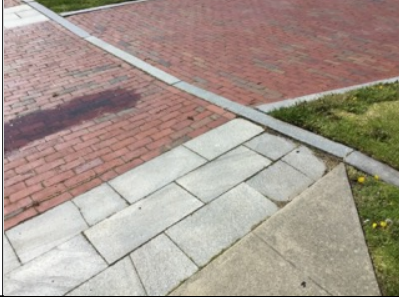
Level changes > 1/4"	1"	Alter change in level to be 1/4" high max.	1	-	\$0
14	Memorial Facing South Street	Ext		Exterior Access Route	Walkway

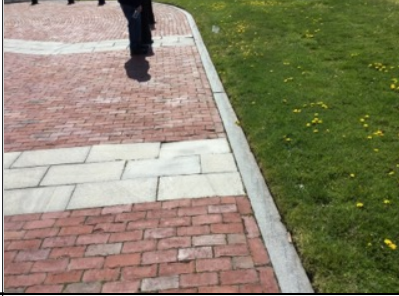
Route not maintained in operable working condition	.75"	Ensure the accessible route is maintained in operable working condition. (Reduce change in level to 1/4" max.)	1	-	\$0
15	Route to Stage	Ext		Exterior Access Route	Exterior

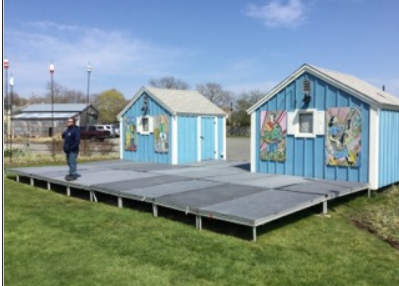
Accessible route not provided	-	Provide a 15.5' long minimum ramp with handrails from the parking lot to have an accessible route to the stage. Provide an accessible route from the existing path on the southwest side of the park to two wheelchair spaces with companion seating approximately 30' from the front of the stage (beach mat).	1	-	\$0

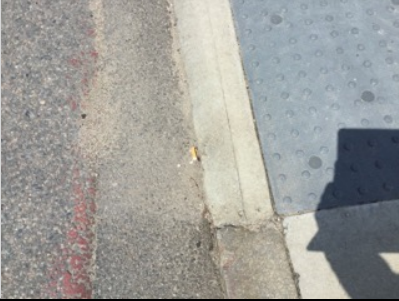
ID	Location	Floor	Room	Element	Type	Photo	Issues	Current Measure	Recommendations	Quantity	Price	Cost Estimation
Curb Ramp												
16	Ocean Street	Ext		Curb Ramp	N/A

Transition from curb ramp to street not flush	-	Ensure transition from curb ramp to street is flush or free of changes in level.	1	-	\$0
17	Ocean Street at Memorial	Ext		Curb Ramp	Parallel

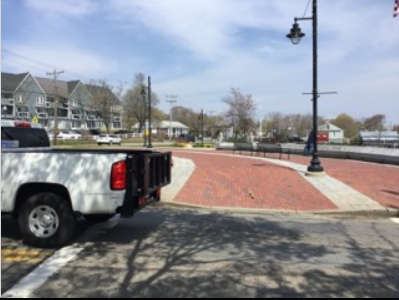
Transition from curb ramp to street not flush Cross slope > 1:50 (2%) (MAAB)	- 4.4%	Ensure transition from curb ramp to street is flush or free of changes in level. Reduce cross slope at curb ramp to be no steeper than 1:50 (2%). Recommend providing detectable warning.	1	-	\$0
18	Ocean Street at Memorial	Ext		Curb Ramp	Parallel

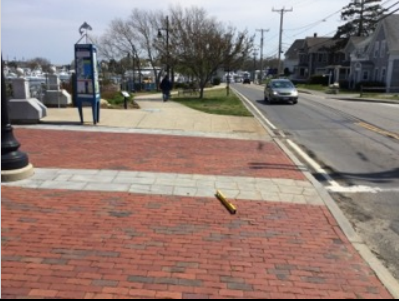
Cross slope > 1:50 (2%) (MAAB)	3.9%	Reduce cross slope at curb ramp to be no steeper than 1:50 (2%).	1	-	\$0
Access to Goods and Services												
Benches												
19	West Side Cement Route	Ext		Benches	Walkway

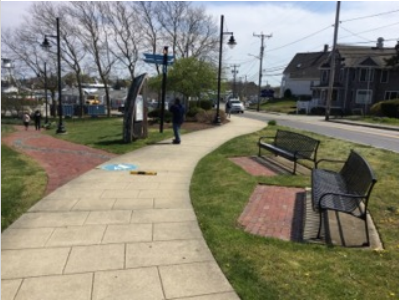
No accessible route to one bench in this area	-	Provide an accessible route to one (1) bench in this area. Recommend providing 36"X48" minimum clear floor space adjacent to the bench. (Cost to provide 4' wide by 6' long asphalt path to bench.)	1	240	\$240

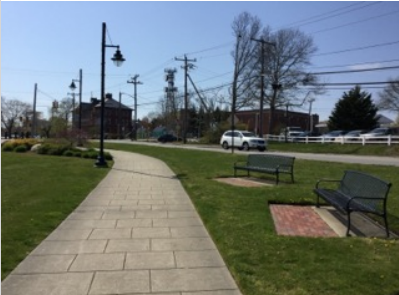
20	East Side Route	Ext		Benches	N/A

No accessible route to one bench in this area	-	Provide an accessible route to one (1) bench in this area. Recommend providing 36"X48" minimum clear floor space adjacent to the bench. (Cost to provide 4' wide by 9' long asphalt path to bench.)	1	360	\$360

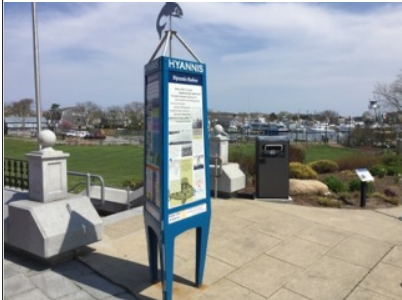
ID	Location	Floor	Room	Element	Type	Photo	Issues	Current Measure	Recommendations	Quantity	Price	Cost Estimation
Best Practice												
Signage												
21	Memorial	Ext		Signage	Informational

Recommend that character size complies with the Character Height Table 703.5.5 in the ADA 2010 Standards.	1	-	\$0
22	West Side Staircase	Ext		Signage	Informational

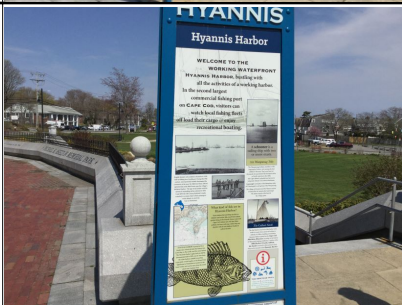
Recommend that character size complies with the Character Height Table 703.5.5 in the ADA 2010 Standards.	1	-	\$0
23	By West Side Benches	Ext		Signage	Informational

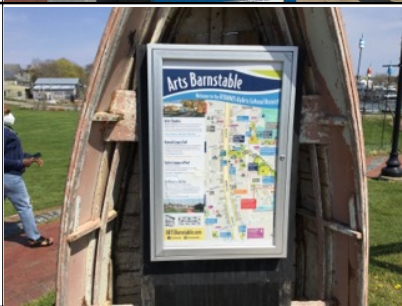
Recommend providing signs with a non-glare finish with characters that have a high contrast to the background.	1	-	\$0
Stairway												
24	East Staircase	Ext		Stairway	Exterior

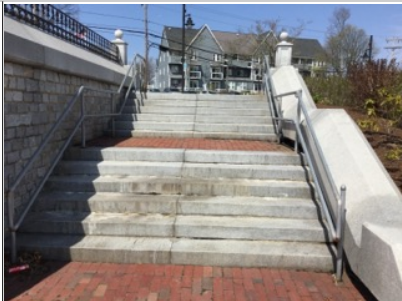
Recommend providing contrast at steps and extending handrails 12' at all exterior staircases.	1	!	\$0
