# Hyannis Golf Course

## Town of Barnstable ADA Transition Plan

August 2021

Institute for Human Centered Design

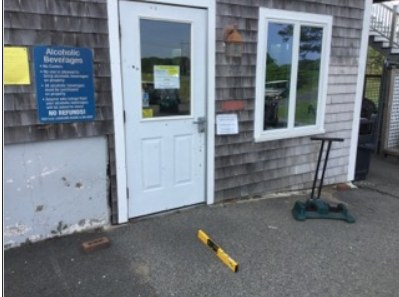
Obstructed by protruding objects Vertical clearance < 80" above ground	8" 64.2"	Relocate lamp so that the bottom of the lamp is 80" min. above the ground.	1	306	\$306
2	Route from Parking to Pro Shop	Ext		Exterior Access Route	Exterior

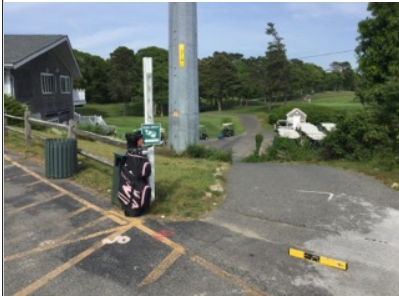
Cross slope > 1:50 (2.00%)	6.3%	Reduce cross slope to be no steeper than 1:50 (2.00%).  (Cost based on asphalt to correct slope.)	1	240	\$240
3	Pro Shop to Stairwell - Hyannis Golf Club	Ext		Exterior Access Route	Exterior

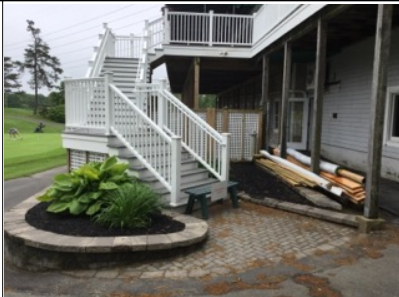
Cross slope > 1:50 (2.00%)	5.5%	Reduce cross slope at stair landing to be no steeper than 1:50 (2.00%) in all directions.  (Cost based on a 4' x 4' brick paver patch.)	1	416	\$416

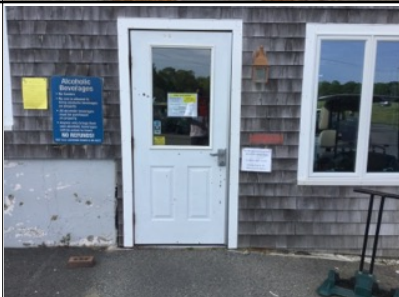
4	Entrance to Pro Shop - Hyannis Golf Club	Ext		Exterior Access Route	Exterior

Cross slope > 1:50 (2.00%) Running slope > 1:20 (5%)	2.9% 9.2%	Reduce slope at door landing to 1:50 (2.00%) in all directions.  (Cost based on asphalt to correct slope.)	1	240	\$240
5	Teeing Station	Ext.		Exterior Access Route	Exterior

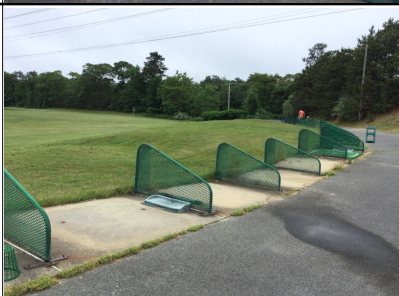
Level changes > 1/4"	1"	Alter change in level to be 1/4" high max. (Ensure that at least 3 of the 55 driving range bays - 5% - are on an accessible route and have an entry with a change in level no greater than 14")  (Cost based on a concrete patch at 3 driving range bays.)	3	256	\$768

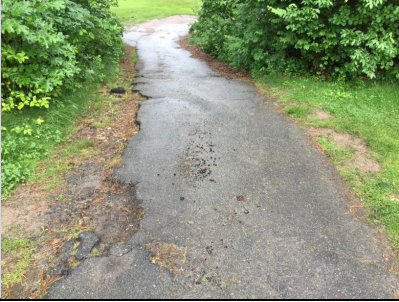
Route not maintained in operable working condition	-	Ensure the accessible route is maintained in operable working condition.  (Cost based on an asphalt patch.)	1	256	\$256
7	Near Hole 4	Ext.		Exterior Access Route	Exterior

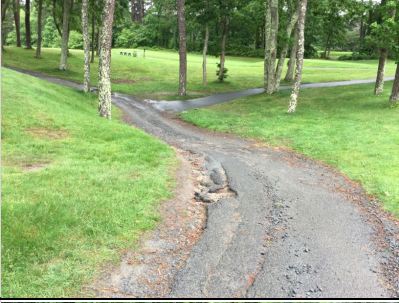
Route not maintained in operable working condition	-	Ensure the accessible route is maintained in operable working condition.  (Cost based on an asphalt patch.)	1	256	\$256
8	Portable Toilet Near Tee 6	Ext.		Exterior Access Route	Exterior

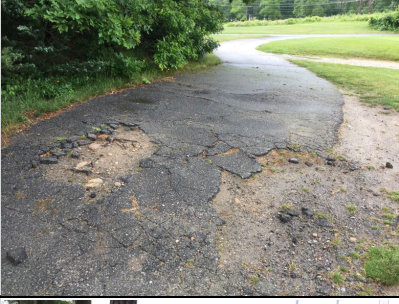
Route not maintained in operable working condition	-	Ensure the accessible route is maintained in operable working condition.  (Cost based on an asphalt patch.)	1	256	\$256
9	To Hole 9 from Hole 8	Ext.		Exterior Access Route	Exterior

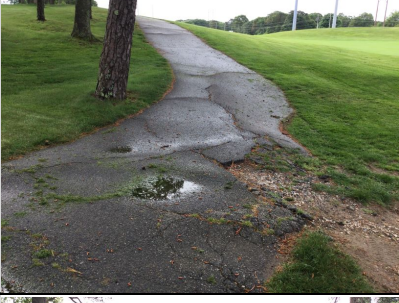
Route not maintained in operable working condition	-	Ensure the accessible route is maintained in operable working condition.  (Cost based on an asphalt patch.)	1	256	\$256

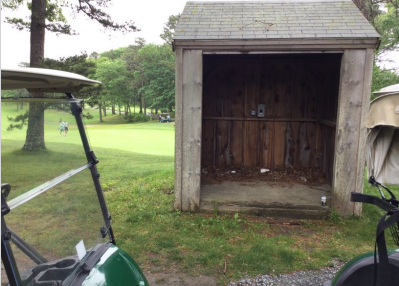
10	Food and Beverage Concession Near Hole 15	Ext.		Exterior Access Route	Exterior

Accessible route not provided	-	Ensure an accessible route is provided most likely by providing a compliant ramp if the shed is once again used to hold a drink vending machine or other amenity.	1	-	\$0

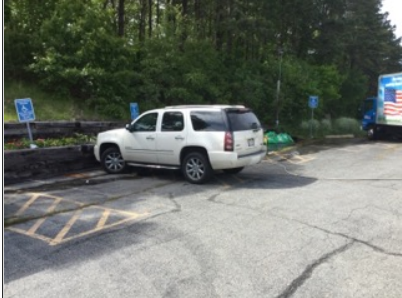
Total # of parking Total # of designated accessible parking spaces Total # of designated van accessible spaces Vehicle space < 96" wide at car space Sign not provided	200 4 1 - -	Provide one additional car accessible parking space that is at least 96" wide with a marked access aisle at least 60" wide. Include an identification sign with the International Symbol of Accessibility (ISA). Provide a sign with the International Symbol of Accessibility (ISA) at the car accessible parking space that is missing an accessible parking identification sign.	1	2350	\$2350
<b>Exterior Ramp</b>												
12	Secondary Ramp to Clubhouse - Hyannis Golf Club	Ext		Exterior Ramp	N/A

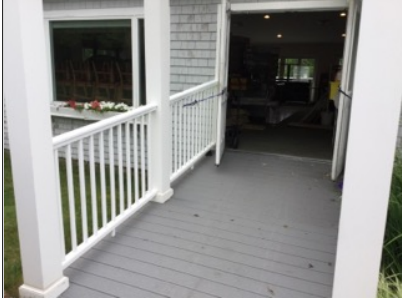
Running slope > 1:12 (8.3%) Handrails < 34" or > 38" above ramp surface. No top or bottom landing provided Directional sign to accessible entrance not provided	14% 43.1" -	Provide a directional sign indicating the location of the nearest accessible entrance.	1	346	\$346

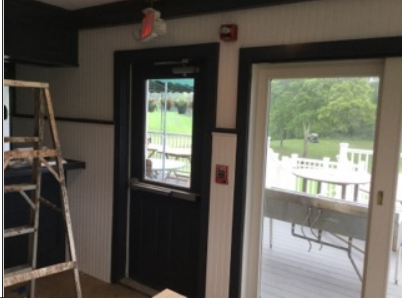
Tactile sign not provided at exit	-	Provide tactile exit signs with raised characters and braille at exit doors. Mount signs between 48"- 60" above the finished floor located on the latch side of the door.	1	232	\$232
14	Pro Shop Entry/Exit	Ext		Emergency Exit	N/A

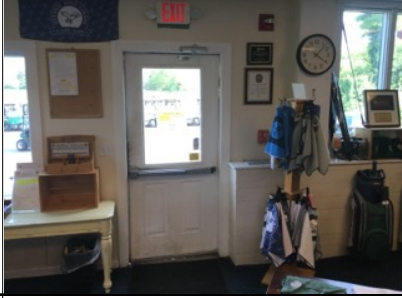
Tactile sign not provided at exit Illuminated Int. Symbol of Acc. not provided (MAAB)	- -	Provide tactile exit signs with raised characters and braille at exit doors. Mount signs between 48"- 60" above the finished floor located on the latch side of the door. If the exit sign is replaced with an illuminated exit sign, provide an illuminated International Symbol of Accessibility (ISA).	1	232	\$232
15	Drive Up Snack Bar - Hyannis Golf Club	Ext		Emergency Exit	N/A

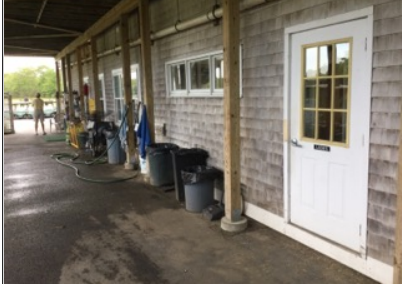
Threshold > 3/4" high	7"	When construction is complete alter the threshold to be 3/4" high max.	1	150	\$150

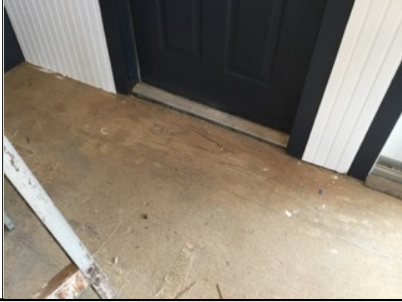
Threshold > 1/2" high	1"	Alter the threshold to be 1/2" high max.	1	150	\$150
<b>Access to Goods and Services</b>												
<b>Means of Egress</b>												
17	Exit via Ramp to Parking Lot From Club House - Hyannis Golf Club	2		Means of Egress	N/A

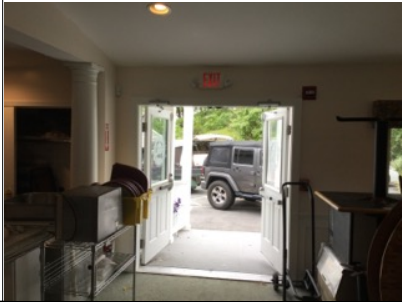
Tactile exit sign not provided	-	Ensure tactile exit signs with raised characters and braille are provided at exit doors. Mount signs between 48"- 60" above the finished floor located on the latch side of the door.	1	232	\$232
18	Emergency Exit via Club House - Hyannis Golf Club	2		Means of Egress	N/A

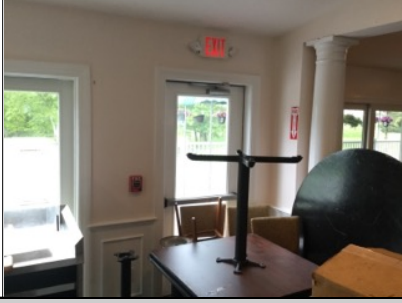
Tactile exit sign not provided	-	Ensure tactile exit signs with raised characters and braille are provided at exit doors. Mount signs between 48"- 60" above the finished floor located on the latch side of the door.	1	232	\$232

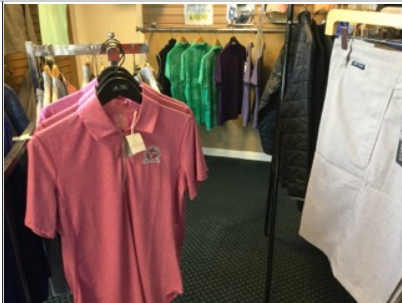
Route < 36" wide	26"	Ensure that a clear width of 36" min. is maintained at the accessible route through the Pro Shop.	1	Labor	\$0
20	From Men's Toilet Room to Women's Toilet Room- Hyannis Golf Club	1		Interior Access Route	N/A

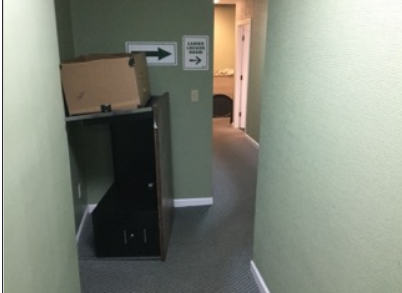
Route < 36" wide	27.4"	Ensure that a clear width of 36" min. is maintained at the accessible route.	1	Labor	\$0

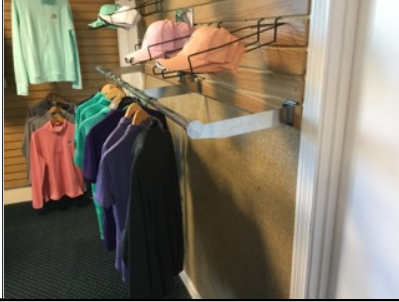
Obstructed by protruding objects Vertical clearance < 80" above finished floor	13.25" 51.3"	Provide a cane-detectable barrier 27" max. above the ground at display racks that protrude into the accessible route.	2	306	\$612
<b>Doors, Doorways, &amp; Gates</b>												
22	Men's Toilet Room	1		Doors, Doorways, & Gates	Toilet Room

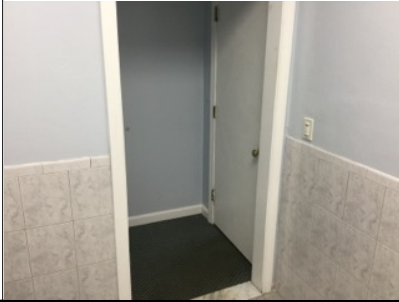
Clear width at door < 32" Threshold > 1/2" high Hardware not operable with a closed fist Clear floor space at opener not provided	27.7" 1" - -	Widen the door so that there is 32" min. clear width. Alter the threshold to be 1/2" high max. Provide hardware that can be operable with one hand and not require tight grasping, pinching, or twisting of the wrist. Provide an automatic door opener with the control positioned prior to entering the vestibule.	1	4000	\$4000

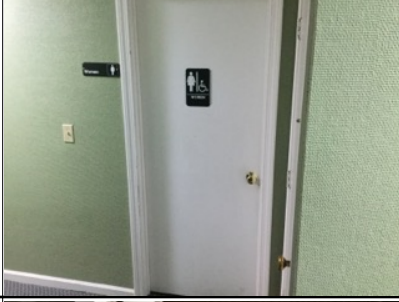
23	Women's Toilet Room	1		Doors, Doorways, & Gates	Toilet Room

Clear width at door < 32" Hardware not operable with a closed fist	27.8" -	Widen the door so that there is 32" min. clear width. Provide hardware that can be operable with one hand and not require tight grasping, pinching, or twisting of the wrist.	1	3850	\$3850
24	Sliding Door Threshold via Club House - Hyannis Golf Club	Ext		Doors, Doorways, & Gates	Emergency Egress

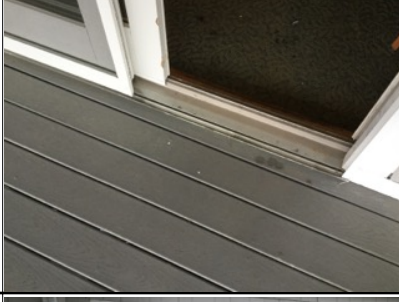
Threshold > 1/2" high	4.5"	Alter the threshold to be 1/2" high max.	1	150	\$150
25	Deck for Club House - Hyannis Golf Club	Ext		Doors, Doorways, & Gates	Emergency Egress

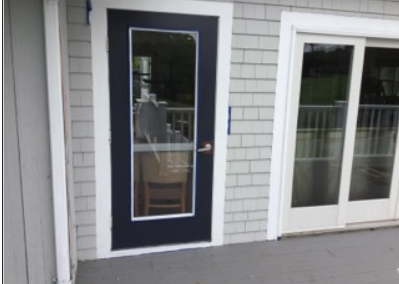
Threshold > 1/2" high	2"	Alter the threshold to be 1/2" high max.	1	150	\$150

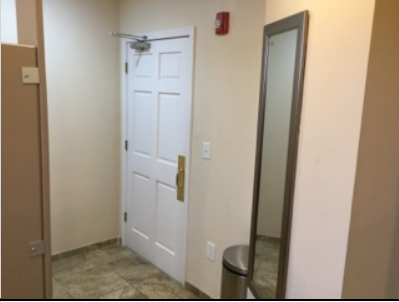
Door requires > 5 lbs. of force to open	15 lbs.	Adjust closers so doors do not require more than 5 pounds of force to open.	1	Labor	\$0
27	Men's Toilet Room	2		Doors, Doorways, & Gates	Toilet Room

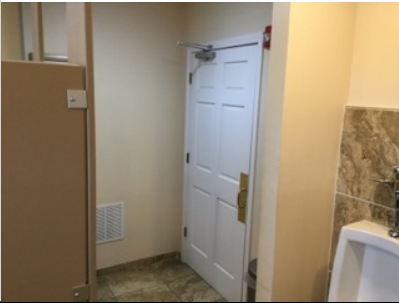
Door requires > 5 lbs. of force to open	13 lbs.	Adjust closers so doors do not require more than 5 pounds of force to open.	1	Labor	\$0
<b>Signage</b>												
28	Women's Toilet Room	1		Signage	Designation

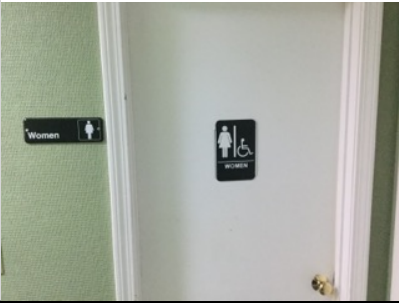
Raised characters not provided on sign Braille not provided on sign International Symbol of Acc. not compliant	- - -	Provide text with raised characters duplicated in braille on sign. Locate sign with International Symbol of Accessibility on latch side of door, but remove sign until an accessible compartment and shower are provided.	1	232	\$232

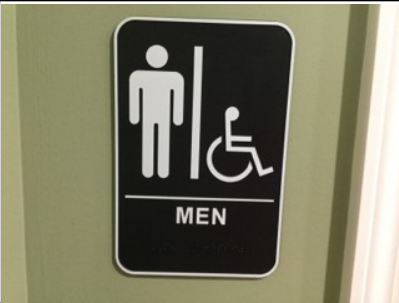
29	Men's Toilet Room	2		Signage	Designation

Raised characters < 48" or > 60" above ground	64.4"	Mount signs so that the baseline of the lowest tactile character is 48" min. above finish floor and the baseline of the highest tactile character is 60" max. above the finished floor.	1	Labor	\$0
<b>Service Counter</b>												
30	Pro Shop	Ext		Service Counter	N/A

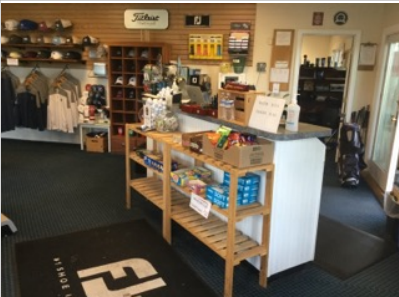
Counter > 36" high	44.9"	Provide a counter that is 36" max. above the ground or finished floor.	1	880	\$880

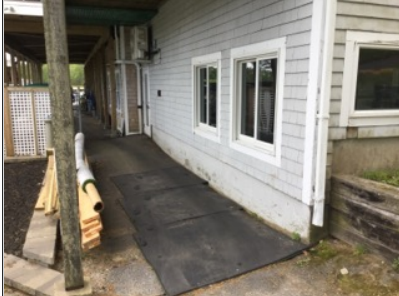
Counter > 36" high	40"	Provide a snack bar service window opening that is 36" max. above the ground or finished floor.	1	880	\$880
32	Restaurant (Under Construction) - Hyannis Golf Club	2		Service Counter	N/A

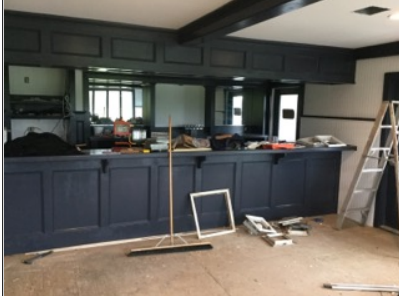
Counter > 36" high	43.75"	Provide a counter that is 36" max. above the ground or finished floor.	1	880	\$880
<b>Operable Parts</b>												
33	Tee 6	Ext.		Operable Parts	Other

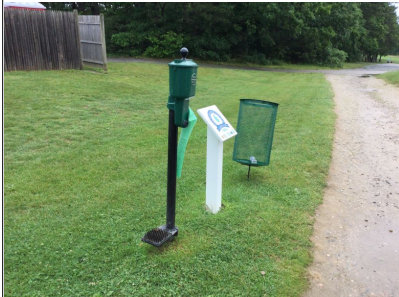
Element not on an accessible route	-	Relocate at least 5% of golf shoe spike scrapers to an accessible route.	1	Labor	\$0
34	Club House	2		Operable Parts	Clothes Rod/Hooks

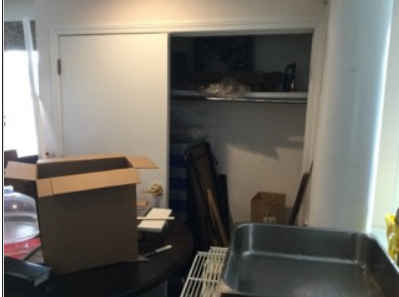
Reach < 15" or > 48"(forward/side approach)	60.7"	Provide a coat rod or coat hooks that are between 15"- 48" above the finished floor.	1	256	\$256
35	Women's Toilet Room	2		Operable Parts	Other

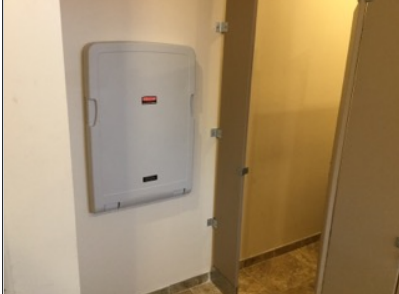
Reach < 15" or > 48"(forward/side approach)	61.5"	Relocate opening control to between 15"- 48" above the finished floor.	1	Labor	\$0

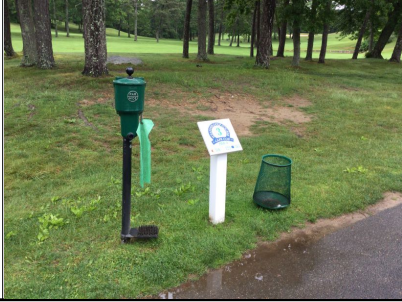
Not operable with a closed fist	-	Provide hardware that can be operable with one hand and not require tight grasping, pinching, or twisting of the wrist.  (IHCD is not aware of an available accessible golf ball washer.)	1	-	\$0
<b>Assembly Area</b>												
37	Club House	2		Assembly Area	N/A

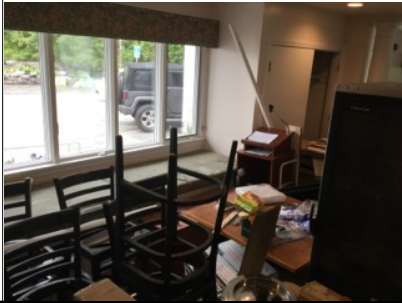
Assistive listening devices not provided	-	If audible communication is integral to the use of the space, provide an assistive listening system.	1	1214	\$1214
<b>Exterior Benches</b>												
38	Tee 2	Ext.		Exterior Benches	N/A

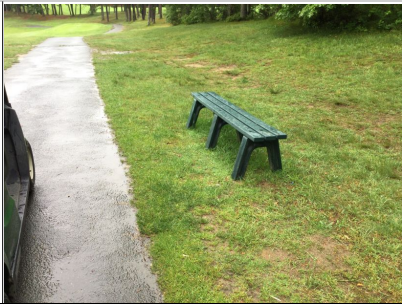
No accessible route to one bench in area	-	Relocate 20% of benches on an accessible route.	1	Labor	\$0
<b>Toilet &amp; Bathing Rooms</b>												
<b>Overall Access</b>												
39	Men's Toilet Room	1		Overall Access	Toilet Room

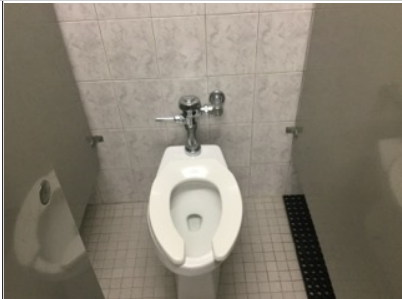
Turning space not provided	-	Renovate toilet room to provide at least one accessible toilet compartment.	1	6182	\$6182

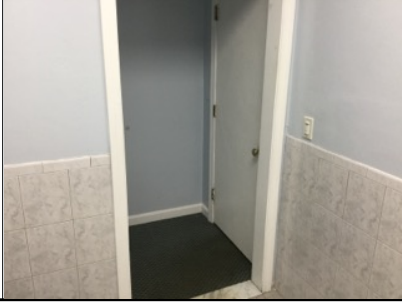
International Symbol of Acc. not provided	- -	Provide a sign with the International Symbol of Accessibility mounted on the latch side of the door once issues with the door, toilet room and shower are made accessible.	1	232	\$232
<b>Lavatory</b>												
41	Women's Toilet Room	1		Lavatory	N/A

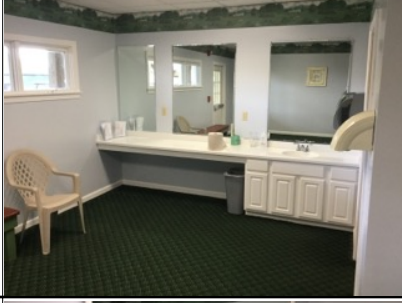
Toe or knee clearances not provided Plumbing underneath is exposed	- -	Provide at least one lavatory with knee and toe clearance positioned for a forward approach. Insulate or otherwise configure pipes to prevent contact for at least one lavatory.	1	1778	\$1778
42	Men's Toilet Room	1		Lavatory	N/A

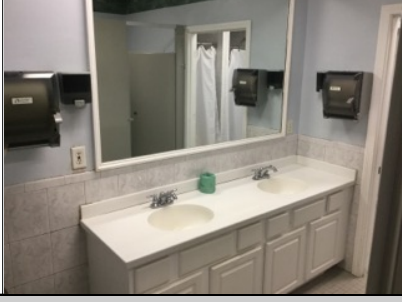
Toe or knee clearances not provided Mirror above lavatory w/reflective surface > 40"	- 43.7"	Provide at least one lavatory with knee and toe clearance positioned for a forward approach. Lower mirror so that the bottom surface is at 40" max. above the finished floor.	1	1942	\$1942

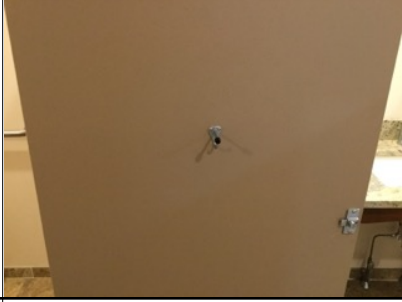
Door has non-compliant hardware Door has malfunctioning self-closing hinge	- -	Provide hardware that can be operable with one hand and not require tight grasping, pinching, or twisting of the wrist. Repair hinge.	1	70	\$70
44	Men's Toilet Room	2		Toilet Compartment	Accessible Compartment

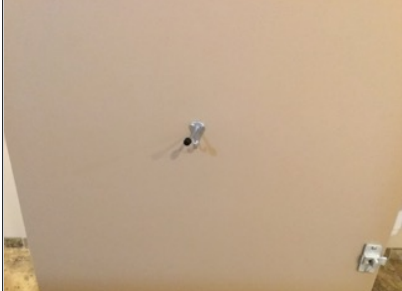
Door has non-compliant hardware Door has malfunctioning self-closing hinge	- -	Provide hardware that can be operable with one hand and not require tight grasping, pinching, or twisting of the wrist. Repair hinge.	1	70	\$70

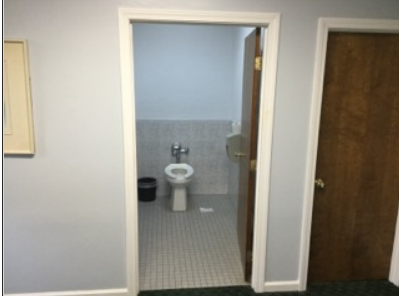
Grab bars not provided Clearance at toilet < 60" clear width	- 51.5"	Provide one grab bar on the side wall of the water closet and one on the rear wall. Provide a wheelchair accessible compartment that is 60" wide min.	1	6182	\$6182
46	Men's Toilet Room	2		Toilet Compartment	Accessible Compartment

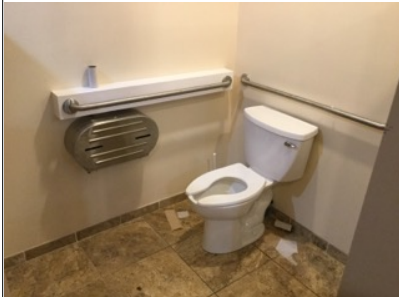
Centerline < or > 18" (MAAB)	22.2"	Relocate toilet so the centerline is 18" from the side wall.	1	2828	\$2828
<b>Urinal</b>												
47	Men's Toilet Room	1		Urinal	N/A

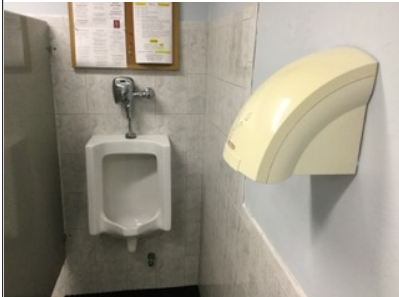
Rim > 17" high	26.7"	Provide at least one urinal with the rim no higher than 17" above the finished floor.	1	3248	\$3248
48	Men's Toilet Room	2		Urinal	N/A

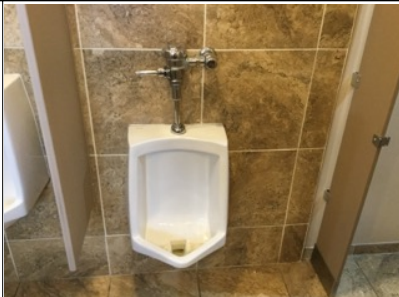
Rim > 17" high	17.7"	Provide at least one urinal with the rim no higher than 17" above the finished floor.	1	3248	\$3248

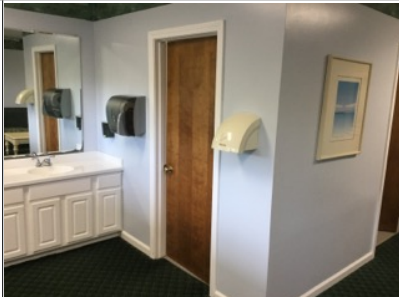
<b>Dispensers</b>												
49	Women's Toilet Room	1		Dispensers	Hand Dryer

Dispenser acts as a protruding object	49.3"	Relocate hand dryer out of the circulation path.	1	353	\$353

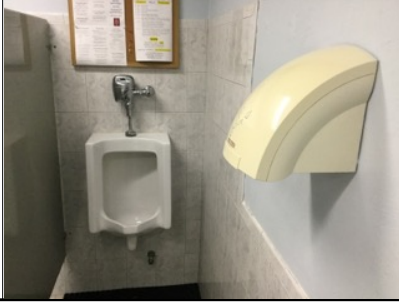
Dispenser acts as a protruding object	-	Relocate dispenser out of the circulation path.	1	353	\$353
<b>Shower Compartment</b>												
51	Women's Toilet Room Shower	1		Shower Compartment	Transfer Type

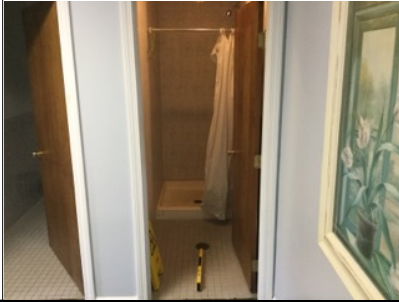
Shower not on an accessible route Clear space at transfer shower > 48" x 36" Grab bars not provided Seat not provided (transfer compartment) Transfer type shower threshold > 1/2" Accessible shower not provided	10.3% 35" - 5" -	Reduce running slope on shower floor to 1:50 (2.00%) max. Provide a 48" x 36" clear floor space for a transfer shower. Provide compliant grab bars. Provide a folding seat. Transfer shower: Ensure the threshold is 1/2" high max. Provide at least one accessible shower.	1	6072	\$6072
52	Men's Toilet Room Shower	1		Shower Compartment	Transfer Type

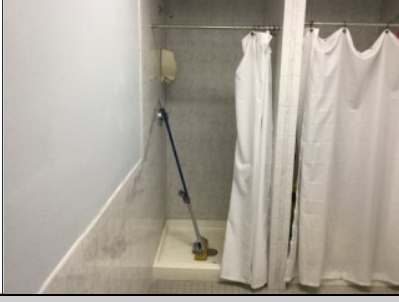
Transfer type shower threshold > 1/2" Accessible shower not provided	4.5" -	Transfer shower: Ensure the threshold is 1/2" high max. Provide at least one accessible shower.	1	6072	\$6072

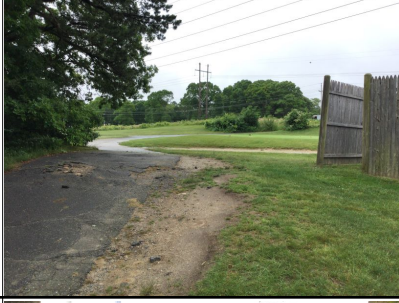
<b>Portable Toilet</b>												
53	Portable Toilet Near Tee 6	Ext.		Portable Toilet	N/A

Not located on an accessible route	-	Locate portable toilet on an accessible route.  (Cost based on a 4' wide min. x 12' long asphalt path to the portable toilet.)	1	480	\$480
54	Portable Toilet Near Tee 6	Ext.		Portable Toilet	N/A

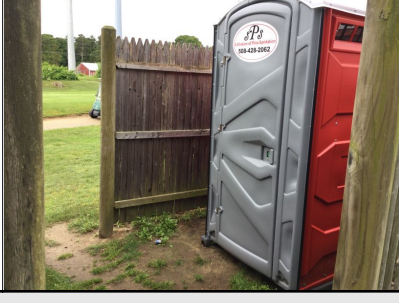
Accessible portable toilets not provided	-	Provide an accessible portable toilet that has 60" wide and 72" deep clear floor space at the toilet. Ensure that at least 5% of portable toilets (at least 1 where portable toilets are provided) are accessible.  (Cost for an accessible portable toilet is not provided.)	1	-	\$0
<b>Best Practice</b>

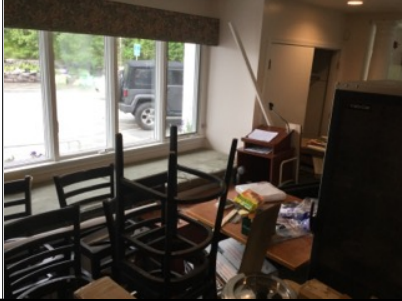
Recommend providing an adjustable height podium with knee and toe clearance.	1	-	\$0
<b>Bench</b>												
56	Tee 2	Ext.		Bench	N/A

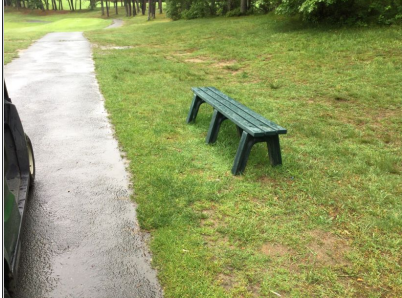
Recommend in each area where there are benches, providing a stable, firm and slip resistant surface on one end of at least one bench (such as stone dust or asphalt) that is at least 36" wide and 48" deep so a person in a wheelchair could sit alongside a companion on the bench with their shoulders aligned.	1	-	\$0
<b>Ramp</b>												
57	Practice Greens Near Pro Shop	Ext.		Ramp	N/A

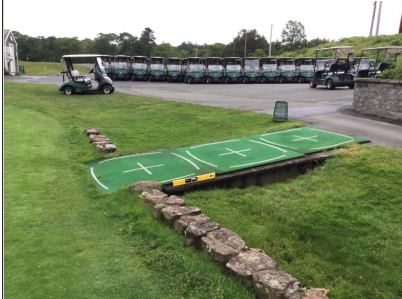
Recommend reducing running slope to be no steeper than 1:12 (8.33%). Recommend providing handrails on both sides. Recommend providing edge protection that prevents the passage of a 4" diameter sphere, where any portion of the sphere is within 4" of the finished floor or ground surface.	1	-	\$0

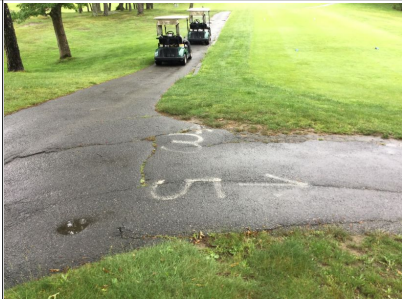
<b>Sign</b>												
58	To Tee 5	Ext.		Sign	N/A

Recommend providing a sign, perhaps with a directional arrow, directing visitors to the fifth hole.	1	-	\$0
