West Barnstable Train Station

Town of Barnstable ADA Transition Plan

August 2021

Institute for Human Centered Design

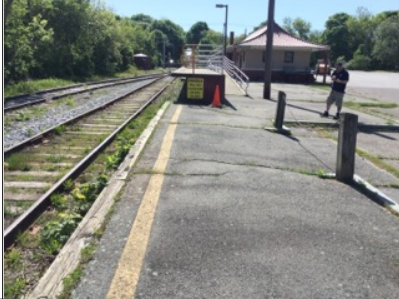
ID	Location	Floor	Room	Element	Type	Photo	Issues	Current Measure	Recommendations	Quantity	Price	Cost Estimation
Approach and Entrance												
Exterior Access Route												
1	Platform - West	Ext.		Exterior Access Route	Exterior

Surface openings > 1/2"	2.5"	Repair surface.	1	-	\$0
2	Platform - North - East	Ext.		Exterior Access Route	Exterior

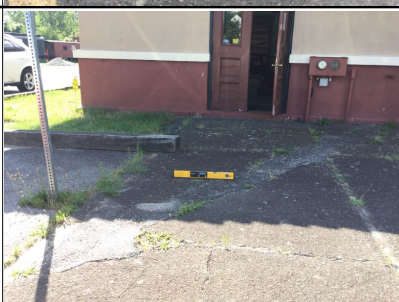
Surface openings > 1/2"	5.5"	Repair surface.	1	-	\$0
3	Entrance/ Exit - East Side	Ext.		Exterior Access Route	Exterior

Cross slope > 1:50 (2.00%)	2.8%	Reduce cross slope to be no steeper than 1:50 (2.00%).	1	-	\$0
4	Platform - North Side	Ext.		Exterior Access Route	Exterior

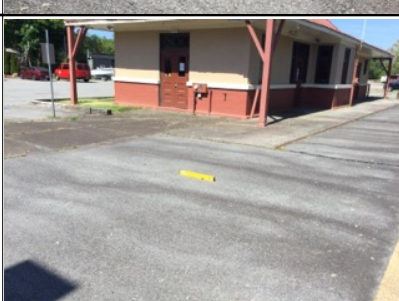
Cross slope > 1:50 (2.00%)	6%	Reduce cross slope to be no steeper than 1:50 (2.00%).	1	-	\$0
5	North East Near Accessible Parking	Ext.		Exterior Access Route	Exterior

Cross slope > 1:50 (2.00%)	3.1%	Reduce cross slope to be no steeper than 1:50 (2.00%).	1	-	\$0

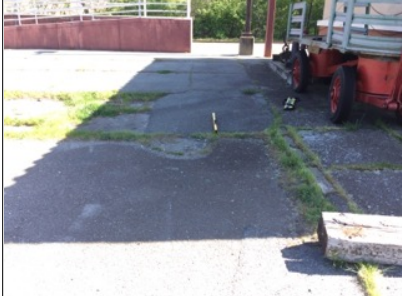
ID	Location	Floor	Room	Element	Type	Photo	Issues	Current Measure	Recommendations	Quantity	Price	Cost Estimation
6	Near Display - West Side	Ext.		Exterior Access Route	Exterior

Cross slope > 1:50 (2.00%) Running slope > 1:20 (5%)	5% 11.1%	Reduce cross slope to be no steeper than 1:50 (2.00%). Reduce running slope to be no steeper than 1:20 (5%).	1	-	\$0
7	To Platform & Ramp	Ext.		Exterior Access Route	Exterior	 	Running slope > 1:20 (5%)	12.8%	Reduce running slope to be no steeper than 1:20 (5%).	1	-	\$0
8	Ramp Top to Raised Platform - West	Ext.		Exterior Access Route	Walkway	 	Level changes > 1/4"	1.5"	Alter change in level to be 1/4" high max.	1	-	\$0
9	To Ramp From North Side	Ext.		Exterior Access Route	Exterior	 	Level changes > 1/4"	1.5"	Alter change in level to be 1/4" high max.	1	-	\$0
10	South Side	Ext.		Exterior Access Route	Exterior	 	Surface is not stable, firm, and slip-resistant	-	Repair surface.	1	-	\$0

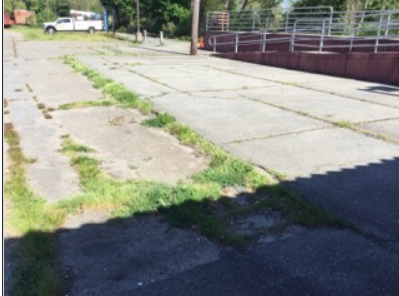
ID	Location	Floor	Room	Element	Type	Photo	Issues	Current Measure	Recommendations	Quantity	Price	Cost Estimation
11	Toward Ramp - West Side	Ext.		Exterior Access Route	Exterior

Surface is not stable, firm, and slip-resistant	-	Repair surface.	1	-	\$0
12	North East Side Near Accessible Parking	Ext.		Exterior Access Route	Exterior

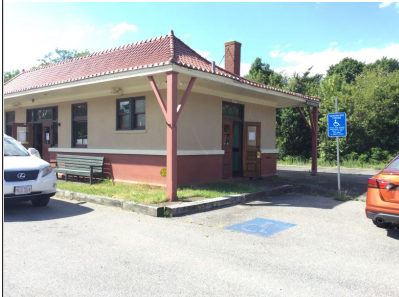
Surface is not stable, firm, and slip-resistant	-	Repair surface.	1	-	\$0
Off-Street Parking Lot or Garage												
13	Accessible Parking - East Side	Ext.		Off-Street Parking Lot or Garage	Visitor

Sign does not have the designation "Van Accessible"	-	Provide a marked access aisle that is at least 96" wide. Add the designation "Van Accessible" to the sign located at the van accessible space.	1	500	\$500
Exterior Ramp												
14		Ext.		Exterior Ramp	N/A

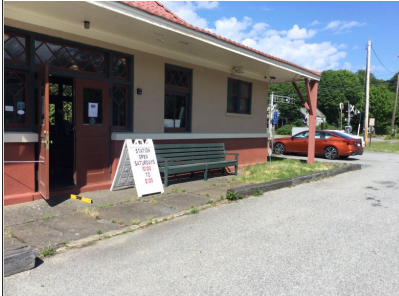
Landing < 60" min. long	55"	Alter so the landing is 60" long min.	1	-	\$0
Entrance												
15	Main Entrance/Exit	Ext.		Entrance	Main Entrance

Directional sign to accessible entrance not provided	-	Provide a directional sign indicating the location of the nearest accessible entrance.	1	346	\$346

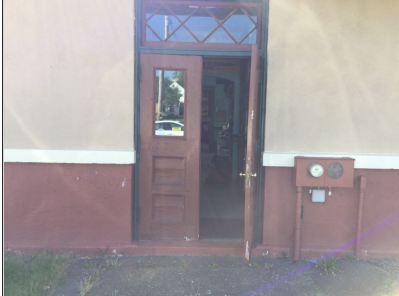
ID	Location	Floor	Room	Element	Type	Photo	Issues	Current Measure	Recommendations	Quantity	Price	Cost Estimation
16	Entrance/ Exit - East Side	Ext.		Entrance	Secondary Entrance

Directional sign to accessible entrance not provided	-	Provide a directional sign indicating the location of the nearest accessible entrance.	1	346	\$346
17	Entrance/ Exit - North East	Ext.		Entrance	Secondary Entrance

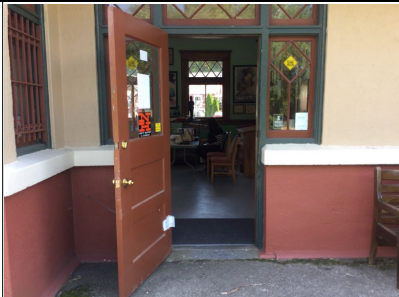
International Symbol of Accessibility not provided Hardware not operable with a closed fist	- -	Provide a sign with the International Symbol of Accessibility (ISA). Provide hardware that can be operable with one hand and not require tight grasping, pinching, or twisting of the wrist. Cost to provide compliant hardware is not included.	1	232	\$232
18	Middle Entrance/ Exit - North Side	Ext.		Entrance	Secondary Entrance

International Symbol of Accessibility not provided Hardware not operable with a closed fist	- -	Provide a sign with the International Symbol of Accessibility (ISA). Provide hardware that can be operable with one hand and not require tight grasping, pinching, or twisting of the wrist. Cost to provide compliant hardware is not included.	1	232	\$232

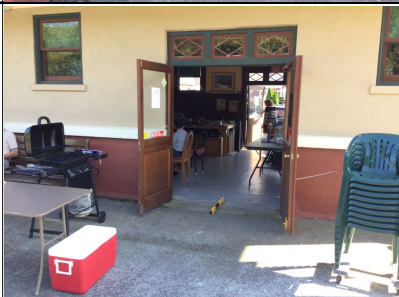
19	Entrance/ Exit - Baggage Room (North)	Ext.		Entrance	Secondary Entrance

Maneuvering clearance at door > 1:50 (2.00%)	11%	Alter so that the slope in all directions is no greater than 1:50 (2.00%). After the slope is made compliant, provide a sign with the International Symbol of Accessibility (ISA).	1	-	\$0
20	Entrance/ Exit - Baggage Room (South)	Ext.		Entrance	Secondary Entrance

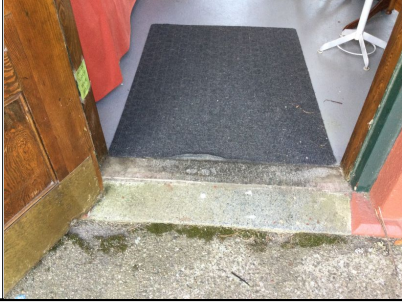
ID	Location	Floor	Room	Element	Type	Photo	Issues	Current Measure	Recommendations	Quantity	Price	Cost Estimation
21	Entrance/Exit - North East	Ext.		Entrance	Secondary Entrance

Threshold not beveled Threshold > 1/2" high	- .75'	Bevel the threshold. Alter threshold to be 1/2" high max.	1	-	\$0
Access to Goods and Services												
Means of Egress												
22	Entrance/Exit - Baggage Room (South)	1		Means of Egress	N/A

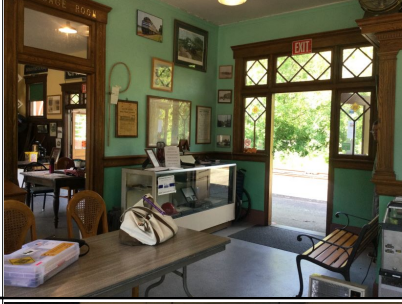
Tactile exit sign not provided	-	Ensure tactile exit signs with raised characters and braille are provided at exit doors. Mount signs between 48"- 60" above the finished floor located on the latch side of the door. If an illuminated exit sign is provided, ensure the sign has the International Symbol of Accessibility (ISA).	1	232	\$232
23	Middle Entrance/Exit - North	1		Means of Egress	N/A

Tactile exit sign not provided	- -	Ensure tactile exit signs with raised characters and braille are provided at exit doors. Mount signs between 48"- 60" above the finished floor located on the latch side of the door. If an illuminated exit sign is provided, ensure the sign has the International Symbol of Accessibility (ISA).	1	232	\$232

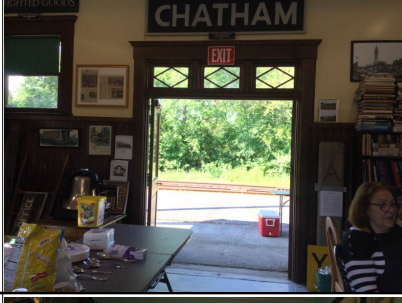
24	Entrance/Exit - North, Baggage Room	1		Means of Egress	129

Tactile exit sign not provided	- -	Ensure tactile exit signs with raised characters and braille are provided at exit doors. Mount signs between 48"- 60" above the finished floor located on the latch side of the door. If an illuminated exit sign is provided, ensure the sign has the International Symbol of Accessibility (ISA).	1	232	\$232
25	To North East Exit	1		Means of Egress	N/A

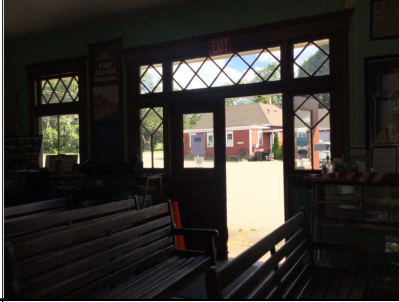
ID	Location	Floor	Room	Element	Type	Photo	Issues	Current Measure	Recommendations	Quantity	Price	Cost Estimation
26	Main Entrance/Exit	1		Means of Egress	N/A

Tactile exit sign not provided Directional sign to accessible emergency exit not provided	- -	Provide a directional sign indicating the location of the nearest accessible emergency exit. Ensure tactile exit sign with raised characters and braille is provided at exit door. Mount sign between 48"- 60" above the finished floor located on the latch side of the door.	1	432	\$432
27	To Entrance/Exit Near Men's Toilet Room	1		Means of Egress	N/A

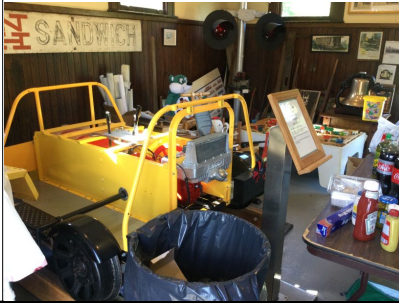
Interior Access Route												
28	Baggage Room	1		Interior Access Route	N/A

Route < 36" wide	-	Ensure that a clear width of 36" min. is maintained at the accessible route.	1	Labor	\$0
29	Ticket Counter - Main Lobby	1		Interior Access Route	N/A

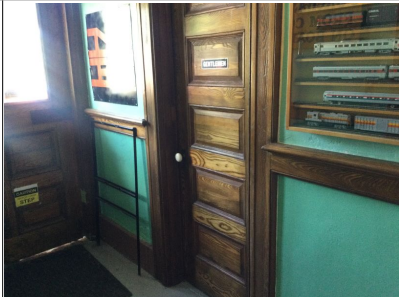
Obstructed by protruding objects	9.5"	Provide a cane-detectable barrier.	2	256	\$512
Signage												
30	Men's Toilet Room	1		Signage	Designation

Raised characters not provided on sign Braille not provided on sign Sign not located on the latch side of the door	- - -	Provide text with raised characters duplicated in braille on sign. Locate sign alongside the door on the latch side.	1	232	\$232

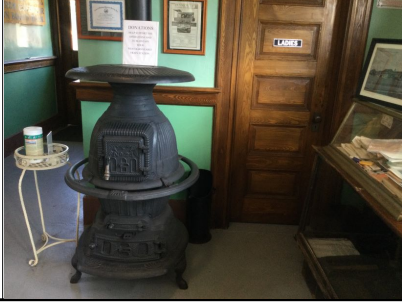
ID	Location	Floor	Room	Element	Type	Photo	Issues	Current Measure	Recommendations	Quantity	Price	Cost Estimation
31	Women's Toilet Room	1		Signage	Designation

Raised characters not provided on sign Braille not provided on sign Sign not located on the latch side of the door	- - -	Provide text with raised characters duplicated in braille on sign. Locate a sign on the latch side.	1	232	\$232
Dining or Work Surfaces												
32	Baggage Room	1		Dining or Work Surfaces	Work Surface

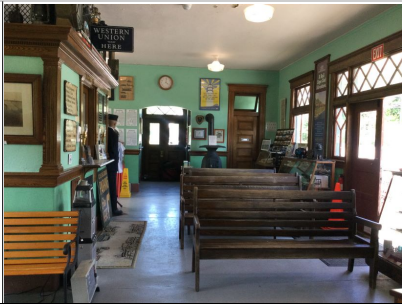
Knee or toe clearance not provided	24"	Provide a work surface with 27" min. knee and toe clearance.	1	700	\$700
Assembly Area												
33	Main Lobby	1		Assembly Area	N/A

Assistive listening devices not provided	-	If audible communication is integral to the use of the space, provide an assistive listening system.	1	-	\$0
Toilet & Bathing Rooms												
Overall Access												
34	Men's Toilet Room	1		Overall Access	Toilet Room

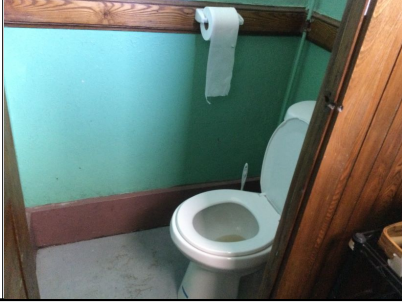
ID	Location	Floor	Room	Element	Type	Photo	Issues	Current Measure	Recommendations	Quantity	Price	Cost Estimation
35	Women's Toilet Room	1		Overall Access	Toilet Room

Accessible plumbing fixtures or stalls not provided	-	If the toilet is open to members of the public, ensure an accessible toilet room is provided.	1	-	\$0
Best Practice												
Display												
36	Near Men's Toilet Room	1		Display	N/A

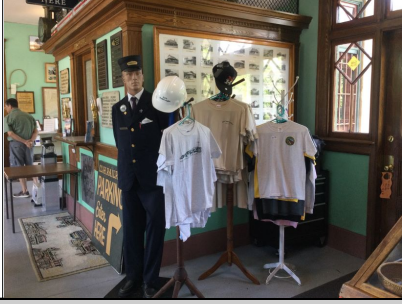
Recommend relocating display to avoid glare.	1	-	\$0
37	Near Entrance/ Exit - North East	1		Display

-	Recommend relocating display to avoid glare and provide clear visibility to the display in the back.	1	-	\$0
Signage												
38	Near Women's Toilet Room	1		Signage	N/A

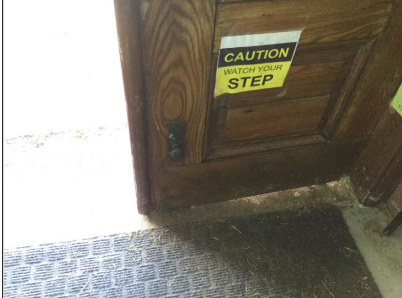
ID	Location	Floor	Room	Element	Type	Photo	Issues	Current Measure	Recommendations	Quantity	Price	Cost Estimation
Signage												
39	Entrance/Exit Near Men's Toilet Room	1		Signage	N/A

-	Recommend locating the sign at least 48" above the finished floor. See ID #27.	1	-	\$0
