Nauset Environmental Services, Inc.

NES Job # 2-207
Report No. NES/ASB-14/1607

Re: Pre-remodeling asbestos inspection & sampling at
Exterior of JFK Museum (Hyannis)
PO#: 14008894

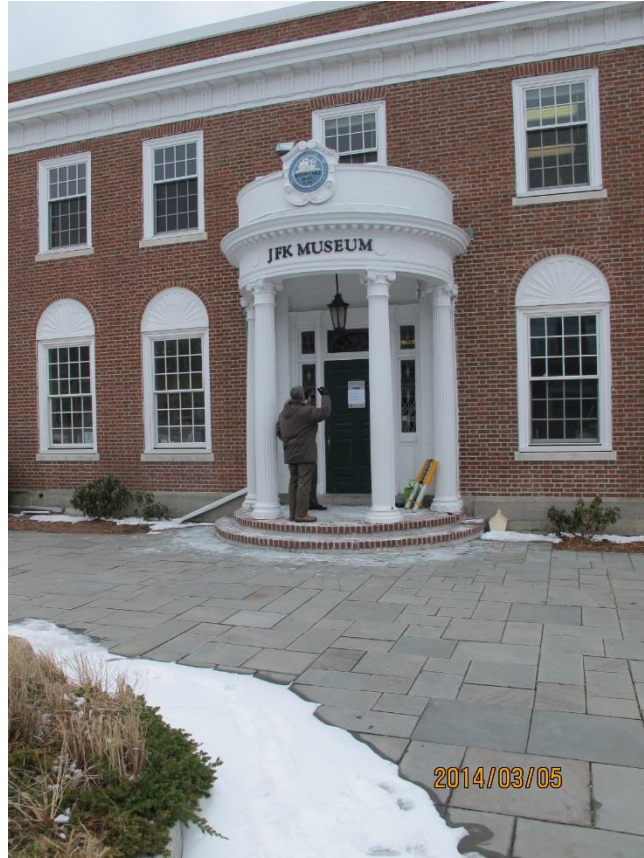
JFK Museum (397 Main Street) front portico

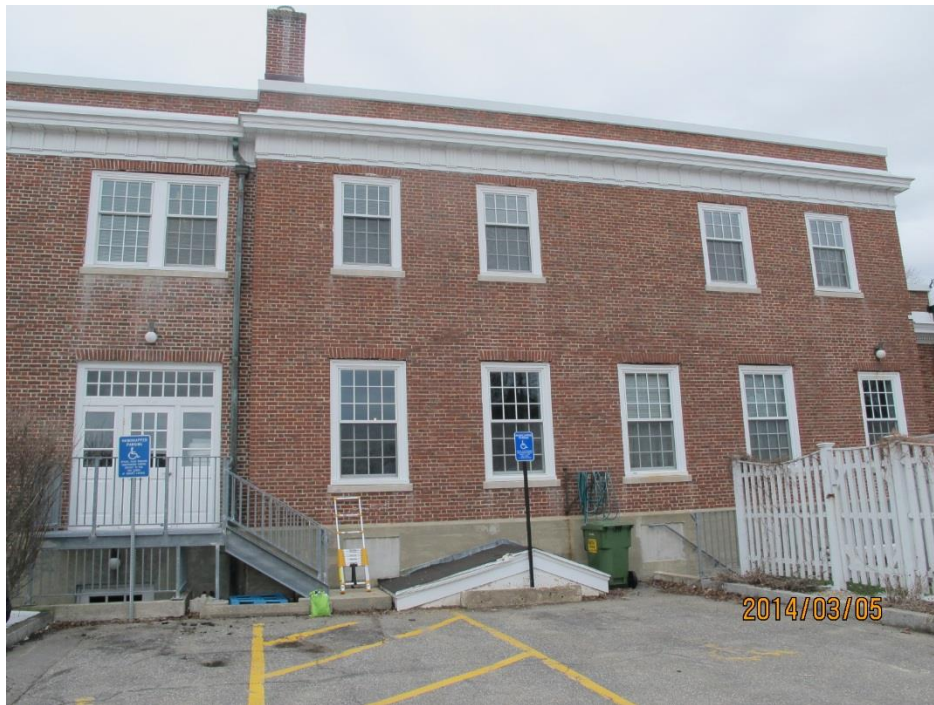
Rear of JFK Museum
