Bismore Park

Town of Barnstable ADA Transition Plan

September 2021

Institute for Human Centered Design

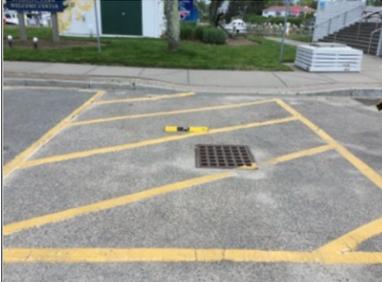
ID	Location	Floor	Room	Element	Type	Photo	Issues	Current Measure	Recommendations	Quantity	Price	Cost Estimation
Approach and Entrance												
Exterior Access Route												
1	Ocean Street Parking Accessible Spots	Ext.		Exterior Access Route	Exterior

Surface openings > 1/2" Level changes > 1/4"	2" 2.25"	Replace or reposition so that openings are 1/2" max. and the long opening dimension is perpendicular to the dominant direction of travel. Alter change in level to be 1/4" high max.	1	2894	\$2894
2	Walkway Through Bismore Park	Ext.		Exterior Access Route	Walkway

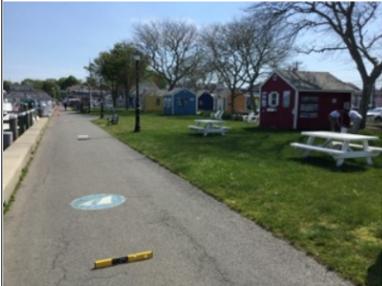
Cross slope > 1:50 (2.00%)	3.7%	Reduce cross slope to be no steeper than 1:50 (2.00%).	1	-	\$0
3	Walkway Through Bismore Park	Ext.		Exterior Access Route	Walkway

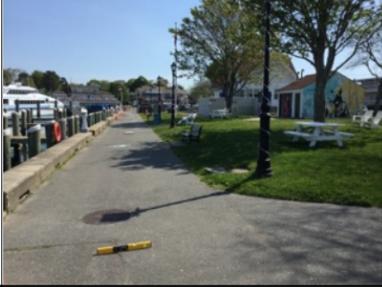
Cross slope > 1:50 (2.00%)	3.3%	Reduce cross slope to be no steeper than 1:50 (2.00%).	1	-	\$0
4	Bench Near Walkway	Ext.		Exterior Access Route	Walkway

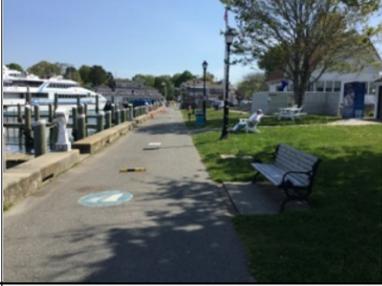
Cross slope > 1:50 (2.00%)	4.4%	Reduce cross slope to be no steeper than 1:50 (2.00%).	1	-	\$0

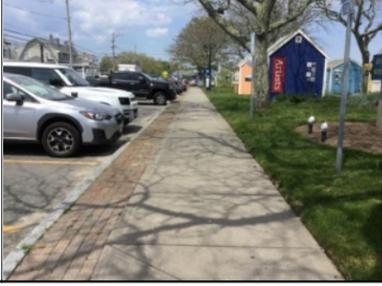
5	Sidewalk Along Ocean Street Heading North	Ext.		Exterior Access Route	Sidewalk

Cross slope > 1:50 (2.00%)	2.9%	Reduce cross slope to be no steeper than 1:50 (2.00%).	1	-	\$0

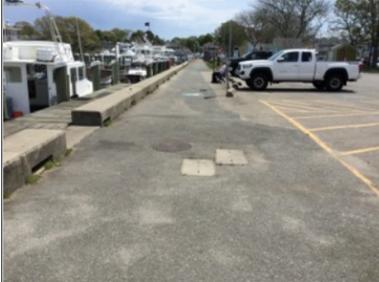
ID	Location	Floor	Room	Element	Type	Photo	Issues	Current Measure	Recommendations	Quantity	Price	Cost Estimation
6	North Side Parking Lot Along Bay	Ext.		Exterior Access Route	Exterior

Cross slope > 1:50 (2.00%)	3.7%	Reduce cross slope to be no steeper than 1:50 (2.00%).	1	-	\$0
7	North Side Parking Lot Along Artist Shanties	Ext.		Exterior Access Route	Sidewalk

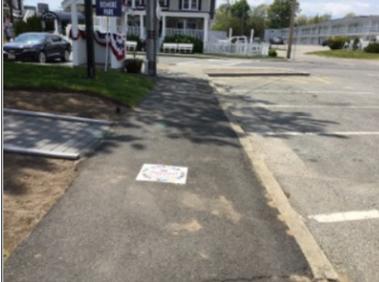
Cross slope > 1:50 (2.00%)	3.5%	Reduce cross slope to be no steeper than 1:50 (2.00%).	1	-	\$0
8	Walkway to Artist Shanties	Ext.		Exterior Access Route	Walkway

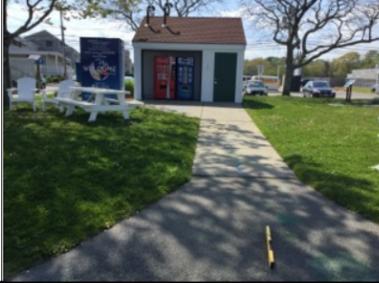
Running slope > 1:20 (5%) Level changes > 1/4"	9.3% 1"	Reduce running slope to be no steeper than 1:20 (5%). Alter change in level to be 1/4" high max.	1	-	\$0
9	Bismore Park Walkway	Ext.		Exterior Access Route	Walkway

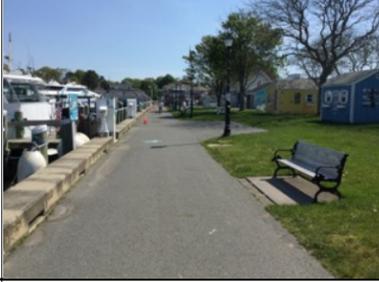
Level changes > 1/4"	1.5"	Alter change in level to be 1/4" high max at bench.	1	256	\$256
10	Walkway Through Bismore Park	Ext.		Exterior Access Route	Walkway

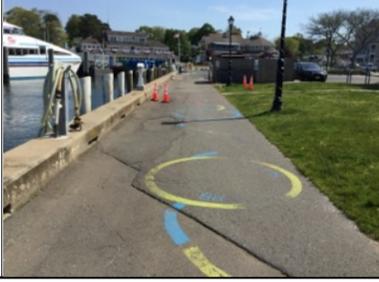
Level changes > 1/4"	0.75"	Alter change in level to be 1/4" high max.	1	-	\$0

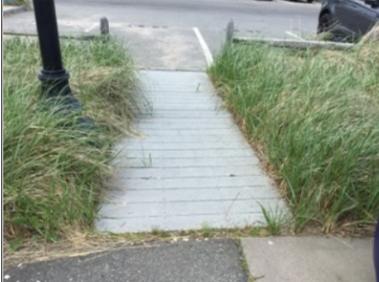
ID	Location	Floor	Room	Element	Type	Photo	Issues	Current Measure	Recommendations	Quantity	Price	Cost Estimation
11	Sidewalk Along Ocean St. Heading South	Ext.		Exterior Access Route	Walkway

Surface is not stable, firm, and slip-resistant	-	Repair surface.	1	-	\$0
12	Walkway Through Bismore Park	Ext.		Exterior Access Route	Walkway

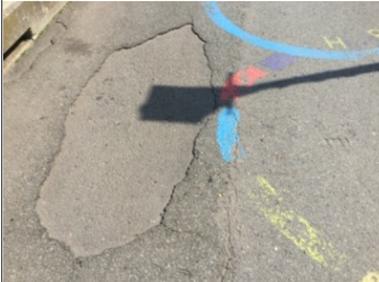
Route not maintained in operable working condition	-	Ensure the accessible route is maintained in operable working condition.	1	-	\$0
13	Sidewalk Along Ocean Street Heading South	Ext.		Exterior Access Route	Exterior

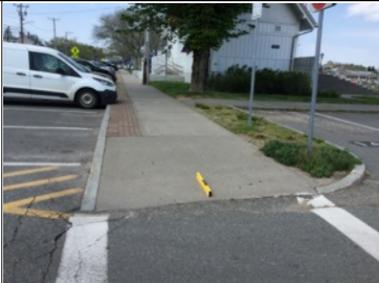
Route not maintained in operable working condition	-	Ensure the accessible route is maintained in operable working condition. Recommend providing detectable warning.	1	-	\$0
14	Sidewalk Along Ocean Street Heading South	Ext.		Exterior Access Route	Exterior

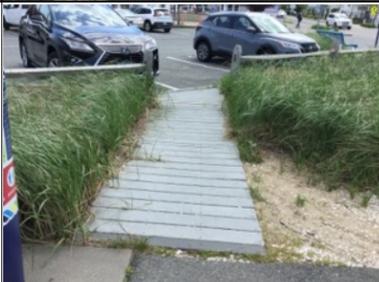
Route not maintained in operable working condition	-	Ensure the accessible route is maintained in operable working condition.	1	-	\$0

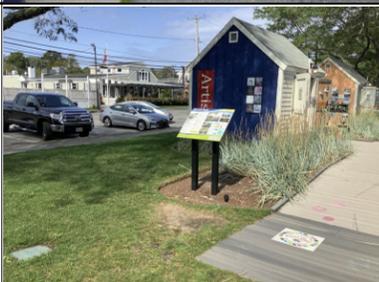
15	Information Sign by Artist Shanties	Ext.		Exterior Access Route	Exterior

Accessible route not provided	-	Ensure an accessible route is provided to the sign.	1	-	\$0

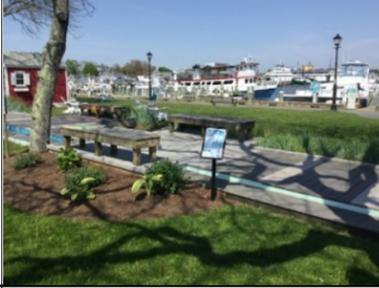
ID	Location	Floor	Room	Element	Type	Photo	Issues	Current Measure	Recommendations	Quantity	Price	Cost Estimation
16	Walkway at Artist Shanty	Ext.		Exterior Access Route	Exterior

Accessible route not provided	-	Rotate sign to face the accessible route.	1	Labor	\$0
17	Walkway at Artist Shanties (South Side)	Ext.		Exterior Access Route	Exterior

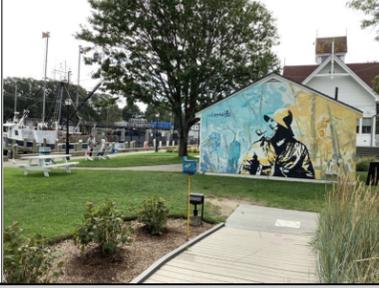
Accessible route not provided	-	Ensure end of artist shanties path is connected to an accessible route. (Estimated 4' wide by 30' long concrete path.)	1	-	\$0
Curb Ramp												
18	North Side Parking Lot Along Artist Shanties	Ext.		Curb Ramp	Parallel

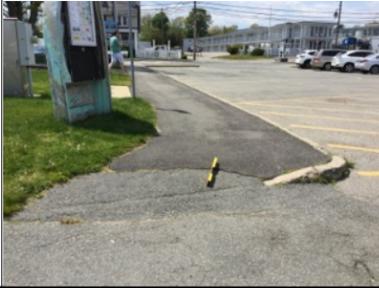
Curb ramp not provided	-	Provide a curb ramp. (Cost estimate for a new concrete curb ramp.)	1	2800	\$2800
19	Sidewalk Along Ocean Street Heading South Side	Ext.		Curb Ramp	N/A

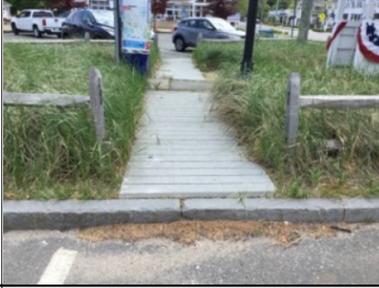
Curb ramp not provided	-	Provide a curb ramp. (Cost estimate for a new concrete curb ramp.)	1	2800	\$2800
20	Sidewalk Along Ocean Street Heading South Side	Ext.		Curb Ramp	N/A

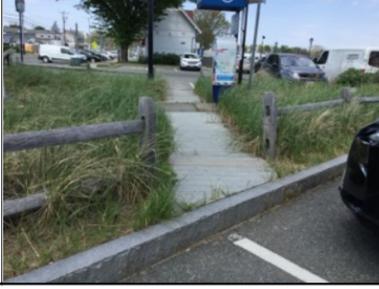
Curb ramp not provided	-	Provide a curb ramp. (Cost estimate for a new concrete curb ramp.)	1	2800	\$2800

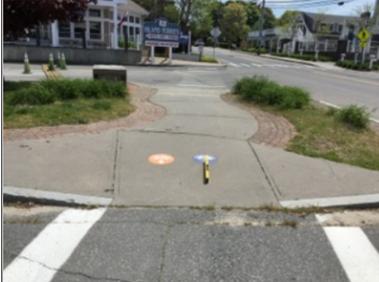
ID	Location	Floor	Room	Element	Type	Photo	Issues	Current Measure	Recommendations	Quantity	Price	Cost Estimation
21	Ocean Street Parking Lot (South Street)	Ext.		Curb Ramp	Parallel

Running slope > 1:12 (8.33%)	10.5%	Reduce running slope to be no steeper than 1:12 (8.33%). Recommend providing detectable warning.	1	2800	\$2800
22	Information Sign Near Artist Shanties	Ext.		Curb Ramp	Parallel

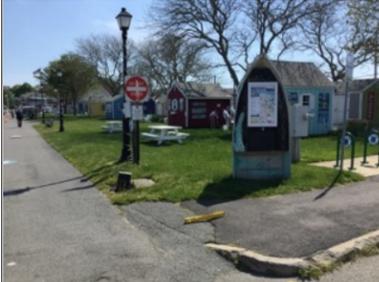
Running slope > 1:12 (8.33%) curb not maintained in operable working condition	11.5%	Provide a new curb ramp. (Cost estimate for a new concrete curb ramp.)	1	2800	\$2800
23	Sidewalk Along Ocean Street	Ext.		Curb Ramp	Perpendicular

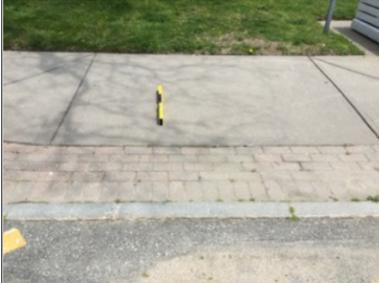
Transition from curb ramp to street not flush	-	Ensure transition from curb ramp to street is flush or free of changes in level. Recommend providing detectable warning.	1	170	\$170
24	Sidewalk Along Ocean Street Heading North Side	Ext.		Curb Ramp	Parallel

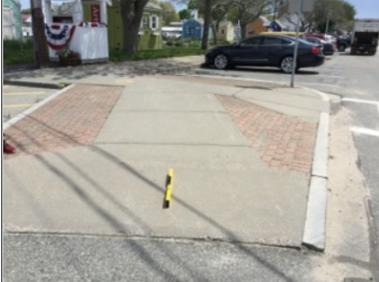
Transition from curb ramp to street not flush	-	Ensure transition from curb ramp to street is flush or free of changes in level. Recommend providing detectable warning.	1	170	\$170

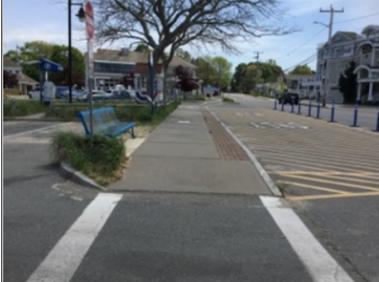
25	Sidewalk Along Ocean Street Heading South	Ext.		Curb Ramp	Parallel

Transition from curb ramp to street not flush	-	Ensure transition from curb ramp to street is flush or free of changes in level. Recommend providing detectable warning.	1	170	\$170

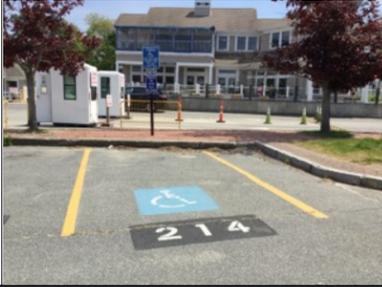
ID	Location	Floor	Room	Element	Type	Photo	Issues	Current Measure	Recommendations	Quantity	Price	Cost Estimation
Off-Street Parking Lot or Garage												
26	South Parking Lot Accessible Spots	Ext.		Off-Street Parking Lot or Garage	Visitor

Total # of parking Total # of designated accessible parking spaces Access aisle not provided Sign does not have the designation "Van Accessible"	24 1 - -	Provide a marked access aisle that is at least 96" wide. Add the designation "Van Accessible" to the sign located at the van accessible space.	1	800	\$800
Emergency Exit												
27	Welcome Center	1		Emergency Exit	N/A

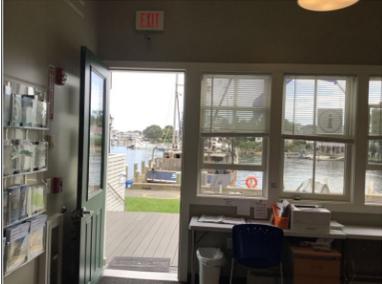
Illuminated International Symbol of Acc. not provided (MAAB) Maneuvering clearance(s) not provided	- -	If the exit sign is replaced with a new illuminated exit sign, provide an illuminated International Symbol of Accessibility (ISA). Remove desk to provide maneuvering clearance at door.	1	200	\$200

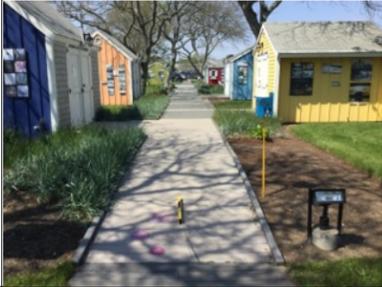
Access to Goods and Services												
Ramps												
28	Walkway Through Shanties	Ext.		Ramps	Exterior

Handrails not provided	-	Provide handrails with 1-1/4" to 1-1/2" circular cross section. (Cost estimate for 20' of handrails.)	2	880	\$1760
29	Walkway Through Shanties to Parking Lot	Ext.		Ramps	Exterior

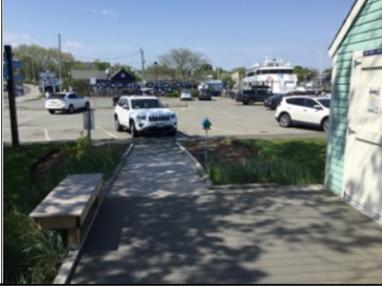
Handrails not provided	-	Provide handrails with 1-1/4" to 1-1/2" circular cross section. (Cost estimate for 20' of handrails.)	2	880	\$1760

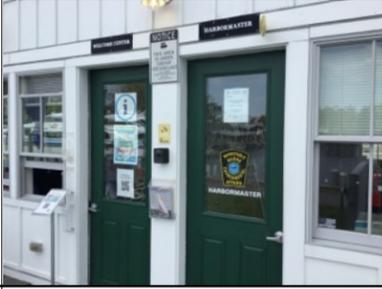
ID	Location	Floor	Room	Element	Type	Photo	Issues	Current Measure	Recommendations	Quantity	Price	Cost Estimation
Signage												
30	Welcome Center	Ext.		Signage	Designation

Raised characters not provided Braille not provided Sign not located on the latch side of the door	- - -	Provide text with raised characters duplicated in braille. Locate sign at permanent rooms alongside the door on the latch side.	2	232	\$464
31	Men's Toilet Room	Ext.		Signage	Designation

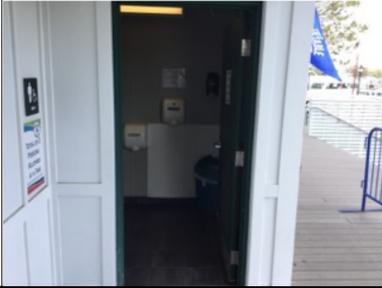
Sign not located on the latch side of the door	-	Locate sign at permanent rooms alongside the door on the latch side.	1	Labor	\$0
32	Women's Toilet Room	Ext.		Signage	Designation

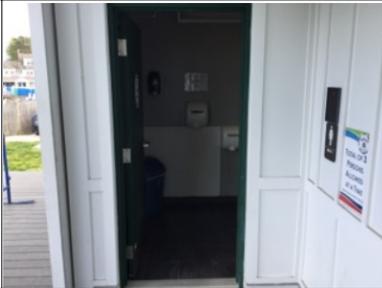
Sign not located on the latch side of the door	-	Locate sign at permanent rooms alongside the door on the latch side.	1	Labor	\$0
33	Artist Shanties	Ext.		Signage	N/A

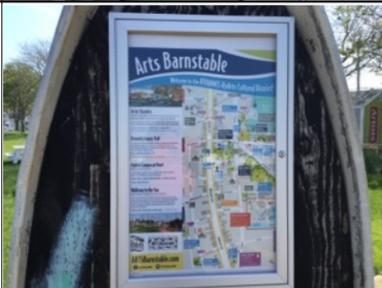
Non glare finish and contrast not provided	-	Provide signs with a non-glare finish with characters that have a high contrast to the background.	1	-	\$0

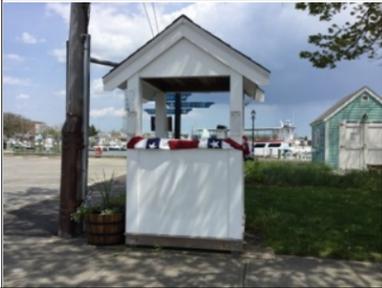
Service Counter												
34	Sidewalk Along Ocean Street Heading North Side	Ext.		Service Counter	N/A

Counter > 36" high	53.25"	Provide a counter that is 36" max. above the ground.	1	880	\$880

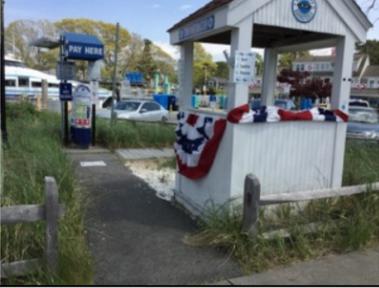
ID	Location	Floor	Room	Element	Type	Photo	Issues	Current Measure	Recommendations	Quantity	Price	Cost Estimation
35	Sidewalk Along Ocean Street Heading South Side	Ext.		Service Counter	N/A

Counter > 36" high	53.25"	Provide a counter that is 36" max. above the ground.	1	880	\$880
36	Welcome Center Service Counter	1		Service Counter	N/A

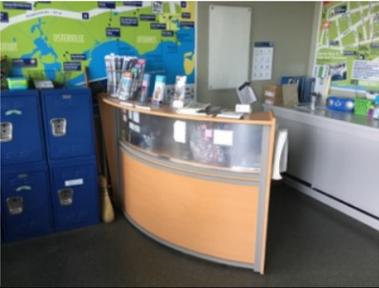
Counter > 36" high	44.5"	Provide a counter that is 36" max. above the ground.	1	880	\$880
Operable Parts												
37	Pay Station at Welcome Center	Ext.		Operable Parts	N/A

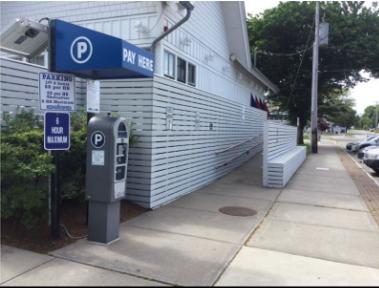
Reach < 15" or > 48"(forward/side approach)	67.25"	Provide a pay meter so that controls are between 15"- 48" above the finished floor.	1	-	\$0
38	Sidewalk Along Ocean Street Heading North	Ext.		Operable Parts	N/A

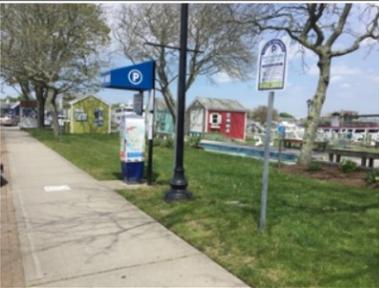
Reach < 15" or > 48"(forward/side approach)	67.25"	Provide a pay meter so that controls are between 15"- 48" above the finished floor.	1	-	\$0
39	Sidewalk Along Ocean Street Heading South	Ext.		Operable Parts	N/A

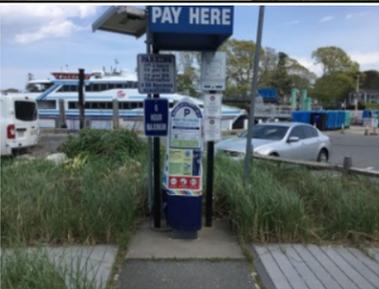
Reach < 15" or > 48"(forward/side approach)	67.25"	Provide a pay meter so that controls are between 15"- 48" above the finished floor.	1	-	\$0

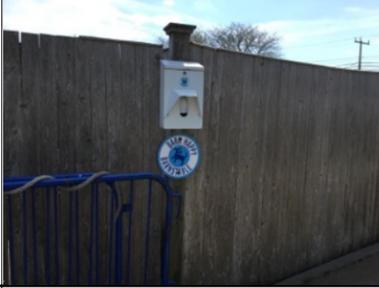
ID	Location	Floor	Room	Element	Type	Photo	Issues	Current Measure	Recommendations	Quantity	Price	Cost Estimation
40	South Side Parking Lot Along Harbormaster Building	Ext.		Operable Parts	Dog Bags

Reach < 15" or > 48"(forward/side approach)	58.25"	Relocate dog waste bags so that controls are between 15"- 48" above the finished floor.	1	Labor	\$0
41	Women's Toilet Room	Ext.		Operable Parts	N/A

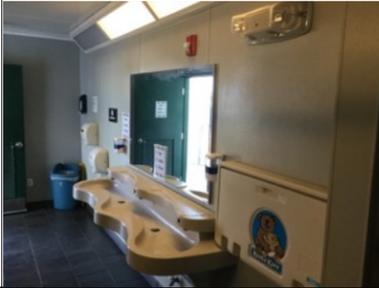
Reach < 15" or > 48"(forward/side approach)	51"	Relocate baby changing table so that controls are between 15"- 48" above the finished floor.	1	Labor	\$0
42	Welcome Center	Ext.		Operable Parts	N/A

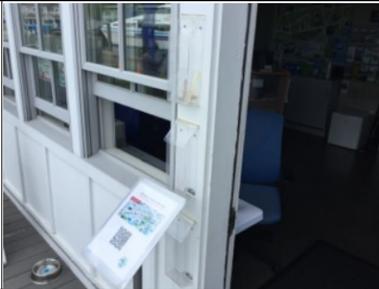
Reach < 15" or > 48"(forward/side approach)	65.5"	Relocate leaflets so that controls are between 15"- 48" above the finished floor.	1	Labor	\$0
43	Welcome Center	1		Operable Parts	N/A

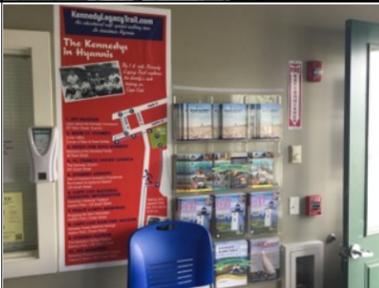
Reach < 15" or > 48"(forward/side approach)	72.5"	Relocate leaflets so that controls are between 15"- 48" above the finished floor.	1	Labor	\$0

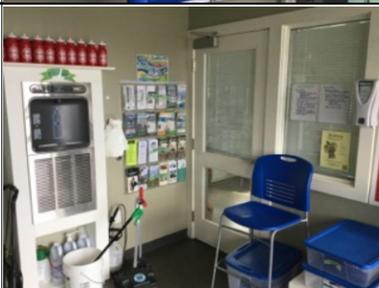
44	Water Fountain Station	1		Operable Parts	N/A

Side reach > 54"	64.25"	Relocate water dispenser so that controls are between 15" - 48" above the finished floor.	1	Labor	\$0

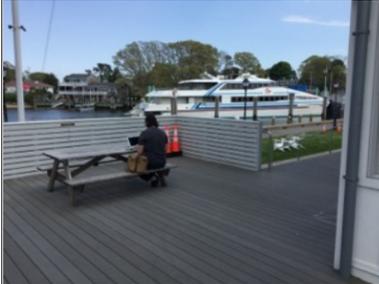
ID	Location	Floor	Room	Element	Type	Photo	Issues	Current Measure	Recommendations	Quantity	Price	Cost Estimation
Picnic Tables												
45	Bathhouse /Welcome Center	Ext.		Picnic Tables	N/A

Toe or knee clearance at table not provided	-	Provide at least one picnic table with top between 28"- 34" above the ground and 27" min. knee clearance underneath.	1	1400	\$1400
46	Bismore Park/Artist Shanties	Ext.		Picnic Tables	N/A

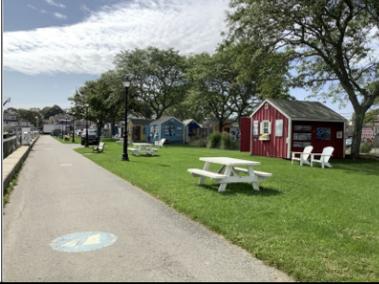
Toe or knee clearance at table not provided Picnic table not on an accessible route	- -	Provide at least one picnic table with top between 28"- 34" above the ground and 27" clear height underneath. Ensure that the picnic table is located to an accessible route.	1	1400	\$1400
Toilet & Bathing Rooms												
Toilet Compartment												
47	Men's Toilet Room	Ext.		Toilet Compartment	Accessible Compartment

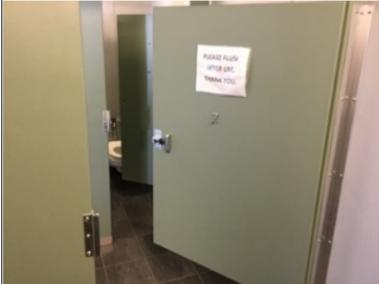
Door with malfunctioning self-closing hinge	-	Repair hinge.	1	Labor	\$0

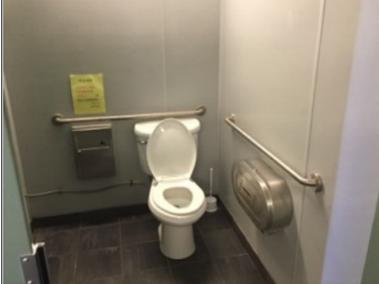
48	Women's Toilet Room	Ext.		Toilet Compartment	Accessible Compartment

Door with malfunctioning self-closing hinge Clearance at toilet < 72" clear depth (MAAB)	- 62"	Repair hinge. Provide a wheelchair accessible compartment that is 60" wide and 72" deep.	1	6182	\$6182

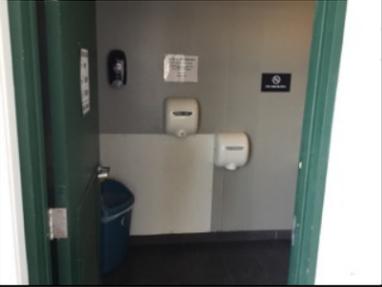
ID	Location	Floor	Room	Element	Type	Photo	Issues	Current Measure	Recommendations	Quantity	Price	Cost Estimation
Dispensers												
49	Women's Toilet Room	Ext.		Dispensers	N/A

Controls > 48" Dispenser acts as a protruding object	58" 8"	Relocate so the hand sanitizer is 48" max. above the finished floor. Relocate hand dryers out of circulation path or provide a cane-detectable barrier 27" max. above the finished floor.	3	256	\$768
50	Men's Toilet Room	Ext.		Dispensers	N/A

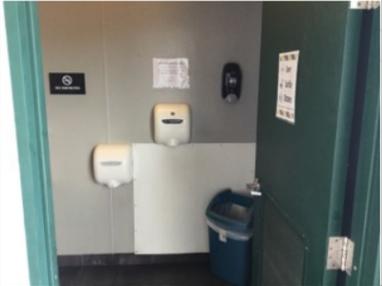
Controls > 48" Dispenser acts as a protruding object	56.75" 8"	Relocate so the hand sanitizer is 48" max. above the finished floor. Relocate hand dryers out of circulation path or provide a cane-detectable barrier 27" max. above the finished floor.	1	256	\$256
Best Practice												
51	Artist Shanties	Ext.			252

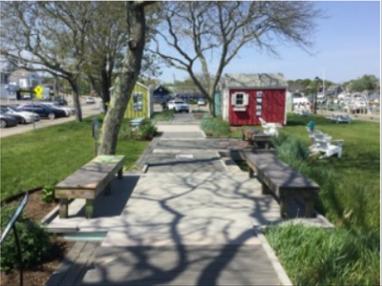
Recommend providing 36"X48" minimum clear floor space adjacent to the bench. Recommend providing one bench with a back and one bench with arms in this area.	1	-	\$0

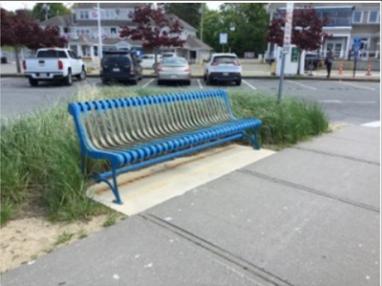
52	Sidewalk Along Ocean Street Heading South	Ext.			252

Recommend providing 36"X48" minimum clear floor space adjacent to the bench.	1	-	\$0

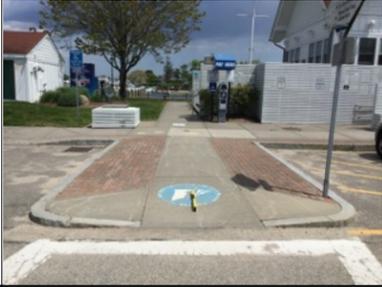
ID	Location	Floor	Room	Element	Type	Photo	Issues	Current Measure	Recommendations	Quantity	Price	Cost Estimation
Curb Ramp												
53	Sidewalk Along Ocean Street Near Harbormaster Building	Ext.		Curb Ramp	N/A

Recommend providing detectable warning at curb ramp.	1	-	\$0
54	Sidewalk Along Ocean Street Heading North	Ext.		Curb Ramp	N/A

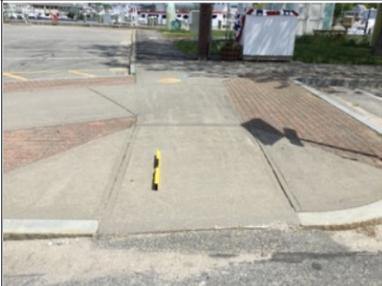
Recommend providing detectable warning at curb ramp.	1	-	\$0
55	South Side Parking Lot	Ext.		Curb Ramp	N/A

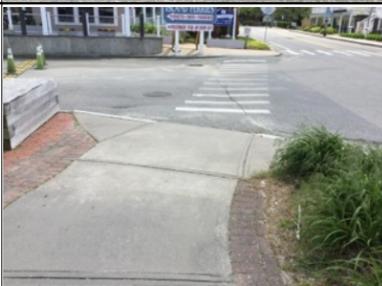
Recommend providing detectable warning at curb ramp.	1	-	\$0
56	South Side Parking Lot	Ext.		Curb Ramp	N/A

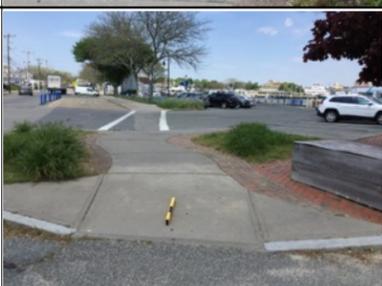
Recommend providing detectable warning at curb ramp.	1	-	\$0
Stairs												
57	Stairs at Welcome Center	Ext.		Stairs	Exterior

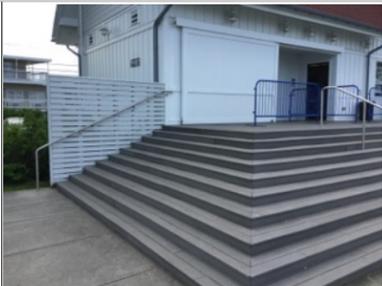
Recommend providing contrasting color strips at exterior staircase.	1		\$0
