Joshua's Pond and Bathhouse

Town of Barnstable
ADA Transition Plan

August 2021

**Town of Barnstable
Joshua's Pond and Bath House**

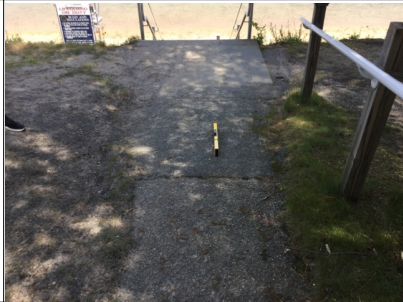
ID	Location	Floor	Room	Element	Type	Photo	Issues	Current Measure	Recommendations	Quantity	Price	Cost Estimation
Approach and Entrance												
Exterior Access Route												
1	Pond Access Route	Ext.		Exterior Access Route	Exterior

Running slope > 1:20 (5%) Surface is not stable, firm, and slip-resistant Accessible route not provided	30% - -	Providing an accessible route might be technically infeasible.	1	-	\$0
Off-Street Parking Lot or Garage												
2	Accessible Parking Spots	Ext.		Off-Street Parking Lot or Garage	N/A

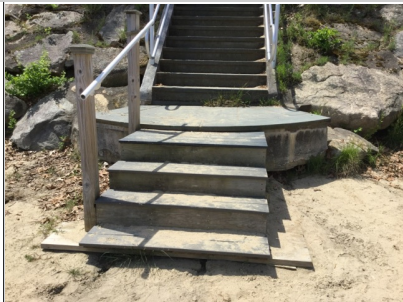
Handrails do not extend 12" from stairs Treads < 11" deep Accessible route not provided Tread widths and/or riser heights are not uniform	- 10.5" - -	Providing an accessible route might be technically infeasible.	1	-	\$0

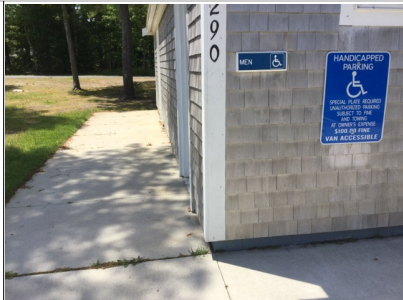
Signage												
4	Route From Parking to Men's Toilet Room	Ext.		Signage	Designation

Raised characters not provided Braille not provided Sign not located on the latch side of the door	- - -	Provide text with raised characters duplicated in braille. Locate sign at permanent rooms alongside the door on the latch side.	1	232	\$232

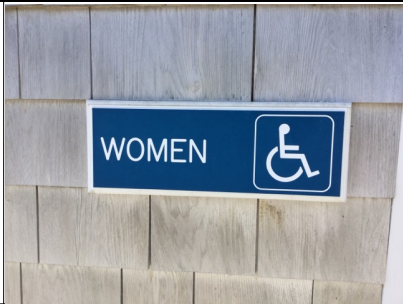
ID	Location	Floor	Room	Element	Type	Photo	Issues	Current Measure	Recommendations	Quantity	Price	Cost Estimation
5	Route From Parking to Women's Toilet Room	Ext.		Signage	Designation

Raised characters not provided Braille not provided Sign not located on the latch side of the door	- - -	Provide text with raised characters duplicated in braille. Locate sign at permanent rooms alongside the door on the latch side.	1	232	\$232
Service Counter												
6	Parking Hut	Ext.		Service Counter	N/A

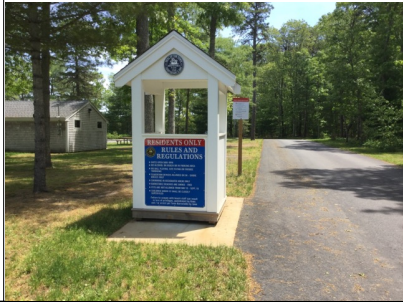
Counter > 36" high	52.75"	Provide a counter that is 36" max. above the ground.	1	880	\$880
Picnic Tables												
7	Field With Picnic Table	Ext.		Picnic Tables	N/A

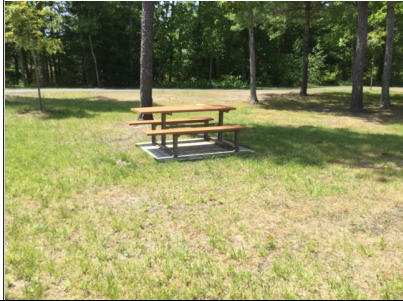
Picnic table not on an accessible route	-	Ensure that the picnic table is connected to an accessible route. (Cost of 4' wide by 12' long concrete path.)	1	600	\$600
Toilet & Bathing Rooms												
Lavatory												
8	Men's Toilet Room	1		Lavatory	N/A

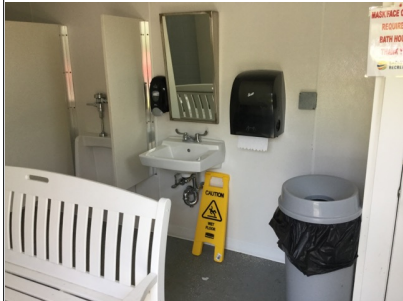
Exposed plumbing underneath	-	Insulate or otherwise configure pipes to prevent contact for at least one lavatory.	1	92	\$92

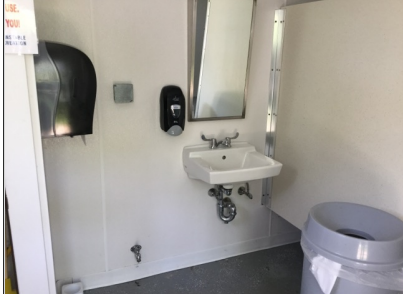
9	Women's Toilet Room	1		Lavatory	N/A

Exposed plumbing underneath Dispenser acts as a protruding object	-	Insulate or otherwise configure pipes to prevent contact for at least one lavatory. Relocate paper towel dispenser out of circulation path.	1	348	\$348

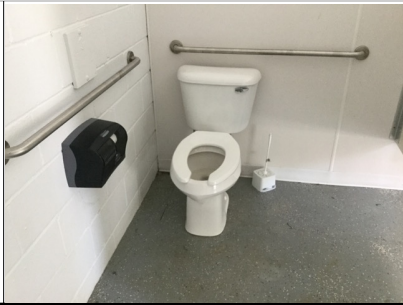
ID	Location	Floor	Room	Element	Type	Photo	Issues	Current Measure	Recommendations	Quantity	Price	Cost Estimation
Toilet Compartment												
10	Men's Toilet Room	1		Toilet Compartment	Accessible Compartment

Door with malfunctioning self-closing hinge	-	Repair hinge.	1	Labor	\$0
11	Women's Toilet Room	1		Toilet Compartment	Accessible Compartment

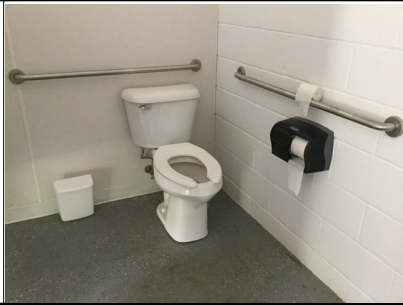
Door with malfunctioning self-closing hinge	-	Repair hinge.	1	Labor	\$0
Dispensers												
12	Men's Toilet Room	1		Dispensers	N/A

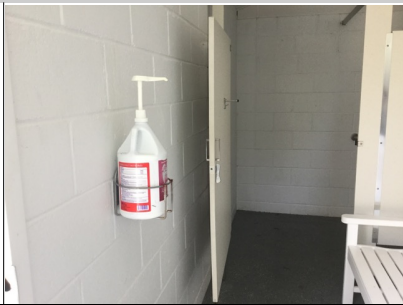
Controls > 42" (MAAB) Dispenser acts as a protruding object	58" 7"	Relocate so the operable part is 42" max. above the finished floor. Relocate hand sanitizer out of circulation path.	1	Labor	\$0
13	Women's Toilet Room	1		Dispensers	N/A

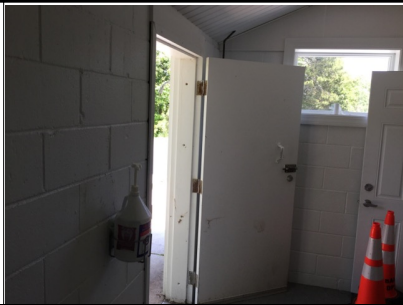
Controls > 42" (MAAB) Dispenser acts as a protruding object	55" 7"	Relocate hand sanitizer so the operable part is 42" maximum above the finished floor. Relocate hand sanitizer out of circulation path.	1	Labor	\$0

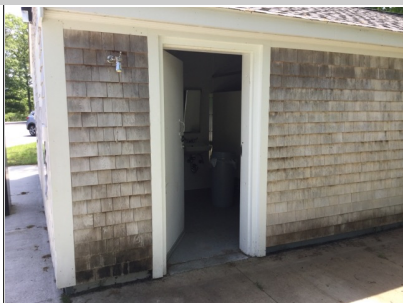
Outdoor Rinsing Showers												
14	Outdoor Shower	Ext.		Outdoor Rinsing Showers	N/A

2 fixed showerheads not provided	-	Provide two showerheads located 48" and 72" min. above the ground.	1	2719	\$2719
