Loop Beach and Bathhouse

Town of Barnstable ADA Transition Plan

October 2021

Institute for Human Centered Design

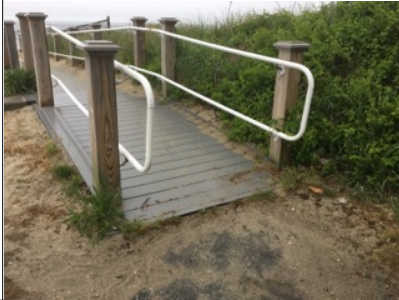
Level changes > 1/4"	1"	Alter change in level to be 1/4" high max.	1	256	\$256
2	Accessible Path to Beach	Ext.		Exterior Access Route	Exterior

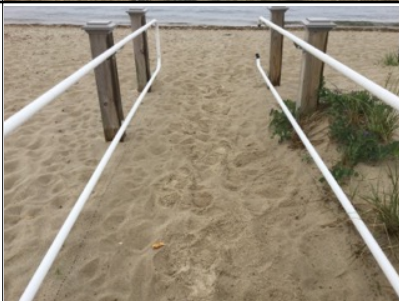
Accessible route not provided	-	Provide a beach mat 6.5' wide and 33' long to the mean high tide level.	1	1909	\$1909
3	Bike Rack by Accessible Path to Beach	Ext.		Exterior Access Route	Exterior

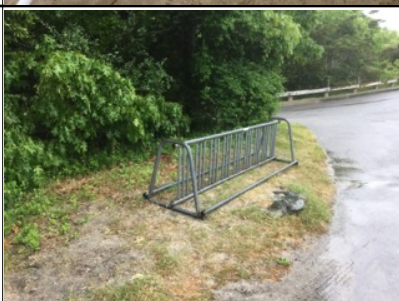
Accessible route not provided	-	Ensure bike rack is located on an accessible route.	1	Labor	\$0
Off-Street Parking Lot or Garage												
4	Parking Lot	Ext.		Off-Street Parking Lot or Garage	Visitor

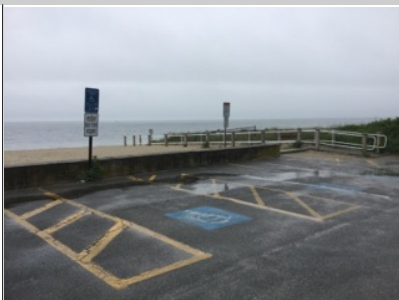
Total # of parking Total # of designated accessible parking spaces Total # of designated van accessible spaces Sign not provided Sign does not have the designation "Van Accessible"	53 2 1 - -	Provide a sign with the International Symbol of Accessibility (ISA) at the car accessible parking space with the bottom of the sign 60" min. above the ground and the top 96" max. above the ground. Add the designation "Van Accessible" to the sign located at the van accessible space.	2	500	\$1000

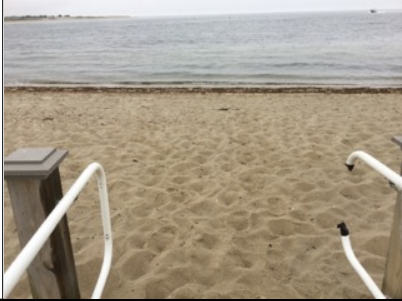
Not maintained in operable working condition	-	Ensure the ramp handrail is maintained in operable working condition.	1	256	\$256
Access to Goods and Services												
Interior Access Route												
6	Men's Toilet Room	1		Interior Access Route	N/A

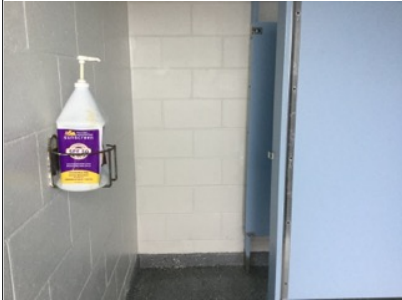
Obstructed by protruding objects Audible and visible alarms not provided	-	Relocate hand sanitizer. When fire system is updated, ensure that a visible and audible fire alarm is installed.	1	256	\$256
Doors, Doorways, & Gates												
7	Men's Toilet Room	1		Doors, Doorways, & Gates	Toilet Room

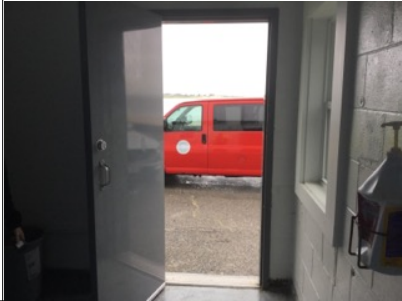
Clear width at door < 32" Maneuvering clearance(s) not provided	29" 4"	Widen the door so that there is 32" min. clear width. Provide an automatic door opener.	1	6426	\$6426

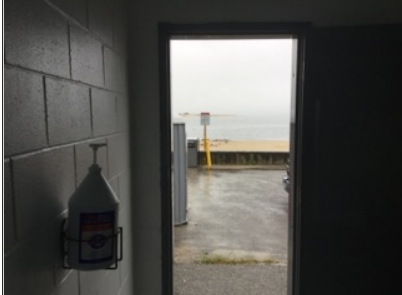
8	Women's Toilet Room	1		Doors, Doorways, & Gates

Clear width at door < 32" Maneuvering clearance(s) not provided	31" 9"	Widen the door so that there is 32" min. clear width. Provide an automatic door opener.	1	6426	\$6426

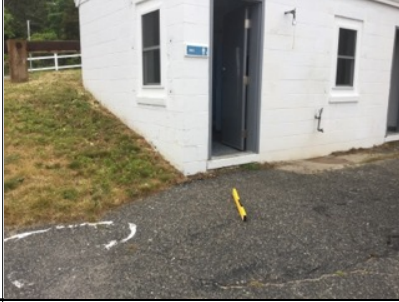
Maneuvering clearance at door > 1:50 (2.00%) Threshold > 1/2" high	15.3% 6"	Alter so that the slope in all directions is no greater than 1:50 (2.00%) / Provide an automatic door opener. Alter the threshold to be 1/2" high max. (Cost estimate of a concrete path 5' wide and 20' long.)	1	1000	\$1000
10	Men's Toilet Room	Ext.		Doors, Doorways, & Gates	Toilet Room

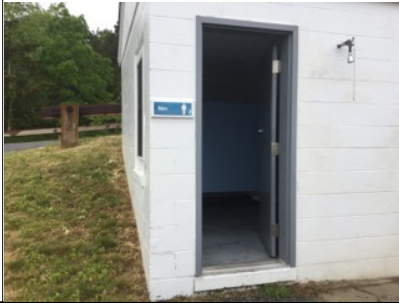
Threshold > 1/2" high	6.75"	Alter the threshold to be 1/2" high max. (Cost provided in ID #10.)	1	-	\$0
11	Women's Toilet Room	Ext.		Doors, Doorways, & Gates	Toilet Room

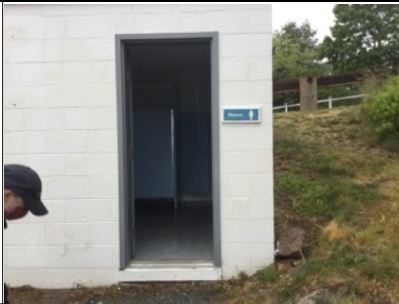
Threshold > 1/2" high	6.5"	Alter the threshold to be 1/2" high max. (Cost provided in ID #10.)	1	-	\$0
Signage												
12	Men's Toilet Room	Ext.		Signage	Designation

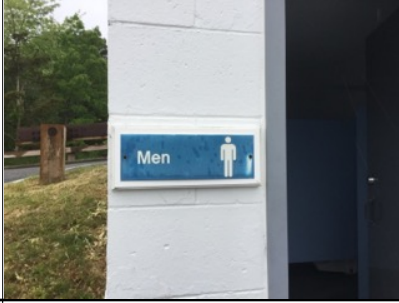
Raised characters not provided on sign Braille not provided on sign	- -	Provide text with raised characters duplicated in braille on sign.	1	232	\$232

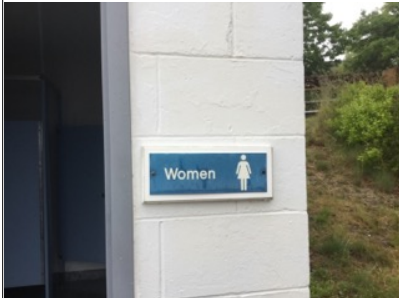
13	Women's Toilet Room	Ext.		Signage	Designation

Raised characters not provided on sign Braille not provided on sign	- -	Provide text with raised characters duplicated in braille on sign.	1	232	\$232

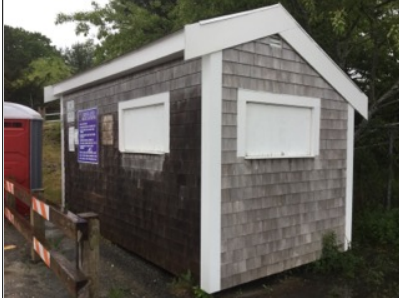
Counter > 36" high	58"	Provide a counter / service window that is 36" max. above the ground or finished floor.	1	880	\$880
Exterior Benches												
15	Bench at Beach next to Stairs	Ext.		Exterior Benches	N/A

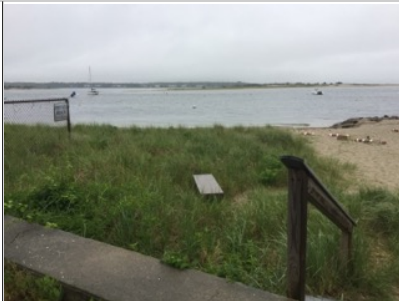
No accessible route to one bench in area	-	Ensure bench is located on an accessible route.	1	labor	\$0
Toilet & Bathing Rooms												
Overall Access												
16	Men's Toilet Room	1		Overall Access	Toilet Room

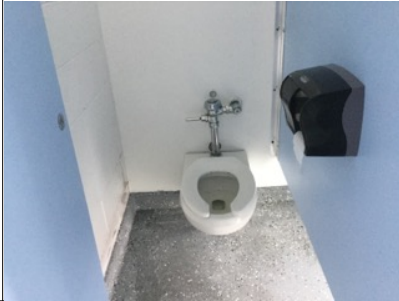
Accessible plumbing fixtures or stalls not provided	-	Remove the partition to provide an accessible single-user toilet compartment. (Install a toilet with a seat height 17"- 19" above the floor and has a centerline of 18". Provide one 42" long grab bar on the side wall of the toilet and one 42" long on the rear wall. Relocate toilet paper so that it is 24" minimum high, located under the grab bar, and between 7" and 9" from the front of the toilet).	1	6182	\$6182

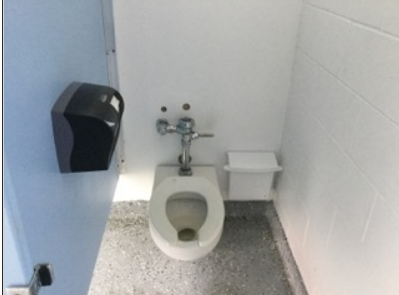
17	Women's Toilet Room	1		Overall Access	Toilet Room

Accessible plumbing fixtures or stalls not provided	-	Remove the partition to provide an accessible single-user toilet compartment. (Install a toilet with a seat height 17"- 19" above the floor and has a centerline of 18". Provide one 42" long grab bar on the side wall of the toilet and one 42" long on the rear wall. Relocate toilet paper so that it is 24" minimum high, located under the grab bar, and between 7" and 9" from the front of the toilet).	1	6182	\$6182

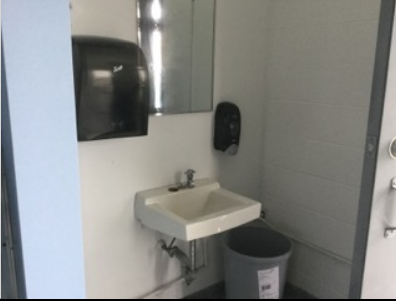
Toe or knee clearances not provided Plumbing underneath is exposed Mirror above lavatory w/reflective surface > 40"	24.75" - 47"	Provide lavatory with knee and toe clearance positioned for a forward approach. Insulate or otherwise configure pipes to prevent contact at lavatory. Lower mirror so that the bottom surface is at 40" max. above the finished floor.	1	2034	\$2034
19	Women's Toilet Room	1		Lavatory

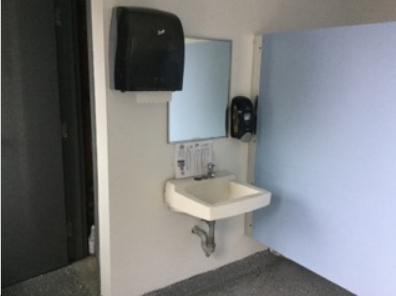
Plumbing underneath is exposed Dispensers not within reach range	- 52"	Insulate or otherwise configure pipes to prevent contact for at least one lavatory. Lower dispensers to 48" max. above the floor.	1	348	\$348
Urinal												
20	Men's Toilet Room	1		Urinal	N/A

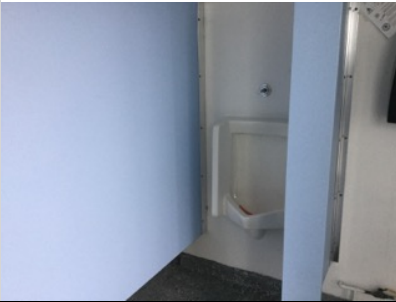
Rim > 17" high	24"	Provide at least one urinal with the rim no higher than 17" above the finished floor.	1	3248	\$3248

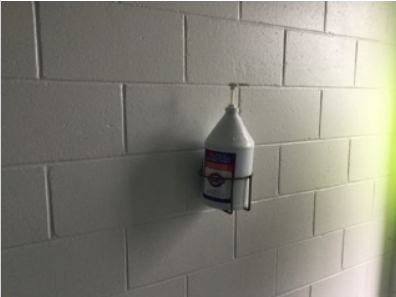
Dispensers												
21	Women's Toilet Room	1		Dispensers

Controls > 42" high Dispenser acts as a protruding object	56" 7"	Relocate so the operable part is 48" maximum above the finished floor. Relocate dispenser out of the circulation path.	1	256	\$256

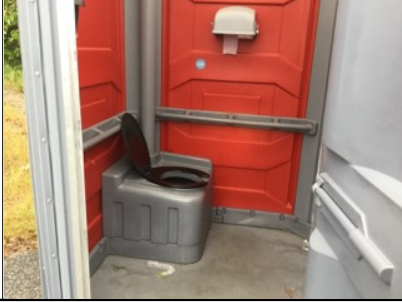
60" by 72" clear space not provided	-	Provide an accessible portable toilet that has 60" wide and 72" deep clear floor space at the toilet.	1	-	\$0
Additional Access												
Drinking Fountains												
23	Drinking fountain.	Ext.		Drinking Fountains	Hi-Lo

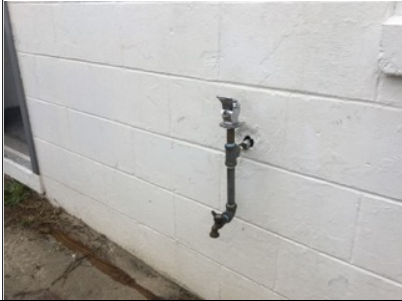
Fountain not on accessible route No drinking fountain provided for standing users No drinking fountain provided for seated users Knee or toe clearance not provided	- - - -	Provide an accessible drinking fountain for a seated and standing user. (Cost for a new Hi-Low fountain.)	1	4216	\$4216
Best Practice												
Exterior Stair												
24	Access to Beach through Stairs	Ext.		Exterior Stair	N/A

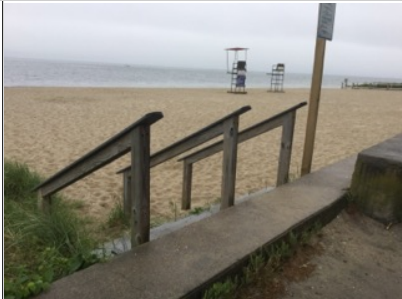
Recommend providing handrails with 1 1/4" - 2" circular cross sections.	1	-	\$0
