## Creative Arts 2

## Town of Barnstable ADA Transition Plan

**Town of Barnstable  
Creative Arts 2**

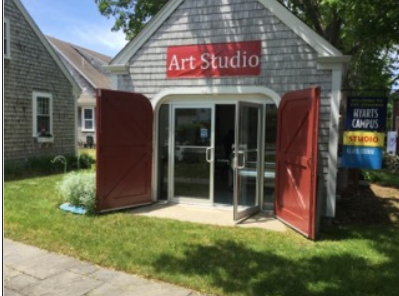
Accessible route not provided	-	Ensure an accessible route is provided.  (Cost estimate of 4' wide and 6' long concrete path.)	1	384	\$384
2	Information Sign Near Parking Lot	Ext.		Exterior Access Route	Exterior

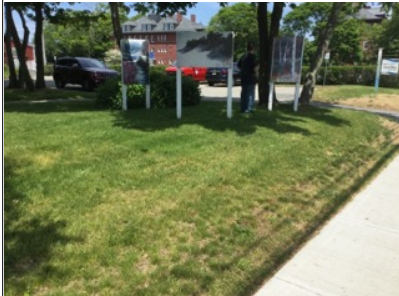
Accessible route not provided	-	Ensure an accessible route is provided to and around art exhibits.	1	576	\$576
3	Information Sign Near Creative Arts	Ext.		Exterior Access Route	Exterior

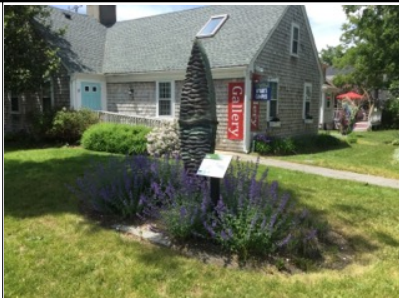
Accessible route not provided	-	Ensure an accessible route is provided to the sign.  (Cost estimate of 4' wide and 15' long stone dust path.)	1	480	\$480
4	Exterior Art Installations by Creative Arts	Ext.		Exterior Access Route	Exterior

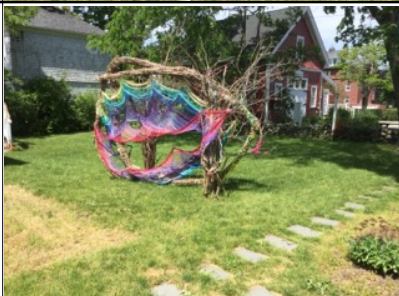
Accessible route not provided	-	Ensure an accessible route is provided to and around art exhibit.  (Cost estimate of 4' min. wide and 90' long stone dust path.)	1	2880	\$2880

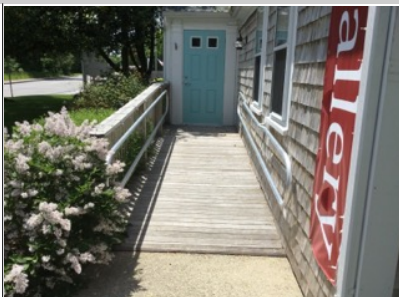
<b>Exterior Ramp</b>												
5	Main Entrance/Egress to Creative Arts	Ext.		Exterior Ramp	N/A

Level changes > 1/4"	1"	Alter change in level to be 1/4" high max.	1	256	\$256

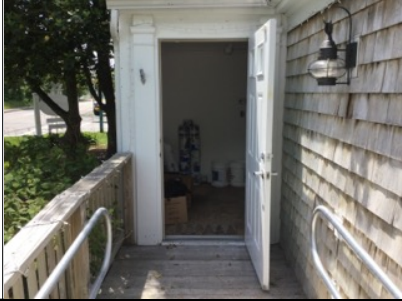
Maneuvering clearance is not provided	11"	Provide an automatic door opener. (18" min. pull side maneuvering clearance is required on the pull-side of the door.)	1	3060	\$3060
<b>Access to Goods and Services</b>												
<b>Means of Egress</b>												
7	Entrance/Egress at Art Studio	Ext.		Means of Egress	N/A

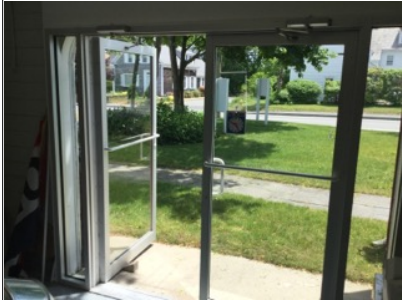
Tactile exit sign not provided	-	Ensure tactile exit signs with raised characters and braille are provided at exit doors. Mount signs between 48"- 60" above the finished floor located on the latch side of the door. If the exit sign is replaced with an illuminated exit sign, provide an illuminated International Symbol of Accessibility (ISA).	1	232	\$232
8	Main Entrance/Egress at Creative Arts	1		Means of Egress	N/A

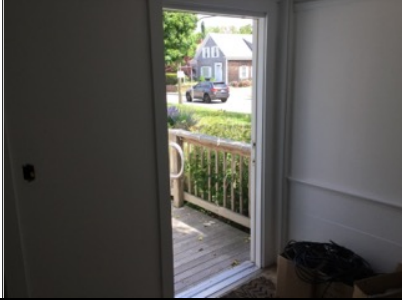
Tactile exit sign not provided	-	Ensure tactile exit signs with raised characters and braille are provided at exit doors. Mount signs between 48"- 60" above the finished floor located on the latch side of the door.	1	232	\$232

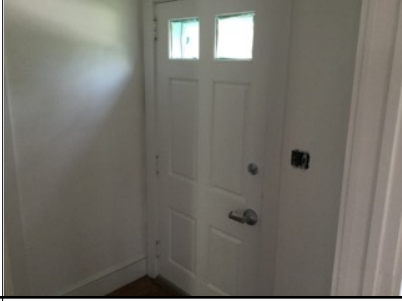
9	Creative Arts 2 Egress Door west Side	1		Means of Egress	N/A

Tactile exit sign not provided Directional sign to accessible emergency exit not provided	- -	Provide a directional sign indicating the location of the nearest accessible emergency exit. Ensure tactile exit signs with raised characters and braille are provided at exit doors. Mount signs between 48"- 60" above the finished floor located on the latch side of the door.	1	464	\$464
10	Creative Arts 2 Egress Door north Side	1		Means of Egress	N/A

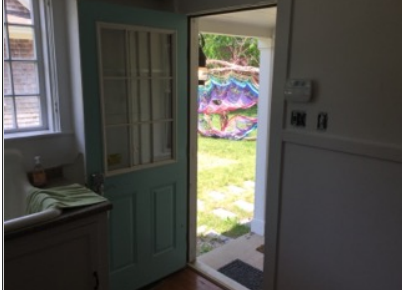
Tactile exit sign not provided Directional sign to accessible emergency exit not provided	- -	Ensure tactile exit signs with raised characters and braille are provided at exit doors. Mount signs between 48"- 60" above the finished floor located on the latch side of the door. Provide a directional sign indicating the location of the nearest accessible emergency exit.	1	464	\$464

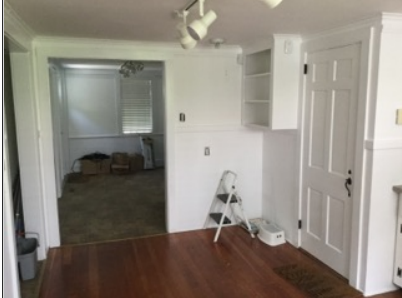
Obstructed by protruding objects	11.5"	Provide a cane-detectable barrier at the wall cabinet.	1	306	\$306
<b>Doors, Doorways, &amp; Gates</b>												
12	Creative Arts 2 Emergency Exit on North Side	1		Doors, Doorways, & Gates	Emergency Egress

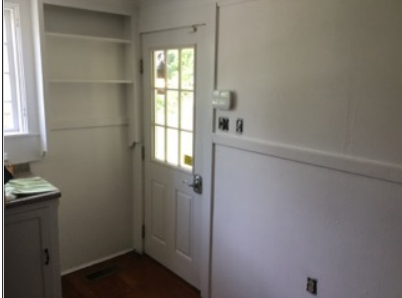
Clear width at door < 32"	29.5"	Widen the door so that there is 32" min. clear width.	1	2232	\$2232
13	Creative Arts 2 Single-User Toilet Room	1		Doors, Doorways, & Gates	Toilet Room

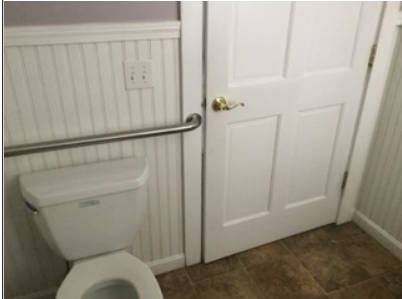
Maneuvering clearance(s) not provided	10"	Provide an automatic door opener. (18" min. pull side maneuvering clearance is required on the pull-side of the door.)	1	3060	\$3060
<b>Operable Parts</b>												
14	Near Entrance to the Art Studio	Ext.		Operable Parts	Other

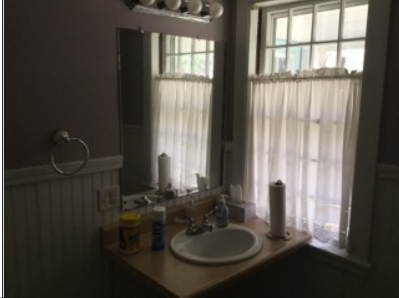
Toe or knee clearances not provided	25"	Provide at least one lavatory with knee and toe clearance positioned for a forward approach.	1	1686	\$1686
<b>Single-User Toilet</b>												
16	Creative Arts 2 Single-User Toilet Room	1		Single-User Toilet	N/A

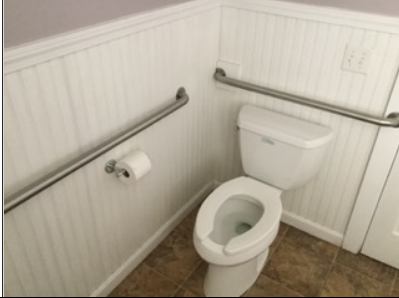
Flush control not on open side	-	Relocate the flush control to the open side.	1	374	\$374
17	Creative Arts 2 Single-User Toilet Room	1		Single-User Toilet	N/A

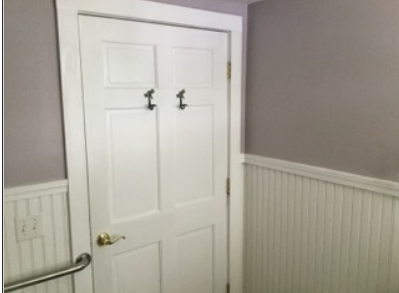
Hook located > 48" high	63.5"	Locate hook no higher than 48" above the finished floor.	1	150	\$150
