# **Town of Barnstable 2014 Hydrilla Control Program: Long Pond, Mystic Lake & Middle Pond**

**Project Completion Report for 2014 Hydrilla Management Tasks Performed at  
Long Pond, Mystic Lake, and Middle Pond – Barnstable, MA**

**December 2014**

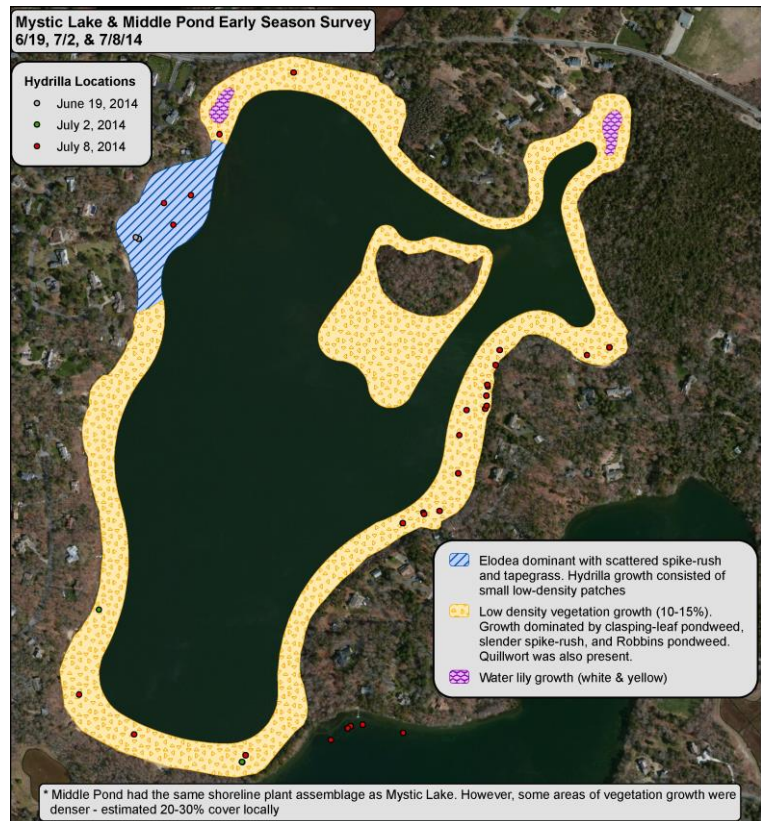
**Figure 3 – 2014 Pre-Treatment Vegetation Distribution**

Vegetation growth at the time of the June 19 survey was very sparse and only a few hydrilla occurrences were identified at that time. The emergence of hydrilla in this area has historically been later than other species; however, on account of the cooler spring in 2014 we suspect that widespread active growth was delayed by a couple of weeks. For this reason the hydrilla infestation was surveyed several times (7/3 and 7/8) in order to compile an accurate depiction of the 2014 hydrilla infestation. The hydrilla growth observed later in the summer suggested a similar level of hydrilla growth outside of the Area A treatment area, but significantly less within the treatment area.

The vegetation growth as a whole was generally confined to the immediate shoreline, extending roughly 75-100' feet from shore to a depth of 10-12 feet creating a contiguous ring around the lake. The plant assemblage was generally characterized by low-density growth of clasping-leaf pondweed (*Potamogeton perfoliatus*) and tapegrass (*Vallisneria americana*) with scattered occurrences of hydrilla (mostly individual plants), common waterweed (*Elodea canadensis*) and slender spikerush. As in 2013, the only area that supported larger denser patches of hydrilla growth was the Area A cove along the western shore (the ~5.5 acre area designated herbicide treatment area). This area supported several moderate density patches of hydrilla. At the time of the surveys the hydrilla growth was still relatively immature and was only 4-5" inches in height. A map of the representative conditions observed on July 8 is above.
