Structures and Grounds Office

Town of Barnstable ADA Transition Plan

September 2021

**Town of Barnstable
Structures and Grounds Office**

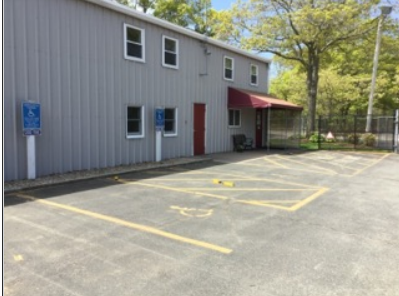
Vehicle space < 96" wide at car space	93"	Provide an accessible space that is at least 96" wide.	1	300	\$300
2	Near Main Entrance	Ext.		Off-Street Parking Lot or Garage	Visitor

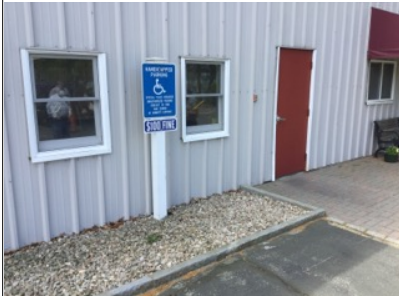
Sign bottom < 60" above finished grade	48"	Locate sign with the bottom of the sign 60" above the ground.	2	Labor	\$0
Entrance												
3	Main Entry/Exit	1		Entrance	Main Entrance

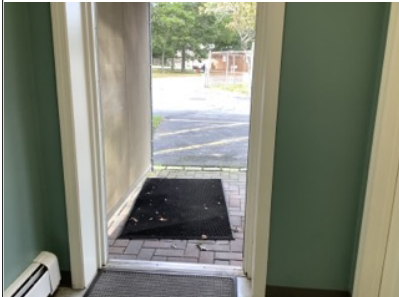
See ID #4.	1	-	\$0
4	Main Entry/Exit	Ext.		Entrance	Main Entrance

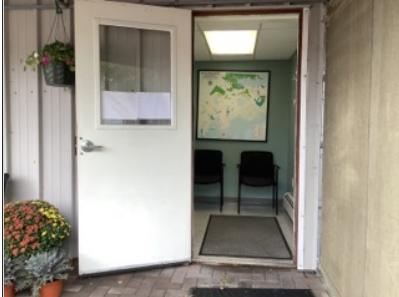
Maneuvering clearance is not provided Threshold not beveled Threshold > 1/2" high	5" - 1.5"	Reverse the swing of the door to provide maneuvering clearance. Bevel the threshold. Alter threshold to be 1/2" high max.	1	2184	\$2184

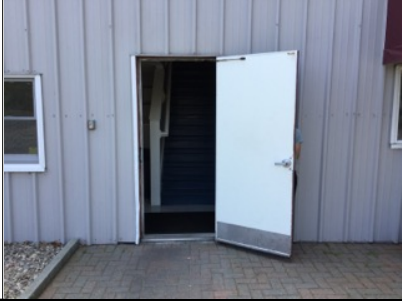
Threshold > 1/2" high Threshold not beveled	2" -	Alter the threshold to be 1/2" high max. Bevel the threshold.	1	300	\$300
Access to Goods and Services												
Means of Egress												
6	Emergency Egress	1		Means of Egress	N/A

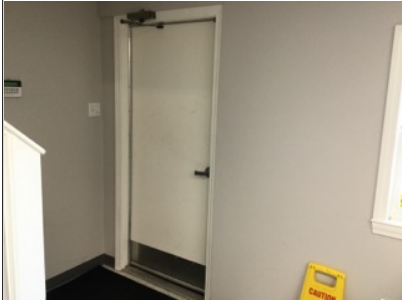
Tactile exit sign not provided	-	Ensure a tactile exit sign with raised characters and braille is provided at exit door. Mount sign between 48"- 60" above the finished floor located on the latch side of the door.	1	232	\$232
Doors, Doorways, & Gates												
7	Women's Toilet Room (Inside Office)	1		Doors, Doorways, & Gates	Toilet Room

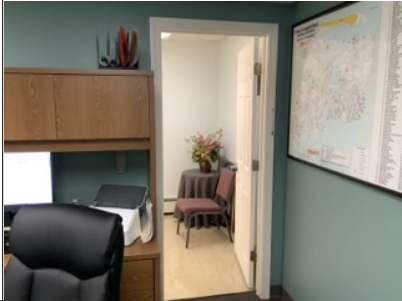
Clear width at door < 32"	28.5"	Widen the door so that there is 32" min. clear width.	1	3366	\$3366
8	Toilet Room	1		Doors, Doorways, & Gates

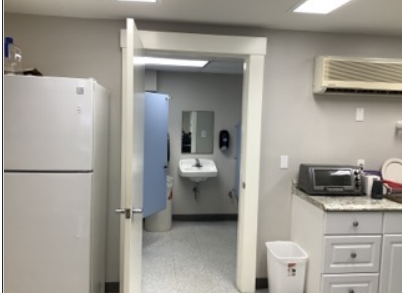
Maneuvering clearance(s) not provided		Remove trash can to maintain the maneuvering clearance at the door.	1	Labor	\$0

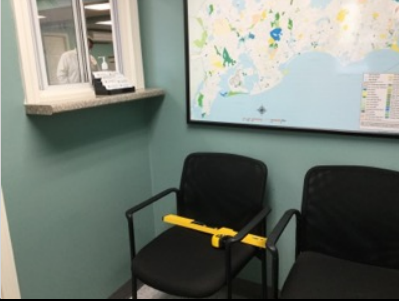
Counter > 36" high Clear floor space not provided	46.25" -	Provide a counter that is 36" max. above the ground or finished floor. Relocate chairs to provide a 30" min. by 48" min. clear floor space at the service counter.	1	880	\$880
Dining or Work Surfaces												
10	Meeting Area	1		Dining or Work Surfaces	Work Surface

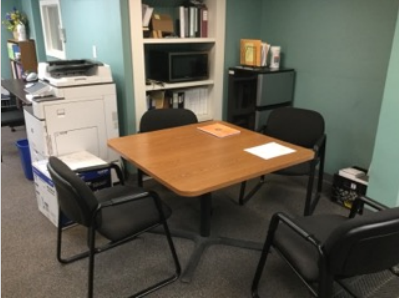
Knee or toe clearance not provided	-	Provide at least 1 work surface with 27" min. knee and toe clearance.	1	700	\$700
Toilet & Bathing Rooms												
Overall Access												
11	Single-User Toilet Room (Inside Office)	1		Overall Access	Toilet Room

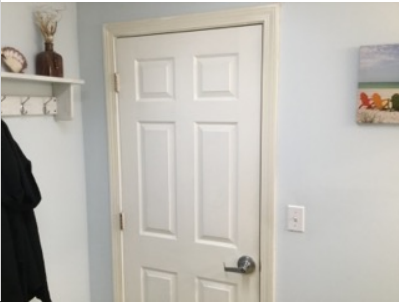
Audible and visible alarms not provided	-	When fire system is updated, ensure that a visible and audible fire alarm is installed.	1	-	\$0
Lavatory

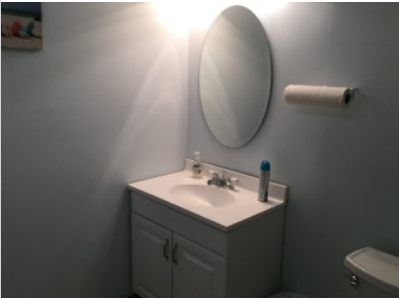
12	Single-User Toilet Room (Inside Office)	1		Lavatory	N/A

Toe or knee clearances not provided	-	Provide at least one lavatory with knee and toe clearance positioned for a forward approach.	1	1686	\$1686

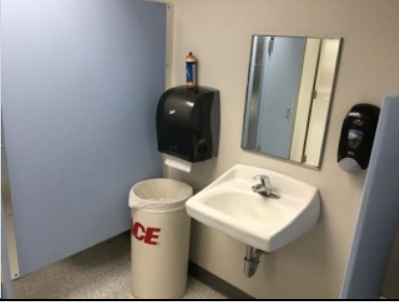
Plumbing underneath is exposed	-	Insulate or otherwise configure pipes to prevent contact for at lavatory.	1	92	\$92
Single-User Toilet												
14	Single-User Toilet Room (Inside Office)	1		Single-User Toilet

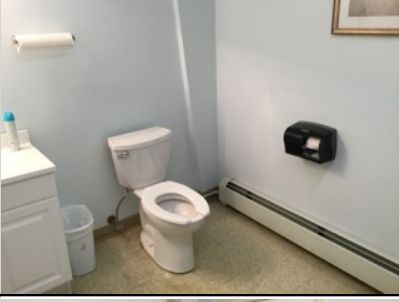
Centerline < or > 18" (MAAB) Grab bar not provided	31" -	Relocate toilet so that the centerline is 18" from the side wall. Provide one grab bar on the side wall of the toilet and one on the rear wall.	1	4624	\$4624
16	Single-User Toilet Room (Inside Office)	1		Single-User Toilet	N/A

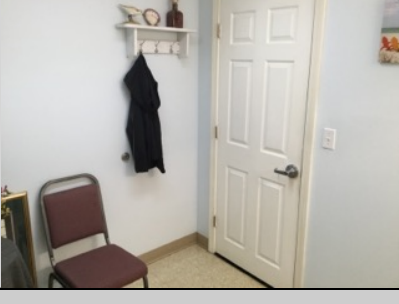
Hook located > 48" high	65.5"	Locate at least one hook no higher than 48" above the finished floor.	1	150	\$150
Toilet Compartment

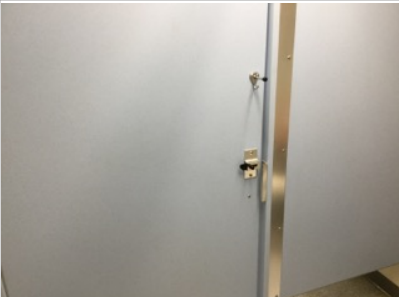
17	Toilet Room	1		Toilet Compartment	Accessible Compartment

Door has malfunctioning self-closing hinge	- -	Repair hinge.	1	Labor	\$0

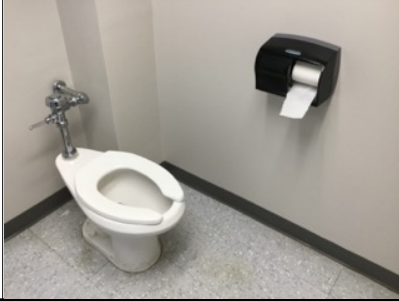
Grab bars not provided Non-compliant toilet paper dispenser Centerline < or > 18" (MAAB)	- 37.5" 22"	Provide one grab bar on the side wall of the toilet and one on the rear wall. Relocate toilet paper so that it is 24" min. high, located under the grab bar, and between 7" - 9" from the front of the toilet. Relocate toilet so the centerline is 18" from the side wall.	1	4880	\$4880
Urinal												
19	Toilet Room	1		Urinal

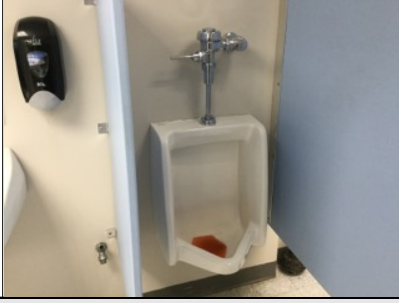
Rim > 17" high Flush control too high or not properly located	19.35" 48.25"	Locate urinal with the rim no higher than 17" above the finished floor. Mount flush control at 44" max. above the finished floor.	1	3248	\$3248
Best Practice												
Signage												
20	Main Entrance/Exit	Ext.		Signage	N/A

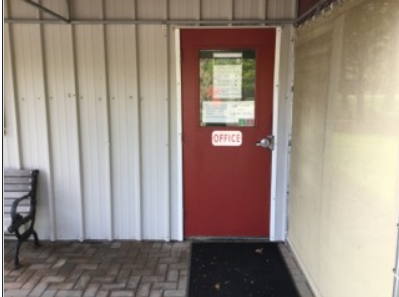
Recommend relocating the information signs to avoid glare.	1	-	\$0

- Recommend relocating the information signs to avoid glare (main entrance/exit).
