# North Street Parking Lot - East

Town of Barnstable  
ADA Transition Plan

September 2021

Institute for Human Centered Design

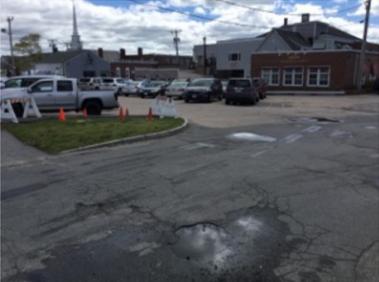
ID	Location	Floor	Room	Element	Type	Photo	Issues	Current Measure	Recommendations	Quantity	Price	Cost Estimation
<b>Approach and Entrance</b>												
<b>Exterior Access Route</b>												
1	Exit Opposite Hyannis Travel Inn From North Street at Parking Lot #1	Ext.		Exterior Access Route	Exterior

Does not prevent accumulation of water Route not maintained in operable working condition	- -	Repair surface to ensure the accessible route is maintained in operable working condition.	1	-	\$0
2	To Barnstable Road From Alberto's Restaurant	Ext.		Exterior Access Route	Exterior

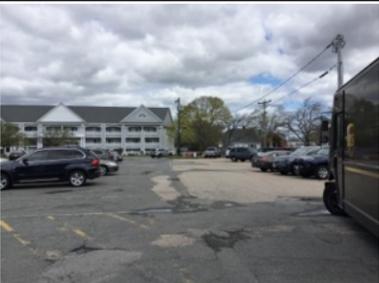
Does not prevent accumulation of water Route not maintained in operable working condition		Repair surface to ensure the accessible route is maintained in operable working condition.	1	-	\$0
3	Near Alberto's Restaurant	Ext.		Exterior Access Route	Exterior

Does not prevent accumulation of water Route not maintained in operable working condition	- -	Repair surface. Ensure the accessible route is maintained in operable working condition.	1	-	\$0

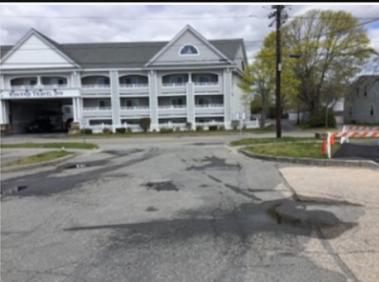
4	Exit Opposite Hyannis Travel Inn From North Street at Parking Lot #1	Ext.		Exterior Access Route	Exterior

Does not prevent accumulation of water Route not maintained in operable working condition	- -	Repair surface to ensure the accessible route is maintained in operable working condition.	1	-	\$0
<b>Off-Street Parking Lot or Garage</b>												
5	Accessible Parking Near Barnstable Road	Ext.		Off-Street Parking Lot or Garage	Visitor

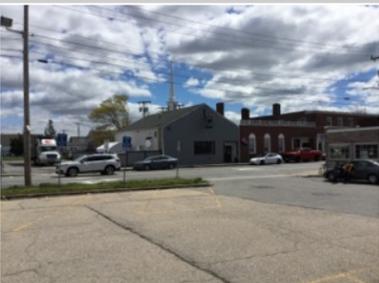
Running or cross slope at access aisle > 1:50 (2.00%) Sign does not have the designation "Van Accessible"	3.5% -	Reduce running or cross slope to be no steeper than 1:50 (2.00%) in all directions. Add the designation "Van Accessible" to the sign located at the van accessible space.	1	-	\$0

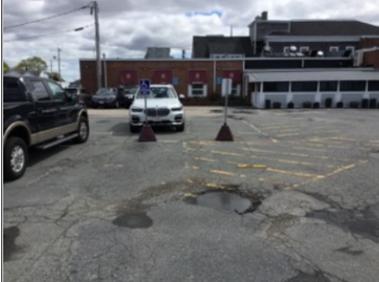
Sign bottom < 60" above finished grade Parking lot not maintained in operable working condition	55" -	Locate sign with the bottom of the sign 60" above the ground. Ensure the parking lot is maintained in operable working condition.	1	Labor	\$0
7	Accessible Parking Near Alberto's	Ext.		Off-Street Parking Lot or Garage	Visitor

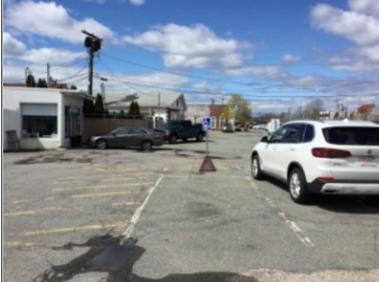
Sign bottom < 60" above finished grade Parking lot not maintained in operable working condition	55" -	Locate sign with the bottom of the sign 60" above the ground. Ensure the parking lot is maintained in operable working condition.	1	Labor	\$0
8	Accessible Parking Near Barnstable Road	Ext.		Off-Street Parking Lot or Garage	Visitor

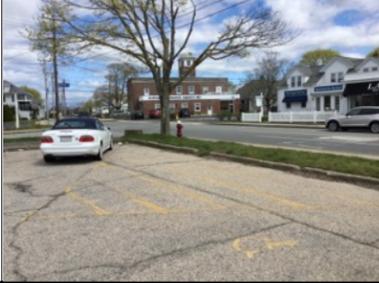
Parking lot not maintained in operable working condition	-	Restripe to ensure the parking lot is maintained in operable working condition.	1	-	\$0

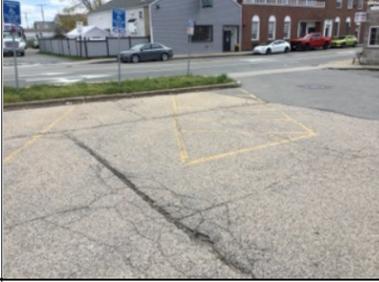
9	Accessible Parking Near Barnstable Road	Ext.		Off-Street Parking Lot or Garage	Visitor

Parking lot not maintained in operable working condition	-	Restripe to ensure the parking lot is maintained in operable working condition.	1	-	\$0
10	Old Accessible Parking in Front of Alberto's (Approved for Tent)	Ext.		Off-Street Parking Lot or Garage	Visitor

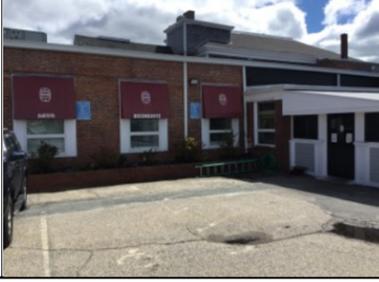
Parking lot not maintained in operable working condition	-	Ensure the parking lot is maintained in operable working condition.	1	-	\$0

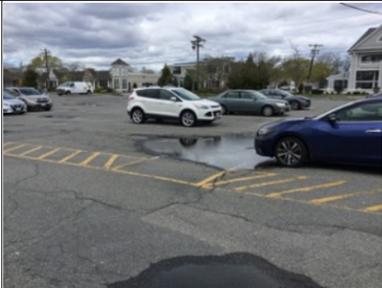
Parking lot not maintained in operable working condition	-	Ensure the parking lot is maintained in operable working condition.	1	-	\$0
<b>Best Practice</b>												
<b>Detectable Warning</b>												
12	Exit Opposite Hyannis Travel Inn From North Street at Parking Lot #1	Ext.		Detectable Warning	N/A

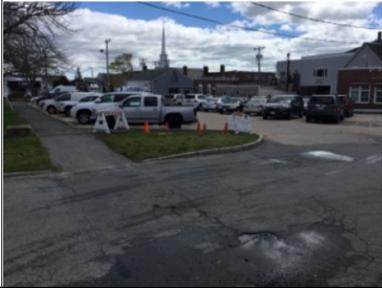
Recommend providing detectable warnings at all the pedestrian routes located near the vehicular entry/exit points.	1	-	\$0

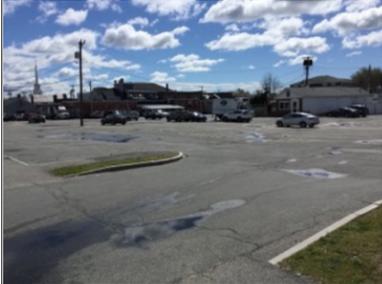
Total # of parking Total # of designated van accessible spaces	19 0	Provide a van accessible space that is at least 132" wide with a marked access aisle that is at least 96" wide. Provide a sign with the bottom of the sign 60" min. above the ground and the top 96" max. above the ground. Add the designation "Van Accessible" to the sign.	1	1850	\$1850
2	North Street at Parking Lot #2	Ext.		Off-Street Parking Lot or Garage	Visitor

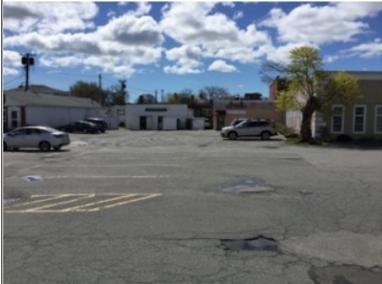
Parking lot not maintained in operable working condition	-	Ensure the parking lot is maintained in operable working condition.	1	-	\$0
<b>Best Practice</b>

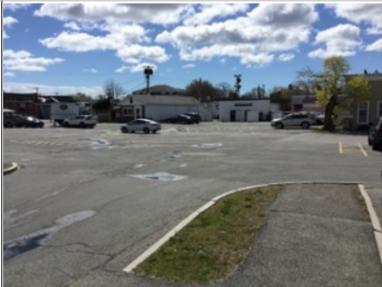
-	Recommend providing detectable warnings at all the pedestrian routes located near the vehicular entry/exit points.	1	-	\$0

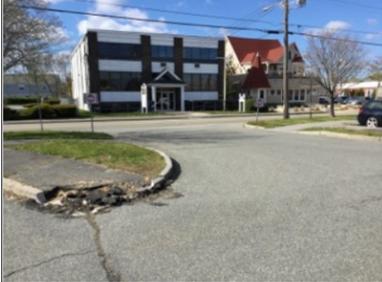
Route not maintained in operable working condition	-	Ensure the accessible route is maintained in operable working condition.	1	-	\$0
<b>Off-Street Parking Lot or Garage</b>												
2	Near Entrance From North Street at Parking Lot #3	Ext.		Off-Street Parking Lot or Garage	Visitor

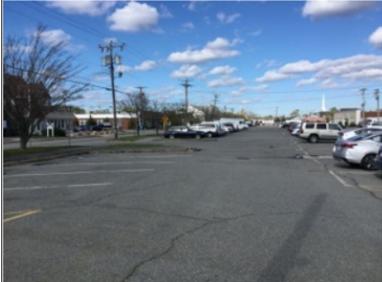
Total # of parking Total # of designated accessible parking spaces Total # of designated van accessible spaces	81 0 0	Provide 3 car accessible parking spaces. Provide 1 van accessible parking space space. Provide signs with the International Symbol of Accessibility (ISA) with the bottom of the sign 60" min. above the ground and the top 96" max. above the ground. Add the designation "Van Accessible" to the sign located at the van accessible space. Ensure that each space has a marked access aisle.	4	1850	\$7400

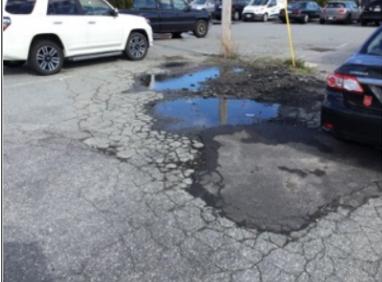
3	Parking Lot - #3	Ext.		Off-Street Parking Lot or Garage	Visitor

Parking lot not maintained in operable working condition	-	Ensure the parking lot is maintained in operable working condition.	1	-	\$0
4	Parking Lot - #3	Ext.		Off-Street Parking Lot or Garage	Visitor

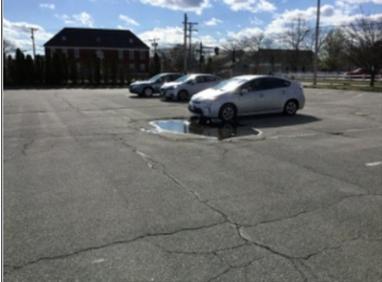
Parking lot not maintained in operable working condition	-	Ensure the parking lot is maintained in operable working condition.	1		\$0
<b>Best Practice</b>

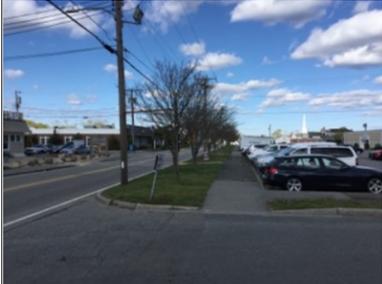
Recommend providing detectable warnings at all the pedestrian routes located near the vehicular entry/exit points.	1	-	\$0
