# Office, Greenhouse and Garage

## Town of Barnstable ADA Transition Plan

August 2021

**Town of Barnstable  
Office, Greenhouse and Garage**

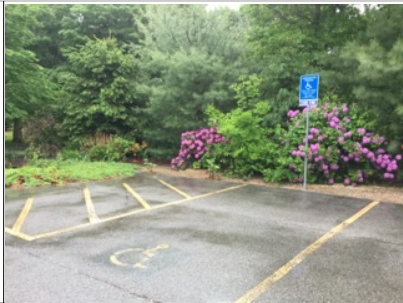
ID	Location	Floor	Room	Element	Type	Photo	Issues	Current Measure	Recommendations	Quantity	Price	Cost Estimation
<b>Approach and Entrance</b>												
<b>Off-Street Parking Lot or Garage</b>												
1	Parking Lot	Ext.		Off-Street Parking Lot or Garage	N/A

Total # of parking Total # of designated van accessible spaces Sign does not have the designation "Van Accessible" Sign top > 96" above finished grade	24 1 - 113"	Add the designation "Van Accessible" to the sign located at the van accessible space. Locate sign with the top of the sign 96" above the ground.	1	500	\$500
<b>Entrance</b>												
2	Office Entrance	Ext.		Entrance	Main Entrance

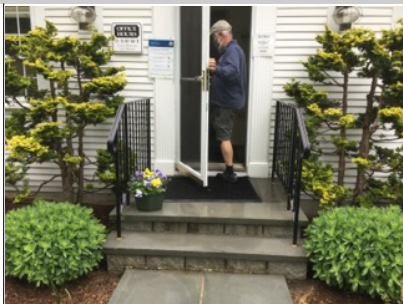
Entrance not on an accessible route	-	Provide a ramp accessible route to the entrance.  (Cost of 6' foot straight ramp.)	1	1600	\$1600
<b>Emergency Exit</b>												
3	Egress - West Side	1		Emergency Exit	N/A

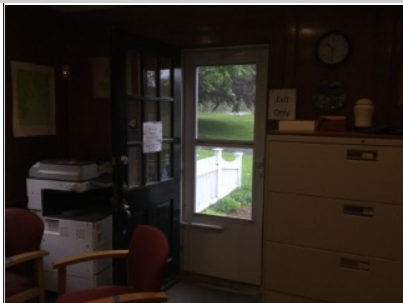
Tactile sign not provided at exit Directional sign to accessible emergency exit not provided	- -	Provide tactile exit signs with raised characters and braille at exit doors. Mount signs between 48"- 60" above the finished floor located on the latch side of the door. Provide a directional sign indicating the location of the nearest accessible entrance/emergency exit.	2	232	\$464

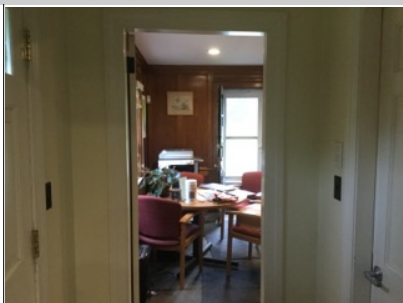
<b>Access to Goods and Services</b>												
<b>Doors, Doorways, &amp; Gates</b>												
4	Meeting Room	1		Doors, Doorways, & Gates	Meeting Room

Clear width at door < 32"	28"	Widen the door so that there is 32" min. clear width.	1	3366	\$3366

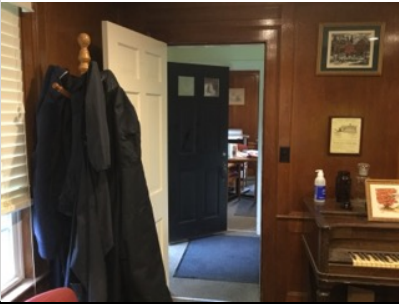
ID	Location	Floor	Room	Element	Type	Photo	Issues	Current Measure	Recommendations	Quantity	Price	Cost Estimation
5	Main Office	1		Doors, Doorways, & Gates	Office

Clear width at door < 32" Maneuvering clearance(s) not provided	28" 10"	Widen the door so that there is 32" min. clear width. Move the piano to provide 18" maneuvering clearance at the hardware side of the door	1	3366	\$3366
6	Main Entrance	1		Doors, Doorways, & Gates	Emergency Egress

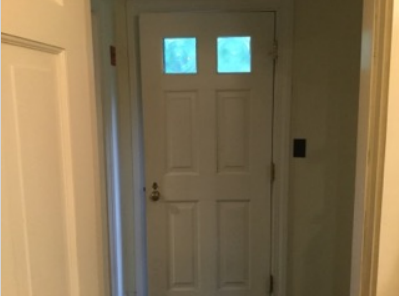
Clear width at door < 32" Maneuvering clearance(s) not provided Hardware not operable with a closed fist	30" 7.5" -	Widen the door so that there is 32" min. clear width. Provide 18" maneuvering clearance at the hardware side of the door. Provide hardware that can be operable with one hand and not require tight grasping, pinching, or twisting of the wrist.	1	3850	\$3850
7	Toilet Room	1		Doors, Doorways, & Gates	Toilet Room

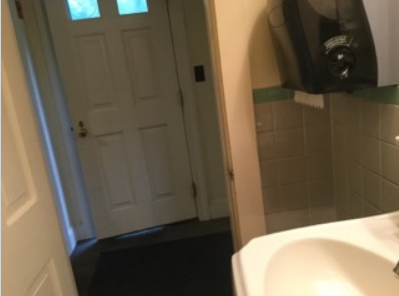
Maneuvering clearance(s) not provided	-	Provide maneuvering clearance at door.  (Cost provided in ID#9)	1	-	\$0

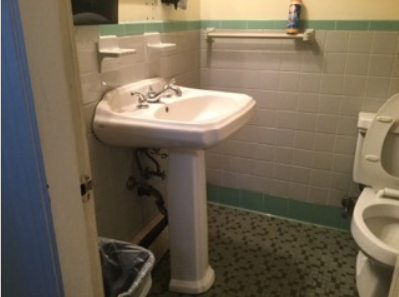
<b>Toilet &amp; Bathing Rooms</b>												
<b>Single-User Toilet</b>												
8	Toilet Room	1		Single-User Toilet	N/A

Grab bar not provided	-	Provide one grab bar on the side wall of the toilet and one on the rear wall.  (Cost provided in ID#9)	1	-	\$0
9	Toilet Room	1		Single-User Toilet	N/A

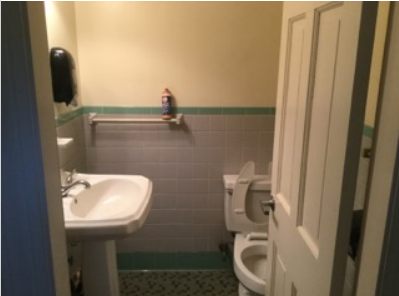
Clearance at toilet < 72" clear depth	59"	Renovate the toilet room to ensure that there is 72" deep min. clear floor space at the toilet.	1	24604	\$24604
