Town of Barnstable Long Pond & Mystic Lake Non-Native Vegetation Management Program

Long Pond & Mystic Lake Hydrilla (*Hydrilla verticillata*) Management

**Project Completion Report for 2013 Hydrilla Management Performed at
Long Pond & Mystic Lake – Barnstable, MA**

February 2014

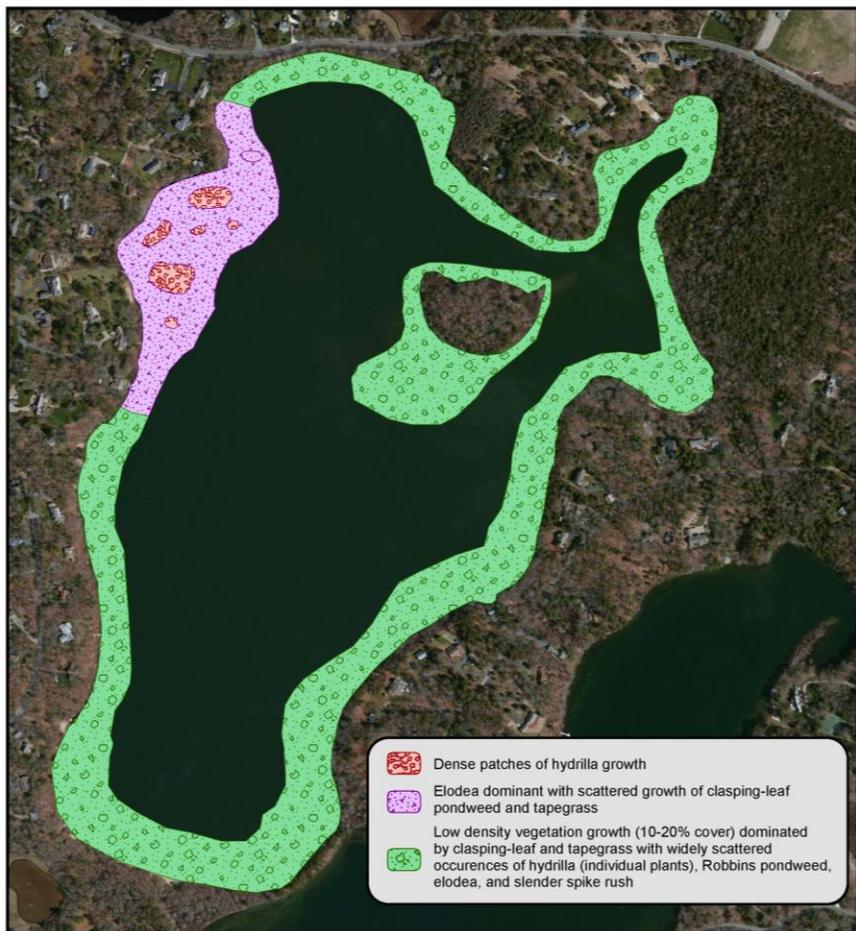
Figure 3 – 2013 Pre-Treatment Vegetation Distribution Map

Vegetation was generally confined to the immediate shoreline, extending roughly 75-100' feet from shore to a depth of 10-12 feet creating a contiguous ring around the lake. The plant assemblage was generally characterized by low-density growth of clasping-leaf pondweed and tapegrass (*Vallisneria americana*) with scattered occurrences of hydrilla (mostly individual plants), Robbins pondweed, common waterweed (*Elodea canadensis*) and slender spikerush. Pockets of hydrilla were observed around much of the lake shoreline, all of which had been previously identified by the lake association. The only area that supported dense contiguous hydrilla growth was the cove area along the western shore (the ~5.5 acre area designated herbicide treatment area). This area was the only area in the lake that had dense growth of the native plant waterweed. Hydrilla growth was still immature in early July and was only 4-6" inches in height. A map of the representative conditions observed on July 5 is above.

This area was the only area in the lake that had dense growth of the native plant waterweed. Hydrilla growth was still immature in early July and was only 4-6" inches in height. A map of the representative conditions observed on July 5 is above.

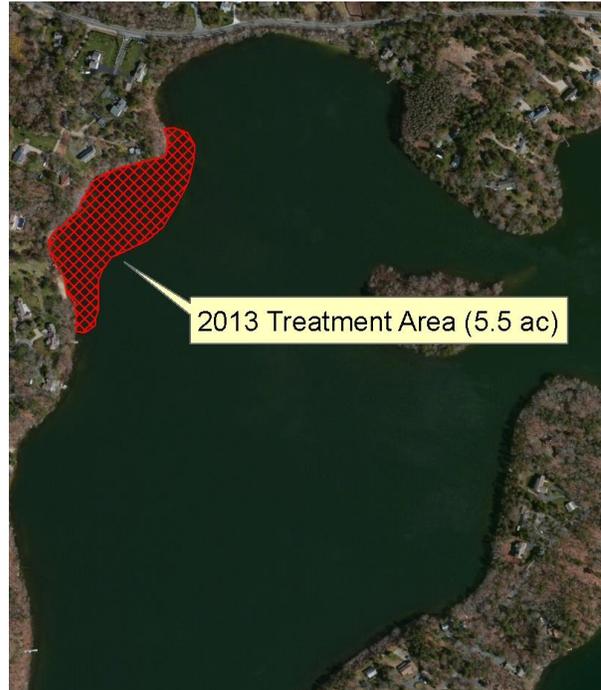
Treatment of the 5.5 acre cove area was performed on Monday July 22 & Tuesday July 23 (see picture right).

The treatment was conducted with an 18 foot work skiff equipped with a specialized low pressure spray system. The liquid Aquathol K herbicide was applied subsurface using weighted hoses to avoid aerial drift of the herbicide. The treatment boat was equipped with a Differential/WAAS GPS navigation system to insure that the herbicide was evenly applied to the designated treatment area.

Treatment was performed as a split application whereby roughly 50% of the herbicide was applied to the designated treatment area on the first day of treatment and then the remaining 50% was applied 24 hours later. This split application approach was used to increase concentration-exposure-time (CET) and increase the efficacy of treatment. Aquathol K herbicide was applied at a target dose of 1.5ppm during each application for a total dose of 3.0 ppm over the course of the two day treatment.

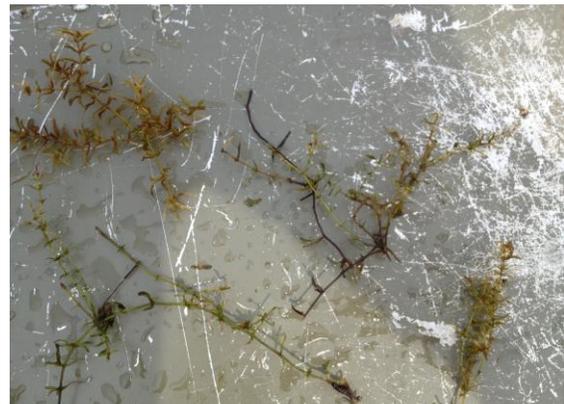
Impacts from the treatment were slow to develop and on August 7 most of the plants in the treatment area appeared relatively unharmed. While the plants appeared to have stopped growing and were the same height as they were prior to treatment, they were still green and erect in the water column. By August 19, twenty eight days after treatment, the hydrilla in the treatment area was showing more typical signs of herbicide exposure having lost their vibrant green color to a more yellowish brown, losing leaflets on the lower portion of their stems and becoming very brittle.

Representative Hydrilla growth on August 19

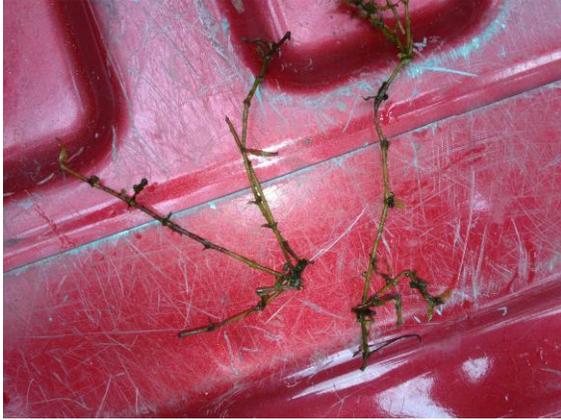
Representative Hydrilla growth on October 15

Hydrilla was still evident in the treatment area at the time of the late season survey on October 15, however impacts from the herbicide were more evident, and most of the observed growth was limp and lying on the lake bottom. No signs of tuber production were evident within the treatment area but some of the plants observed on the periphery of the treated area were not as degraded, so it is possible that some recovery and tuber production did occur outside of the 5.5 acres area.
