Nauset Environmental Services, Inc.

NES Job # 2-207
Report No. NES/ASB-14/1607

Re: Pre-remodeling asbestos inspection & sampling at
Exterior of JFK Museum (Hyannis)
PO#: 14008894

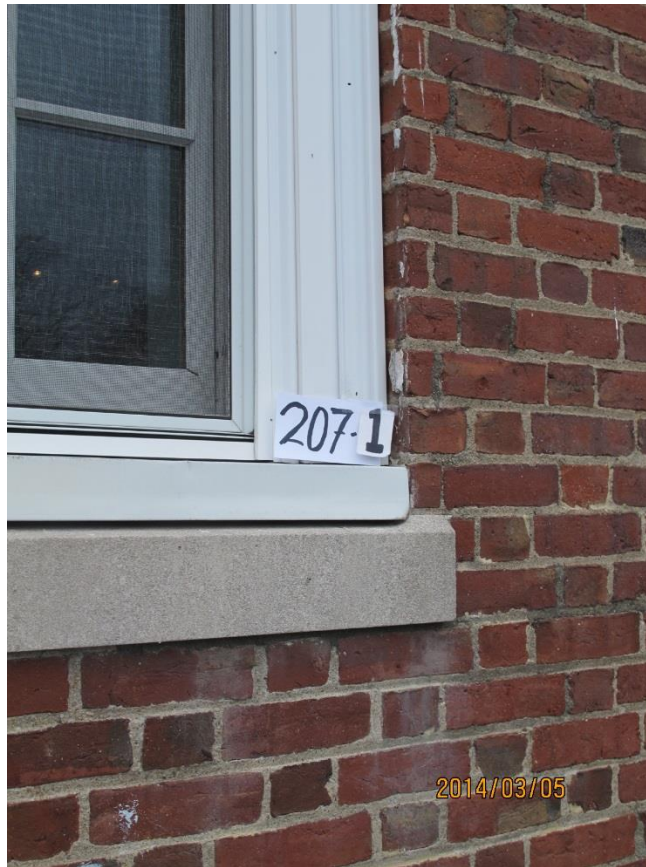
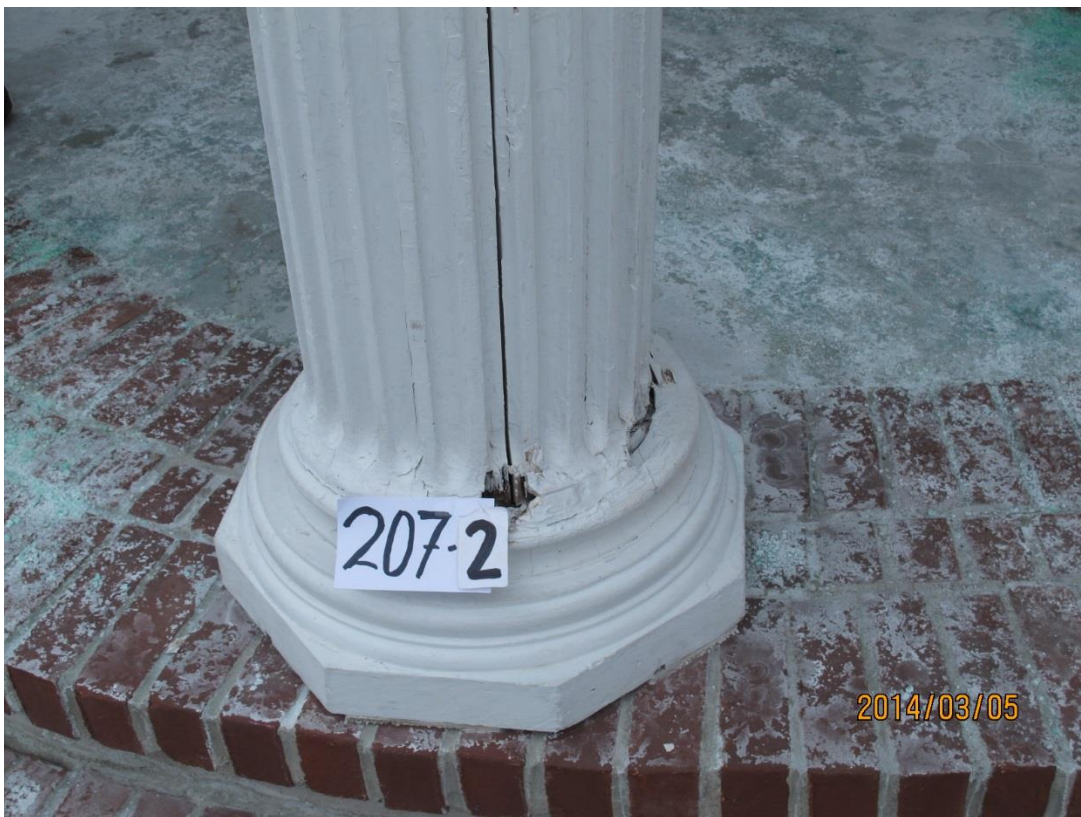
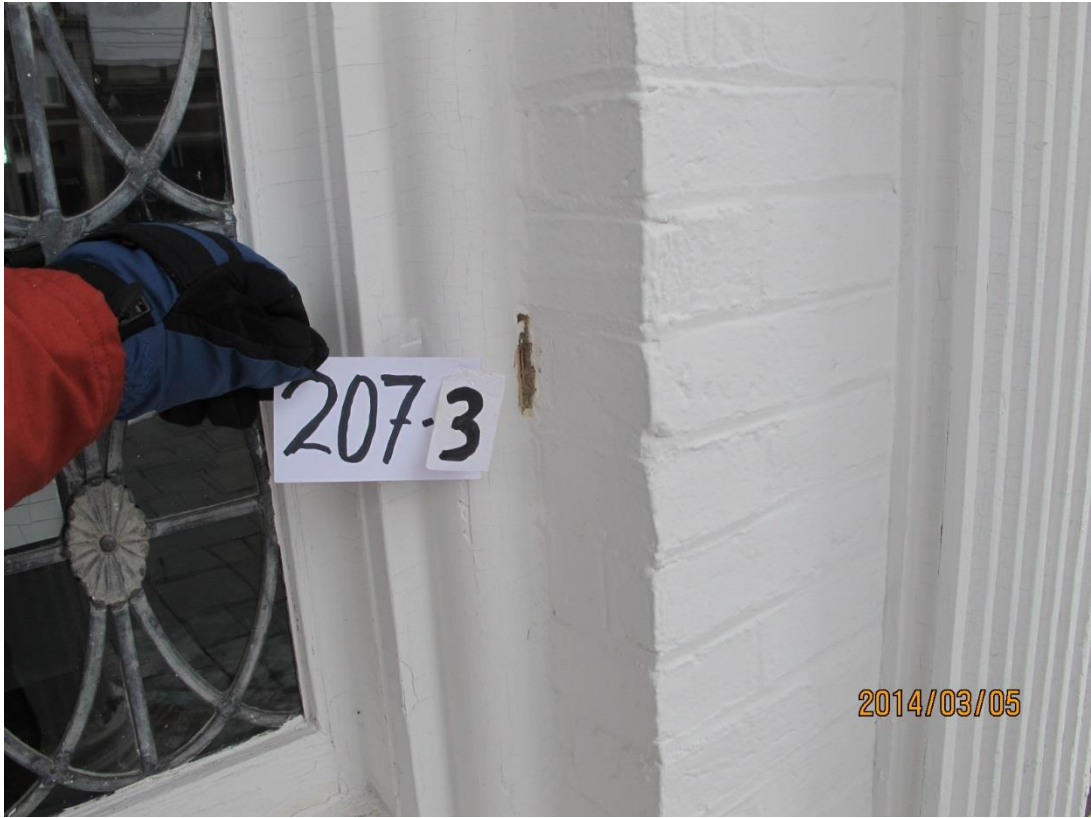
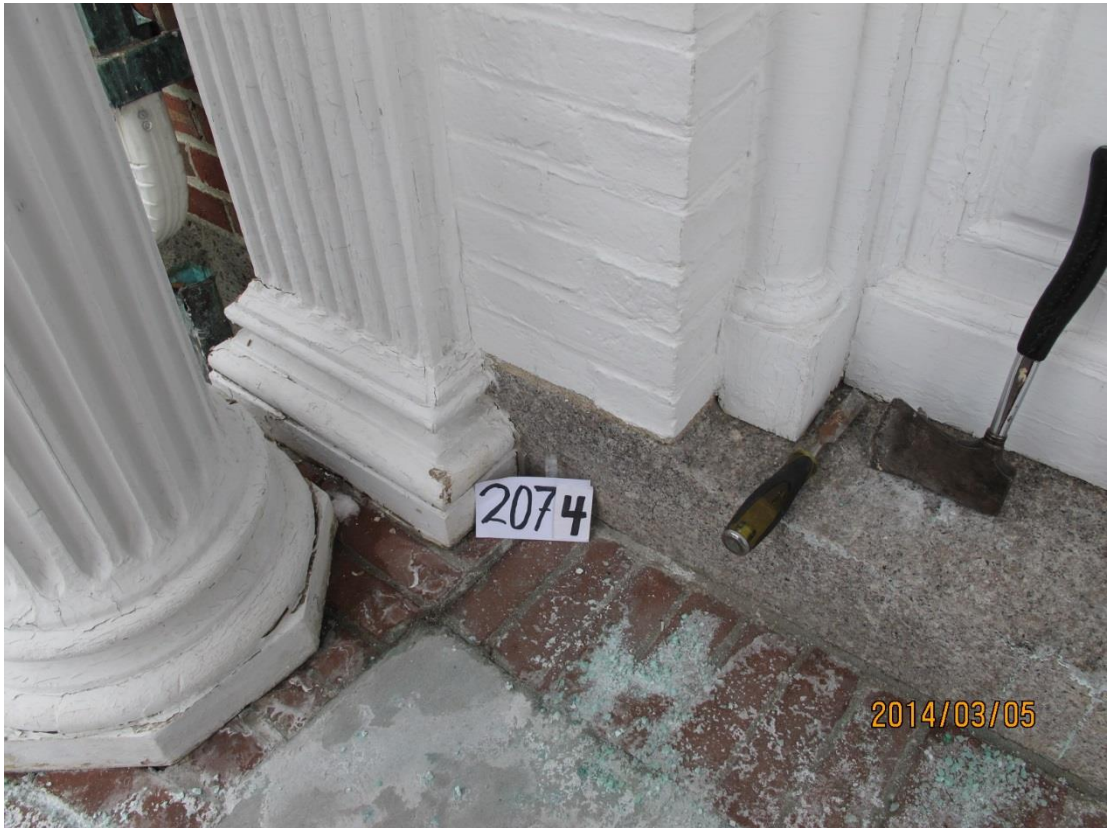
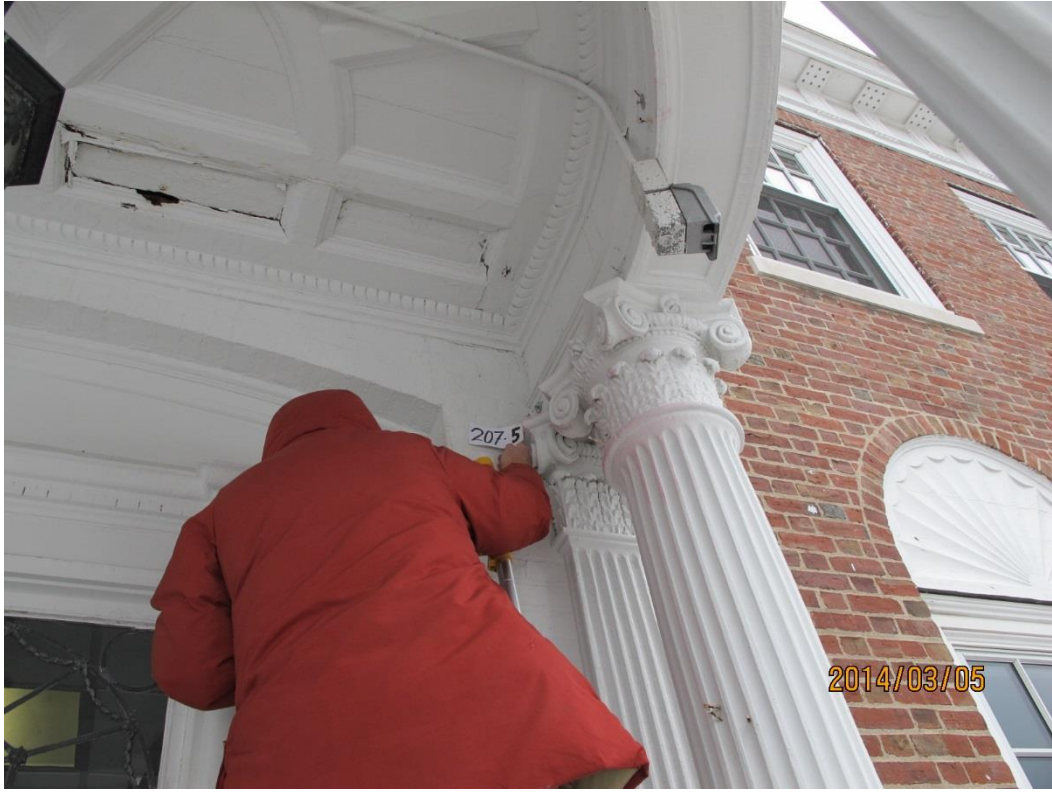
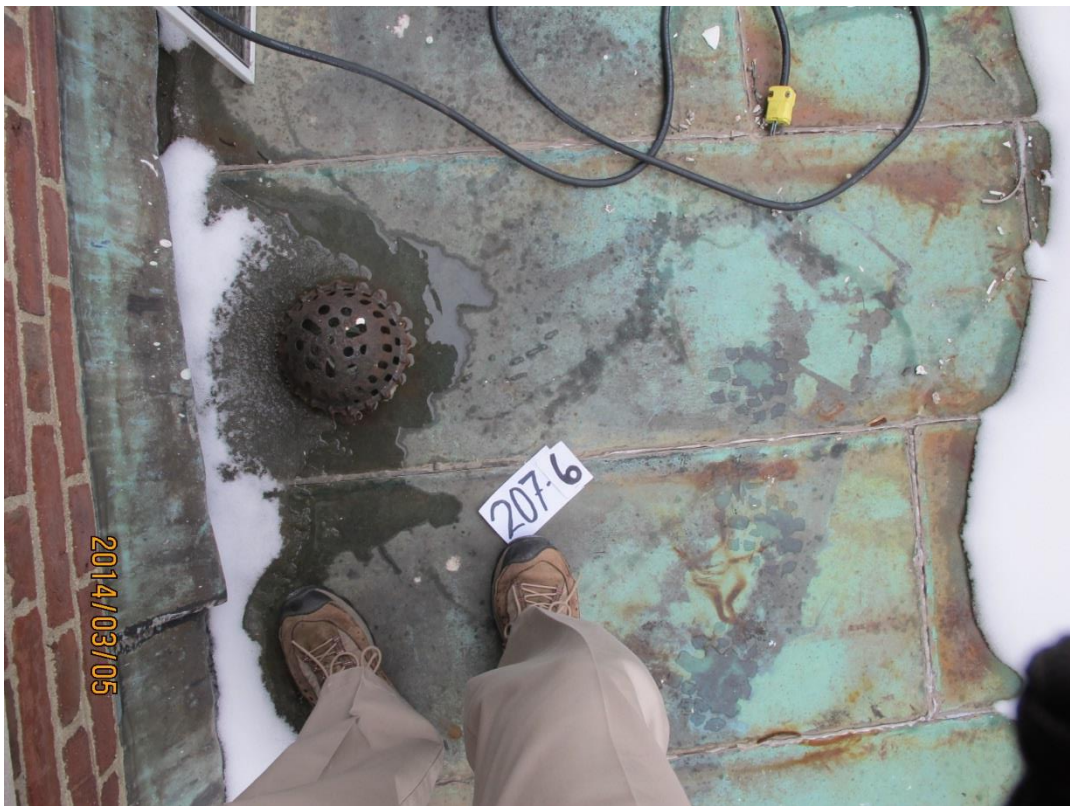
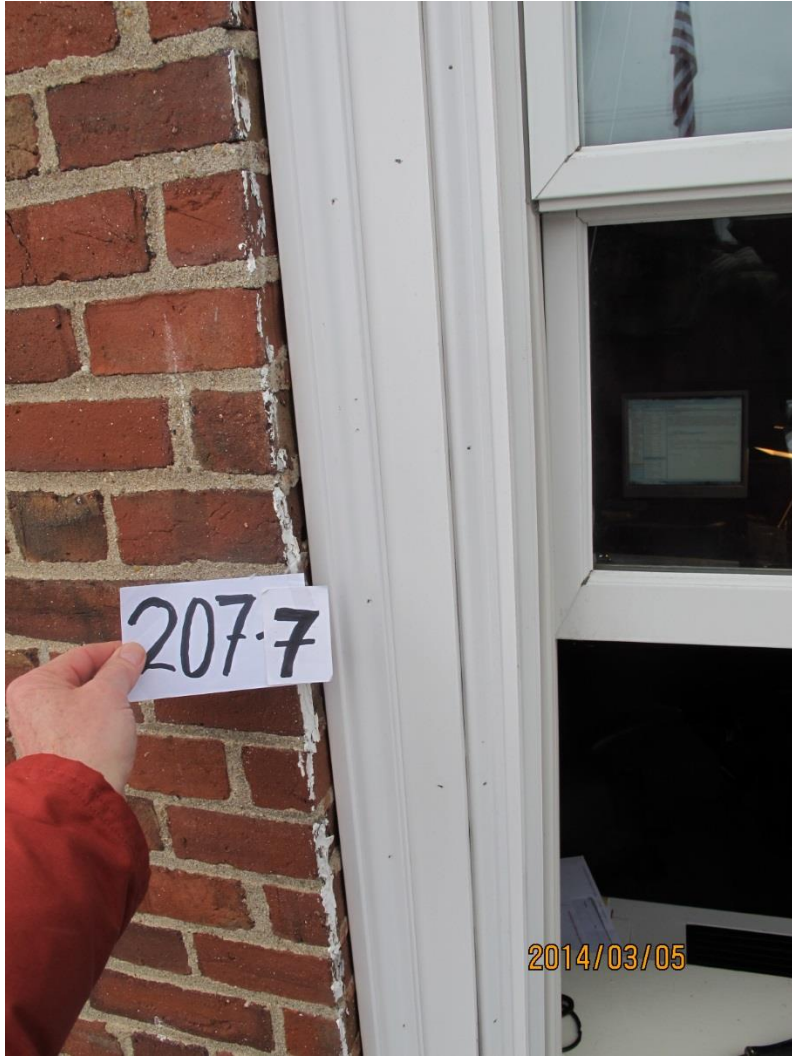
Sampling locations

From sample results, asbestos was found at three locations – the two window frame locations and the caulk/glazing between the brick wall and the front door framing (see photo for sample 207-3). The latter would apply to both sides of the front door and **not** any of the caulk/sealants between wooden structures forming the pseudo Greek columns themselves.

- Any residual window caulking/glazing found around any/all windows
- The caulking/glazing used to seal the gaps between the bricks and the front door framing on both sides of the door.
