Bismore Park

Town of Barnstable ADA Transition Plan

September 2021

Institute for Human Centered Design

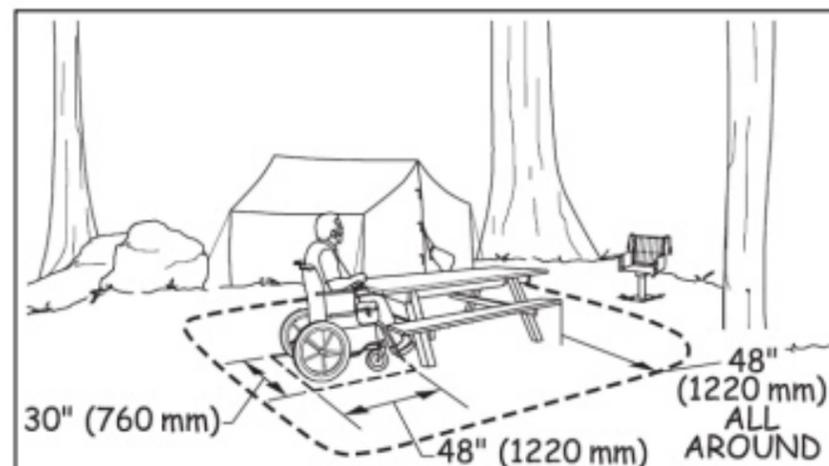
Best practice and inclusive design recommendations include elements that are not required in the standards but may create enhanced experiences for all users.

- Recommend providing some benches with back support and some with armrest.
- Recommend providing a 36" by 48" clear floor space adjacent to one (1) bench at Ocean Street (south side) and one (1) bench at the Artist Shanties and ensure shoulder alignment is provided.
- Recommend adding contrasting strips at the edge of each step at the exterior stairs.
- Recommend providing a detectable warning at curb ramps.
- When an accessible picnic table is provided on an accessible route, IHCD recommends providing a stable, firm and slip-resistant surface for 48" clear on all sides of the picnic table. See the following illustration:
