## Sandy Neck Beach Gatehouse

### Town of Barnstable ADA Transition Plan

August 2021

Institute for Human Centered Design

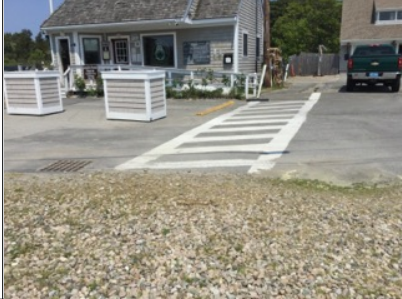
ID	Location	Floor	Room	Element	Type	Photo	Issues	Current Measure	Recommendations	Quantity	Price	Cost Estimation
<b>Approach and Entrance</b>												
<b>Exterior Access Route</b>												
1	Path to Gate House From Parking Lot	Ext.		Exterior Access Route	Exterior

Surface is not stable, firm, and slip-resistant	-	Repair surface.  (Cost of 4' wide by 12' long concrete path from access aisle to street crossing.)	1	768	\$768
<b>Off-Street Parking Lot or Garage</b>												
2	Parking Lot	Ext.		Off-Street Parking Lot or Garage	Visitor

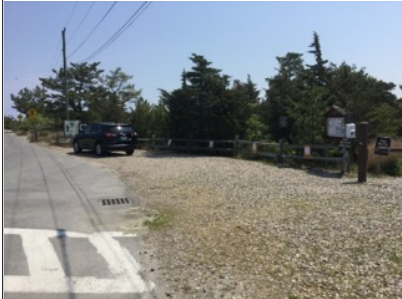
Total # of parking Total # of designated accessible parking spaces Total # of designated van accessible spaces Surface not stable, firm, and slip-resistant	6 - - -	Provide a compliant van accessible parking space with a marked access aisle. Include a designation sign with the International Symbol of Accessibility (ISA) and the designation "Van Accessible"  (Cost for a van accessible space with a concrete surface for the space and access aisle.)	1	6458	\$6458

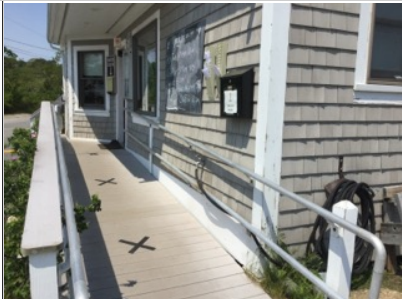
<b>Exterior Ramp</b>												
3	Ramp to Bathhouse Entrance	Ext.		Exterior Ramp	N/A

Handrails < 1 1/2" to adjacent surface Edge protection < 4" high	1" - -	Alter the handrails so they are mounted 1-1/2" min. from adjacent surface. Provide edge protection that prevents the passage of a 4" diameter sphere, where any portion of the sphere is within 4" of the finished floor or ground surface.	2	1260	\$2520
<b>Access to Goods and Services</b>												
<b>Doors, Doorways, &amp; Gates</b>												
4	Toilet Room	1		Doors, Doorways, & Gates	Toilet Room

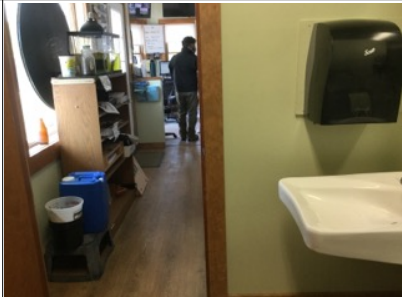
Maneuvering clearance(s) not provided	11.5"	Provide an automatic door opener.	1	3060	\$3060

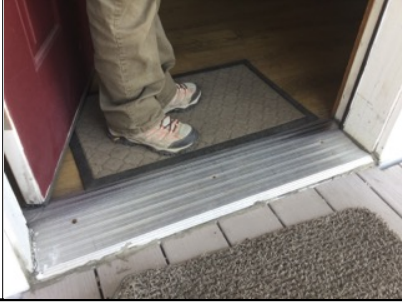
ID	Location	Floor	Room	Element	Type	Photo	Issues	Current Measure	Recommendations	Quantity	Price	Cost Estimation
5	Bathhouse Entrance	Ext.		Doors, Doorways, & Gates	Emergency Egress

Threshold > 1/2" high	1.25"	Alter the threshold to be 1/2" high max.	1	150	\$150
<b>Operable Parts</b>												
6	Ramp to Bathhouse Entrance	Ext.		Operable Parts	Other

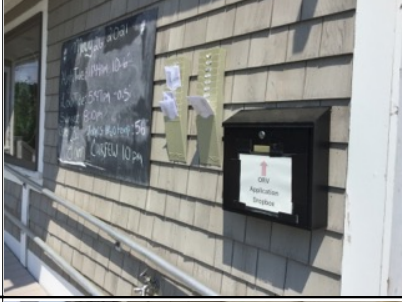
Side reach > 54"	58.75"	Relocate application box so that controls are between 15" - 48" above the finished floor.	1	Labor	\$0
7	Bathhouse Entrance	Ext.		Operable Parts	Other

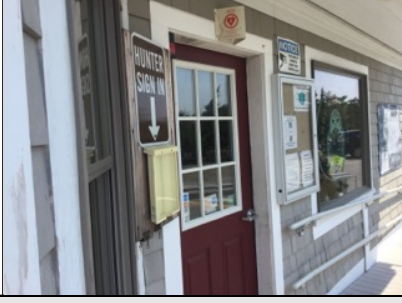
Side reach > 54"	57"	Relocate sign in sheets box so that controls are between 15" - 48" above the finished floor.	1	Labor	\$0
<b>Toilet &amp; Bathing Rooms</b>												
<b>Lavatory</b>												
8	Toilet Room	1		Lavatory	N/A

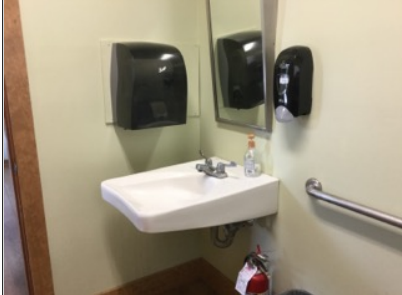
Mirror above lavatory w/reflective surface > 40"	43"	Lower mirror so that the bottom surface is at 40" max. above the finished floor.	1	256	\$256

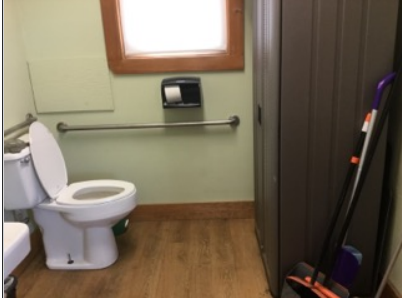
ID	Location	Floor	Room	Element	Type	Photo	Issues	Current Measure	Recommendations	Quantity	Price	Cost Estimation
<b>Single-User Toilet</b>												
9	Toilet Room	1		Single-User Toilet	N/A

Centerline < or > 18" (MAAB) Side or rear grab bar < 33" or > 36" high Clearance at toilet < 72" clear depth Toilet paper dispenser is not compliant	19" 31" - -	Relocate toilet so that the centerline is 18" from the side wall. Mount grab bars 33"- 36" above the floor. Relocate cabinet. Relocate toilet paper so that it is 24" min. high, located under the grab bar, and between 7" and 9" from the front of the toilet.	1	3340	\$3340
